Zierer Wave Swinger service bulletin

Service Bulletin

Zierer Bulletin #	Revision:	Page	System	Description:	Date:	Issued:
SB-WS-1004	1	1 of 5	Wave Swinger	Service Bulletin	15.01.2016	röt/hast
Original Ride Manufacturer			Release Date	Affected Production Dates:	Ride Name:	
ZIERER – Karussell und Spezialmaschinenbau			2016		Wave Swinger

1 Reason for this service bulletin

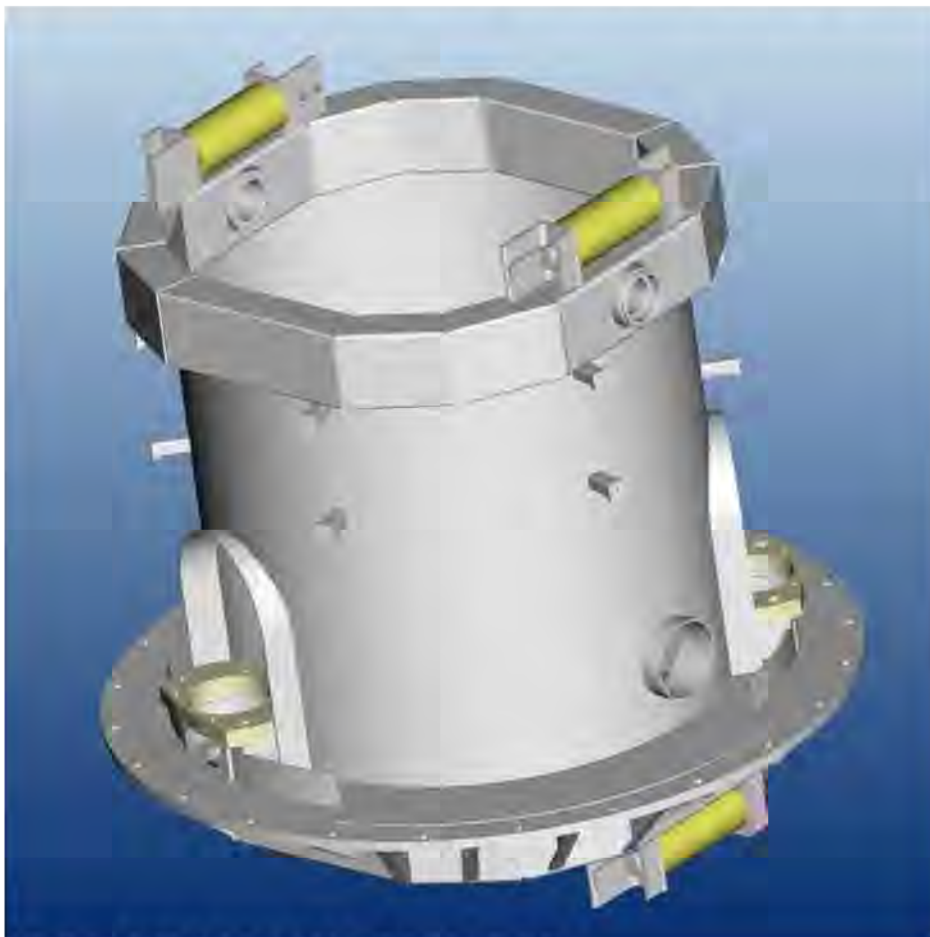
Image 1: 3-D model of the inner basket

The inner basket is one of the spots this service bulletin wants to focus on.

We want you to perform a visual check of the welding seams **once a month** and not like in the old revision of the NDT schedule once a year.

Please make sure that you clean the welding seams before each check.

At the bigger check (the first time after 12 years and then every 6 years (Y12 in testing schedule)) you have to check the welding seams either with magnaflux, paint penetration or ultrasonic method to make sure that there are no cracks.

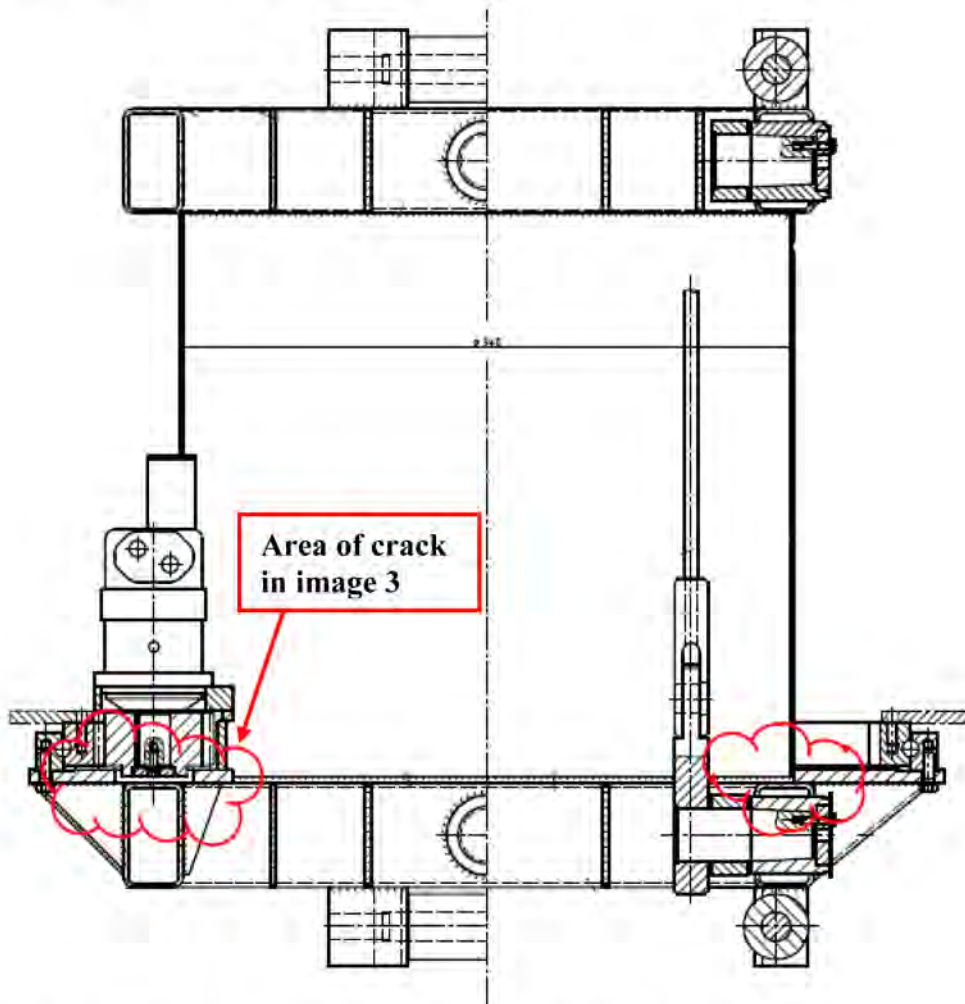
Image 2: Drawing of inner basket with highlighted areas

The following images should give you an idea where the most critical areas for cracks are

Check all of the welding seams on the basket, especially those in the highlighting clouds. Please inspect the seams in regular intervals and contact us if there are any complications.

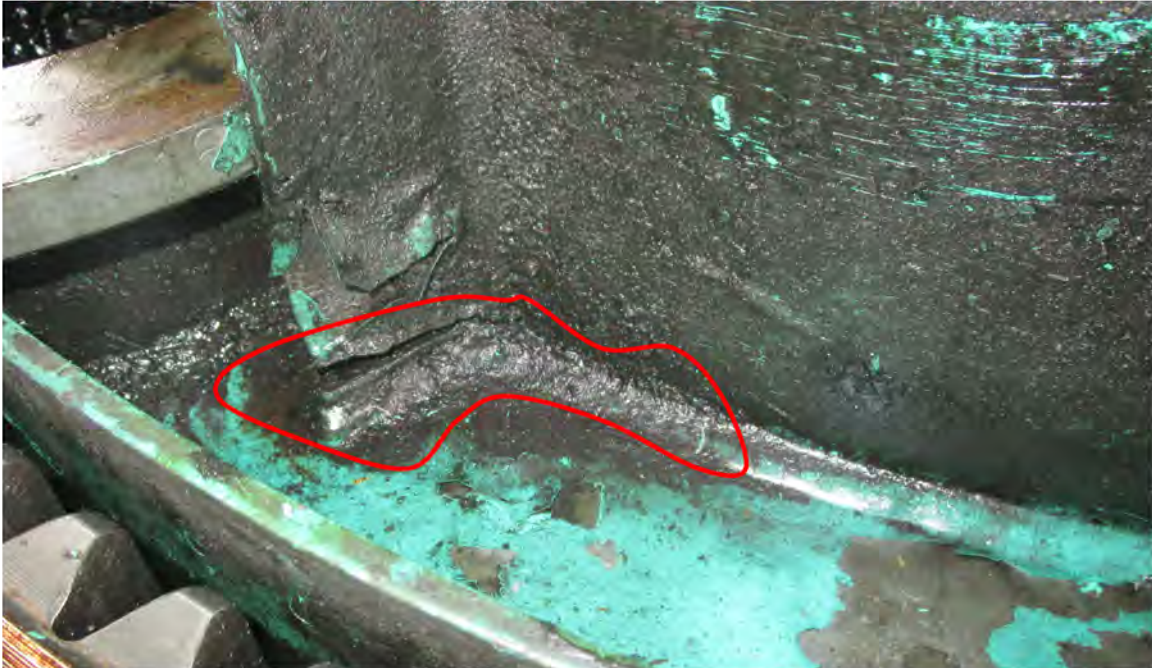
Image 3: Crack over the welding seam at an inner basket

As a bad example we want to show you image 3, which displays an area of a basket which is cracked because of metal fatigue. Please note that this would not have happened if the owner of this ride would have performed regular checks.

Do not take the crack in image 3 as a reference because this is the worst case!!

To identify a crack as soon as possible is very important according to the safety aspect. Another goal why you have to identify a crack as early as possible is the fact that fixing a little crack is a way more easy than a bigger one (Image 3).

If you see a crack it does not matter how big it is, you have to shut down your ride and fix all cracks by an expert in a proper way. To operate a ride with a crack is strictly not allowed!
