TO ALL SKYMASTER AND
HIGHFLYER OWNERS:

SERVICE BULLITIN:

RE: LAP BAR PAWLS

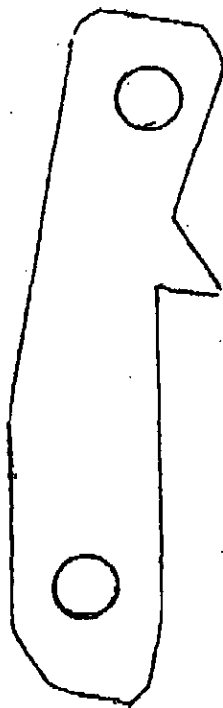
NORMAL

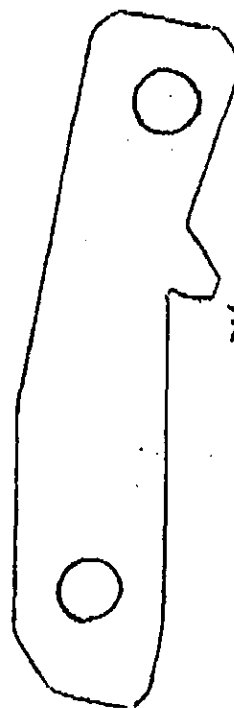
THIS IS TO INFORM SKYMASTER AND HIGHFLYER OWNERS THAT THE PRACTICE OF LOADING OF PASSENGERS WITH THE LAP BARS IN THE "UP" POSITION, AND THE "LOCKED" POSITION, WILL SPEED UP THE NORMAL WEAR & TEAR OF THE PAWL TOOTH.

WHEN A PASSENGER IS LOADED AND PULLS THE LAP BAR DOWN, AND IT RATCHETS, WE HAVE FOUND WILL EXPEDITE THE PAWLS NORMAL WEAR.

CHECK LAP BAR PAWL TIP FOR WEAR AND DEFECTS.

MAXIMUM TIP WIDTH NOT TO EXCEED 1.5mm.

EXCESSIVE WEAR

Approximate 1/8"
MAX.
WEAR
EXCEEDS
1.5mm

WE RECOMMEND LOADING OF THE RIDE, THEN ALL LAP BARS BE PULLED DOWN BEFORE LAP BARS ARE "LOCKED" AND THEN CONFIRMED ALL ARE SECURE BY THE OPERATOR.

IF WEAR EXCEEDS THIS AMOUNT THEN REPLACE
WITH A NEW FACTORY UNIT.
