BREDGE COMPANY

RE: BIG EII Rides that have been trailer-mounted, modified, or otherwise "re-manufactured" elsewhere.

BIG ELI® WHEEL BULLETIN NUMBER 3

Big Eli® Wheel Bulletin No. 6

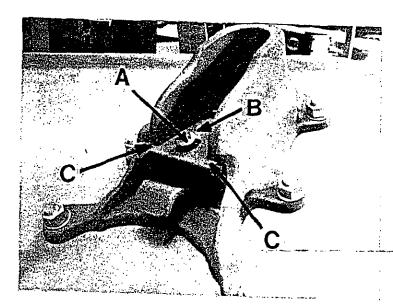
We immediately began an investigation to determine what the situation was. We found that on our last production run completed on April 28 some of the pins marked "A" were slightly shorter than the standard length. The hinged part, "B", was prevented from pressing against the shoulders, marked "C", because "B" was touching pin "A". Therefore, even though the seat lock did lock in the seat hanger casting, it was not as firmly locked as we feel it should be.

Our records indicate only five customers have been shipped seat locks since that production run was completed, and you are one of them. It is possible that you received one or more of these short-pin seak locks, and we ask that you check each one to be sure that the hinged part "B" is touching the seat hanger casting at points "C". Those that do not touch points "C" should be replaced.

We feel that it is mandatory that all short-pin seat locks be replaced.

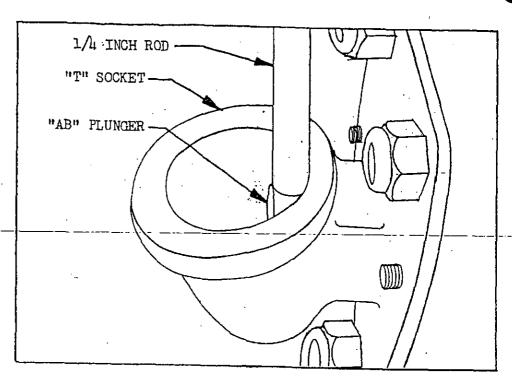
he way there may not be enough engagement of the plunger in the "J" lock. If it appears you have alweak spring, do not hesitate to replace it.

Over a period of time if the lower edge of the slot in the "J" lock becomes rounded or chipped as much as 1/16 inch, then the "J" lock should be replaced.

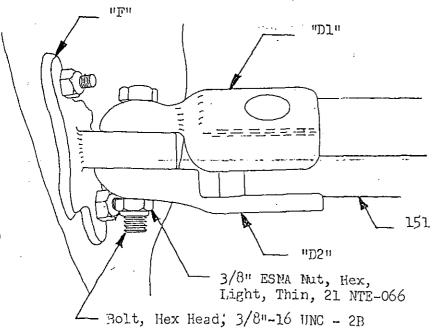
There have been reports of the No. 152 Handlebar Cap Screw working loose, which requires re-tightening. In an effort to prevent it becoming loose again, the cap screw is sometimes tightened too much, and the

"D1" and "D2" castings are bent toward each other. This then squeezes the two castings against the "F" hinge, so that the handlebar will not swing freely.

We are installing on all new seats a 2 inch long 3/8" coarse thread bolt, and outside the "D2" casting we are adding a 3/8 inch coarse thread thin height self-locking nut with a Nylon insert. The bolt should be tightened enough to hold the two castings to the handlebar, but not so tight that they are benithen the self-locking nut should be

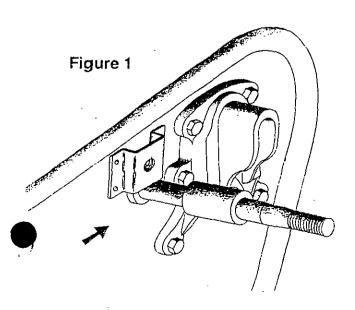
In the other case, the owner had installed the hair guard bracket incorrectly: he had rotated the bracket one-quarter turn so that the opening under the bracket was on the bottom instead of on the side where it should have been. The operator then lowered the seat into position, but instead of the seat pin entering the "Y" casting the head of the pin was inserted inside this hair guard bracket. This is shown in Figure 1.

Thinking that the seat was hung properly the operator reached around and inserted the "MYNY" seat lock without looking at the end of the seat. Had he looked, it would have been obvious the seat was not hanging properly, and the seat lock was actually locking nothing.

') your Wheel does not have hair guards, we consider it mandatory that they be used. If the hair guard bracket on either side of the seat has been located as shown in Figure 1, then it should be replaced. The hair guard brackets on the back of the seat can be turned either way because safety is not affected.
