# NAFLIC

TECHNICAL BULLETIN — February 2015

## **388. Huss Enterprise/UFO boom cracking**

### Service-Information 05-02

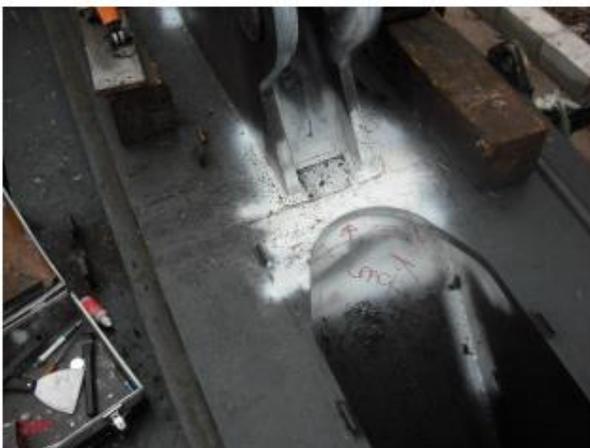
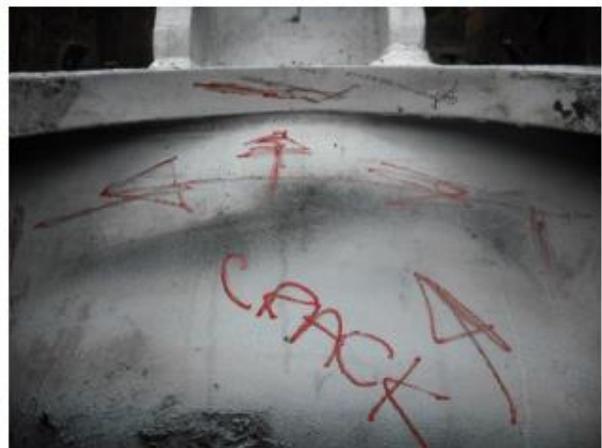
The cracking is located below the upper ram attachment area and under the main boom plate. Both areas of cracking that have been found are between 370mm - 390mm long and were both found visually and then subjected to MPI to establish the full length of the crack.

One of the devices was inspected with the ram removed and the other with the ram in place; on both devices the cracking was easily found.

It is understood Huss has issued a repair procedure that incorporates additional strengthening plates. Please see photographs below and attached related documents.

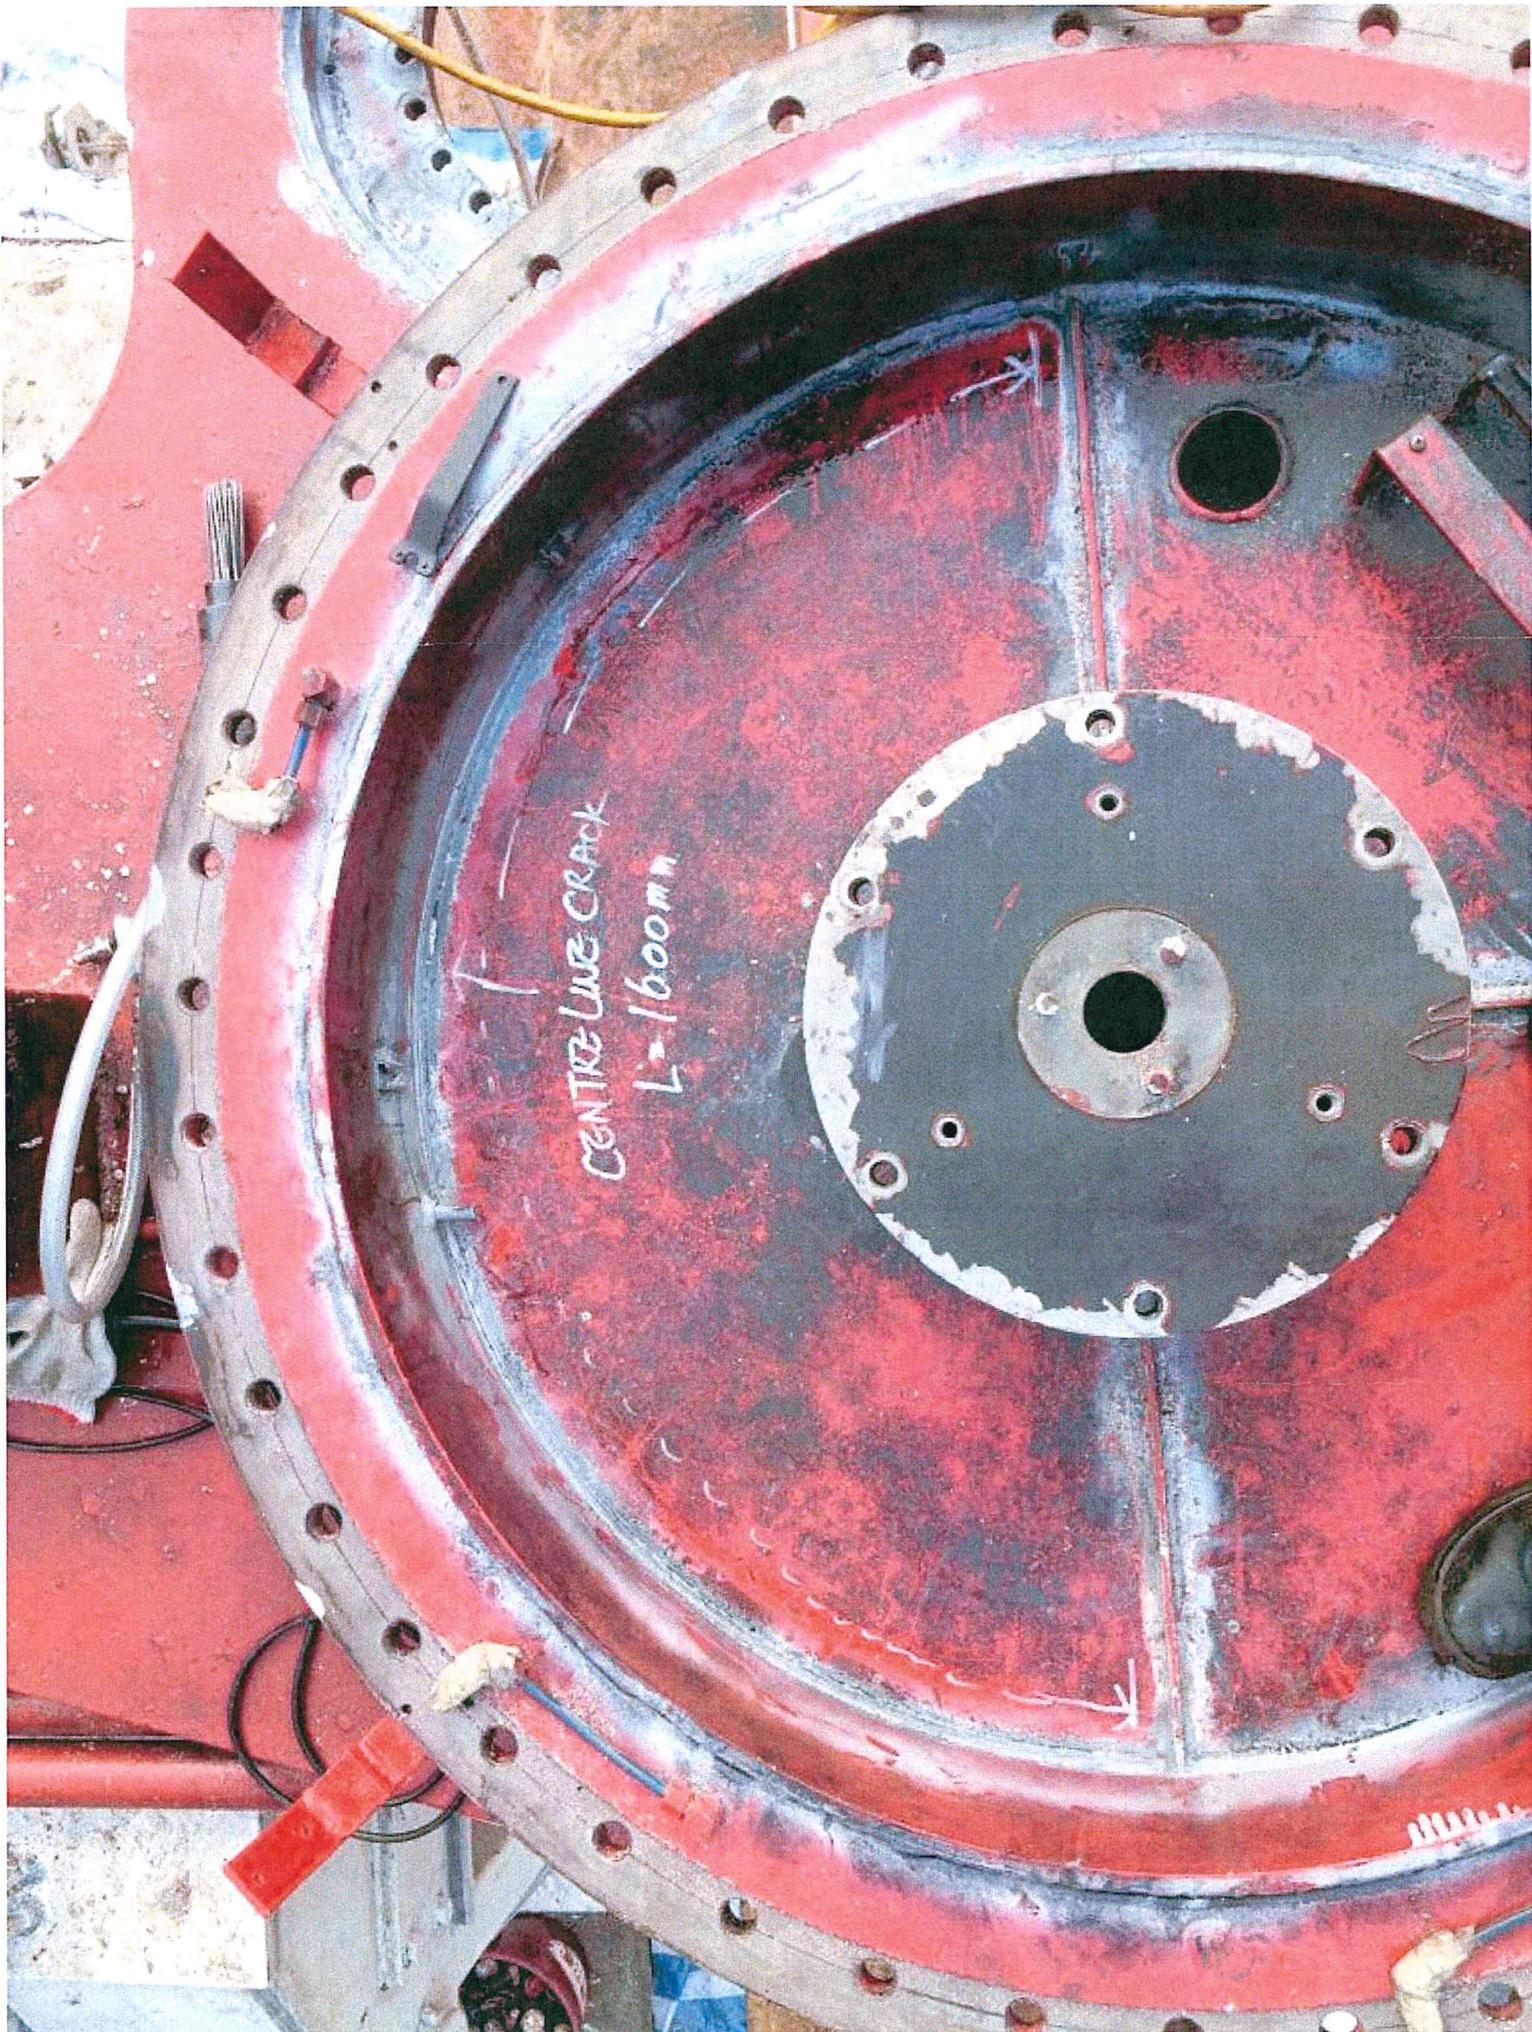
During a general overhaul of an Enterprise ride, cracks in the area of the boom head have been detected.

CENTRE LINE CRACK  
L=1600mm

It is strongly recommended to get this area inspected by a certified company.
