Bulletin No.: SR-8.5- 07002
Release Date: May 3, 2007
Effective Date: Immediate
Completion Date: Annually
Page 1 of 3

SERVICE BULLETIN

Ride Manufacturer: Moser Rides srl
Ride Name: Spring Ride – Permanent –Ground Mount and Protable-8.5 meter tall
Affected Serial Numbers: All including New Jersey TC-00045-00 & -01 S/N ZA9SR0407USH34131

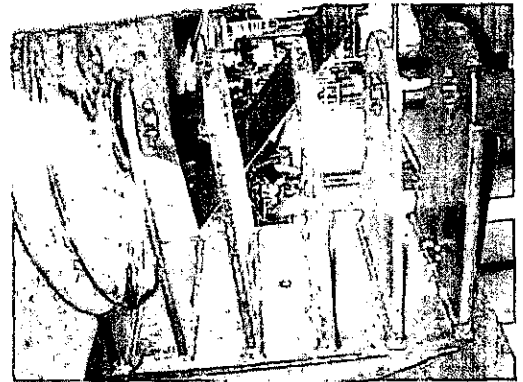
Visually inspect the structural welds for possible cracks or excessive corrosion of the: Column, trolley, seat benches and, base. Particular attention must be given to the connection of the tower structure connection to the base frame of the ride and to the bolted coupling connecting the benches to the trolley. Also check the welds at the sheave structure at the top of the tower and any other accessible structural areas

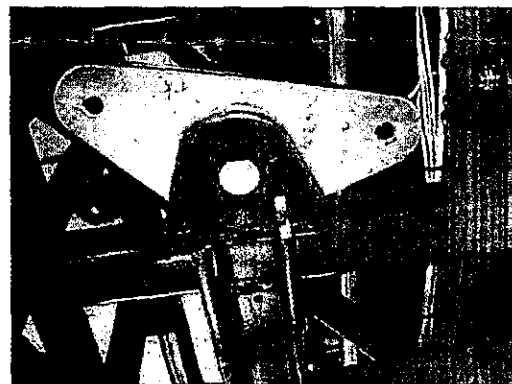
Visually check the pins and bushings of the upper sheaves for wear. Visually check the pins and bushings of the wire rope balance assembly. The wear in this area is normally related to the bushings. If the sheaves or balance arms wobble, it is necessary to replace the pin and the bushing.

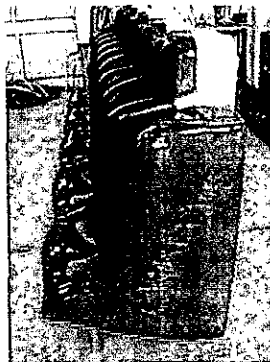
Visually check for any wobble in the safety restraint by pulling each side of each restraint in opposite directions. Any wobble indicates that there is wear in the restraint bushings of the restraint being checked. If there is wobbling in the restraint being checked, the restraint bushings need to be replaced.
