November 15, 1994

SERVICE BULLETIN 94-2

SUPER LOOPS (RING OF FIRE)

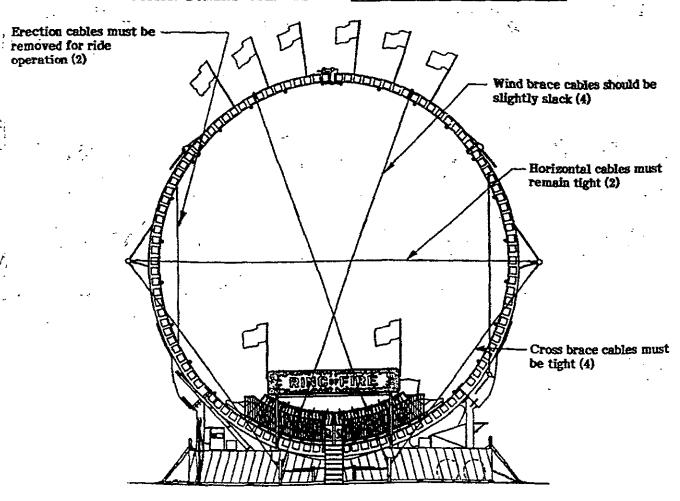
The purpose of this bulletin is to alert ride operators/ride inspectors of the proper cable tensions for Super Loops (Ring of Fire). The illustration below depicts the proper cable tensions on the horizontal and cross brace cables. The two (2) erection cables shown, for illustration ONLY, must be removed before any passengers are allowed on this ride. The reason the erection cables must be removed is so passengers cannot reach hands and arms outside the train and grab the cables.

The reason the wind brace cables must not be tight is to keep the track a true circle. These cables, when overtightened, will crush the circle into an elliptical shape. This causes extreme pressures on the jactuators and the train axles during operation.

THE ERECTION CABLES MUST ABSOLUTELY BE REMOVED FROM RIDE CAUTION: BEFORE PASSENGER OPERATION. DO NOT TIE ERECTION CABLES TO TRACK DURING OPERATION - REMOVE CABLES FROM RIDE!
