RE: Austin, TX, Himalaya Death of 3/19/98;

# **SERVICE BULLETIN**

**RIDE: HIMALAYA**

**SUBJECT: HIMALAYA SECONDARY SWEEP REINFORCEMENT**

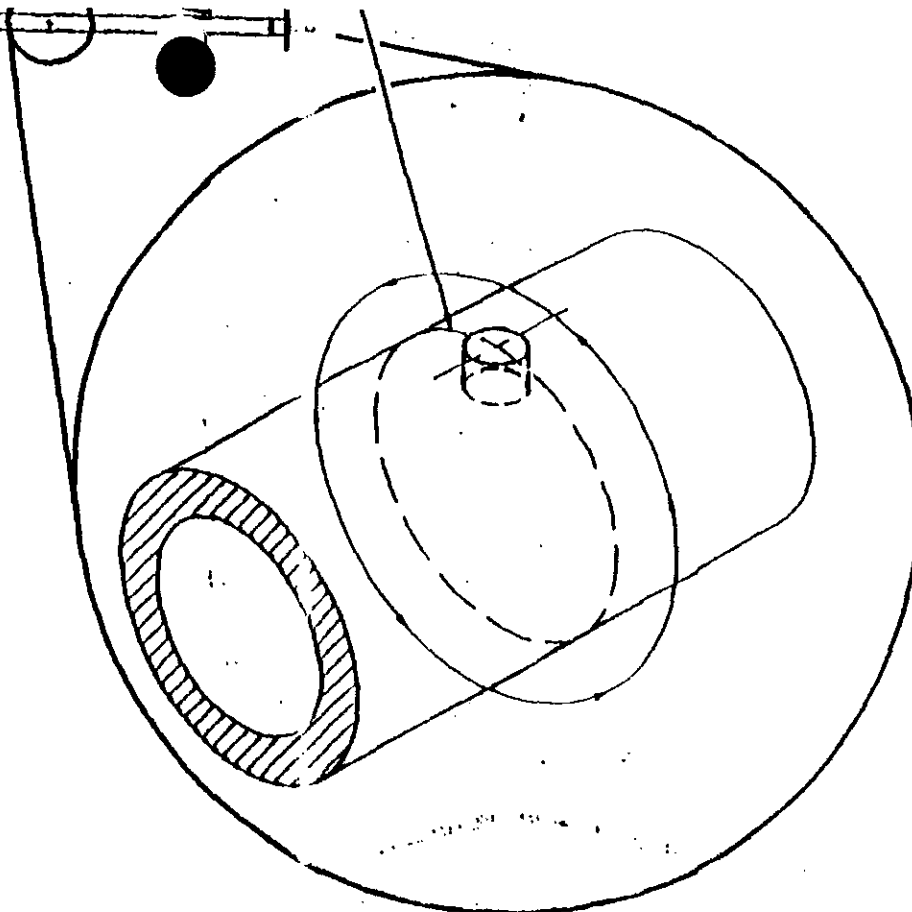
DRAWN BY: SAS
DATE:			REVISED
DESCRIPTION <b>CAR SWEEP</b>			
EQUIPMENT: <b>MID-SIZE HIMALAYA</b>		DRAWING NUMBER <b>CAR_SWEEP</b>

INSPECT AROUND PIPE NEAR THE AIR LINE HOLE  
ON SECONDARY SWEEP TUBE FOR CRACKS.

CLEAN OFF GREASE & DIRT BEFORE INSPECTING.

USE VISUAL INSPECTION FOLLOWED BY MAGNA  
FLUX OR DYE PENETRANT.

IF CRACKS ARE FOUND, DO NOT OPERATE THE  
RIDE UNTIL CONTACTING WISDOM INDUSTRIES AT  
(800) 634-6097 FOR REPAIR OR REPLACEMENT  
INSTRUCTIONS.
