SUBJECT: STABILIZER ASSEMBLY ON ALL TM1400 AND TM1800

SCOOTER BUILDINGS

SERVICE BULLETIN

91-4

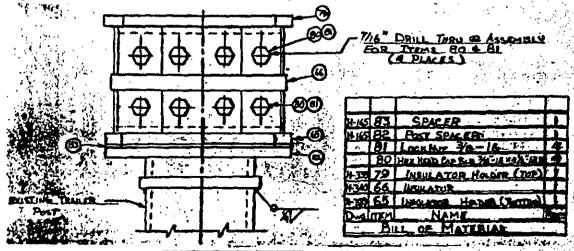
Majestic scooter buildings, TM1400 and TM1800 built prior to serial no. 2121 utilizes a wood insulator design to insulate the trailer and top assemblies. This design may be converted in the field by ordering necessary conversion parts shown in view below which uses a durable plastic type insulating material in place of wood.

These parts are readily available and may be ordered directly from our service and parts department.

When ordering, give model of building, serial no. and year manufactured.
