**WISDOM
INDUSTRIES, Ltd.**

SAFETY BULLETIN

DATE: OCTOBER 18, 2004
RIDE: SIZZLER AND DELUXE SIZZLER ONLY
SUBJECT: SIZZLER SEAT FRAME AND FOOT TUB
ATTACHMENT INSPECTION
TIME: IMMEDIATE
FREQUENCY: ANNUAL

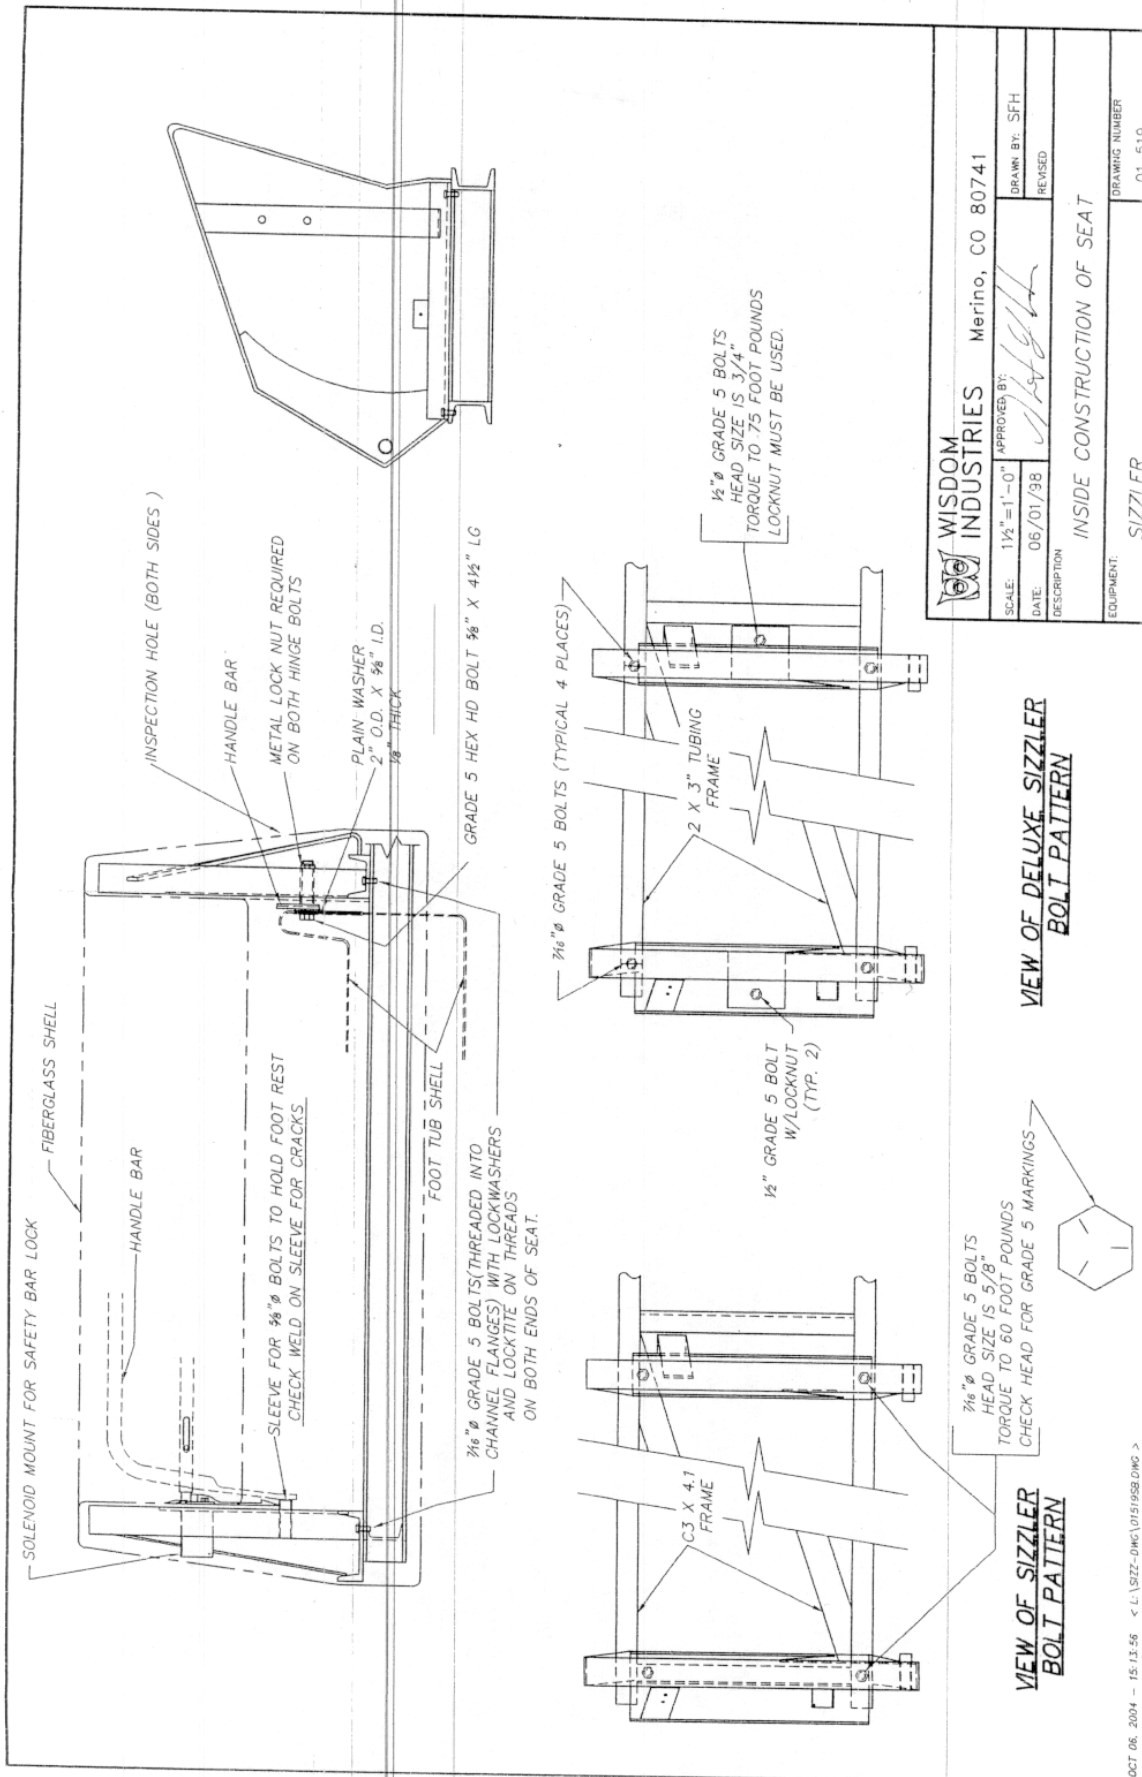
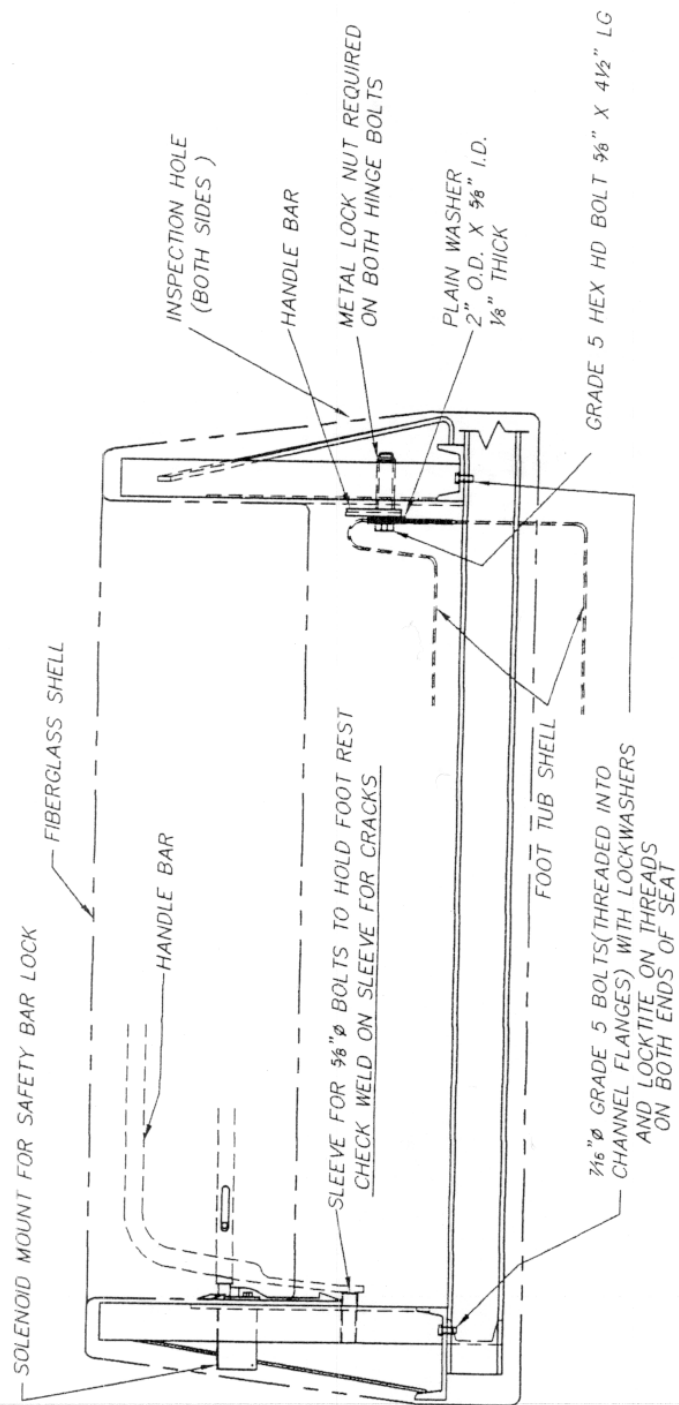
SEAT INSPECTION GUIDE

1. Inspect, grade & torque of the 4 internal frame bolts.
2. Inspect foottub hinge bolts for proper grade and all metal locknut installed.
3. Inspect internal frame welds.

❖ **NOTE: If replacement bolts are needed contact Wisdom Industries for replacement. If the bolts are purchased locally verify grade 5 bolts by the head marking (See drawing). Many hardware stores only sell grade 2 or 3 bolts. These bolts are unacceptable and dangerous.**

1. Remove the two ¼ inch bolts holding the seat lock brass to the side of the car.
2. Slide out the side quarter panel.
3. Inspect the two internal frame mounting bolts for proper Grade 5.

4. Replace if they are loose or broken and use Red Loctite.
5. Inspect bolts for proper 7/16 inch diameter. Check proper head size using a 5/8 inch socket.
6. Check that torque of 7/16 inch bolt is 60 foot pounds .

➤ **NOTE: IF BOLT IS LOOSE REMOVE THE BOLT CLEAN THREADS WITH WIRE BRUSH AND APPLY RED LOCKTITE. TORQUE BOLT TO 60 FOOT POUNDS.**
