SAFETY BULLETIN

04-15

RIDE: TORNADO

SUBJECT: MAIN SEAT PIPE WEAR COMPLIANCE DATE: IMMEDIATE

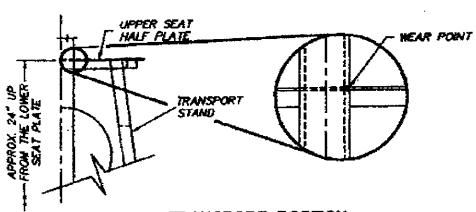
DURING TRANSPORTATION THE UPPER SEAT HALF IS MOVING SIDEWAYS AND WEARING ON THE MAIN SEAT PIPE. THIS WEAR CAN CAUSE A WEAKENING OF THE SEAT PIPE AND THE POTENTIAL OF FAILURE AND INJURY.

SHOWN IN TRANSPORT POSTION

- Inspect seat pipes (approximately 6" below the spin wheel) for wear in the pipe. (Review attached drawing)
- 2) Measure the depth of wear.
- If the depth of wear is greater than .062 inch, the pipe must be replaced. (See Drawing)
- 4) Install Trim Lock around the inside of the upper seat half that is causing wear on the pipes.
- 5) You may need to enlarge the hole in the upper seat half to reduce the chance that wear will occur. If hole is enlarged, sand edges smooth and install trimlock.
 - NOTE: Keep the transport tumbuckles tight to prevent wear from occurring.
- 6) Contact Wisdom Industries, Ltd. for replacement procedure at (800) 634-6097 if you have any questions.

- 1. MEASURE ACROSS THE CENTER POLE AT THE DEEPEST PART OF THE GROOVE (A). IF THE WIDTH IS LESS THAN 2.436" AT THE NARROWEST POINT, THE CAR WILL HAVE TO BE RED TAGGED AND THE CENTER POLE REPLACED.
- 2. MEASURE FROM THE SURFACE TO THE DEEPEST WEAR AREA (B). IF THIS DEPTH IS MORE THAN 0.062" THE CENTER POLE MUST BE REPLACED.
- 3. IF THESE DIMENSIONS ARE WITHIN 0.02" OF REJECTION. MAKE A RECORD OF THIS AND REMEASUREMENT EVERY WEEK.
- 4. ONCE THE CENTER POLE IS AT THE POINT OF REJECTION THAT CAR MUST BE RED TAGGED. IF CRACKING OF THE PIPE IS SHOWING THE RIDE MUST BE SHUT DOWN UNTIL THE CENTER POLE IS REPLACED.

DALY INSPECT ALL BOLES SHOWING WEAR FOR CRACKING IS REGIMED
