**WISDOM
INDUSTRIES, Ltd.**

SERVICE BULLETIN

DATE: FEBRUARY 4, 2000
RIDE: ALL SMALL COASTERS
SUBJECT: COASTER WHEEL BRACKETS
COMPLIANCE DATE: IMMEDIATE

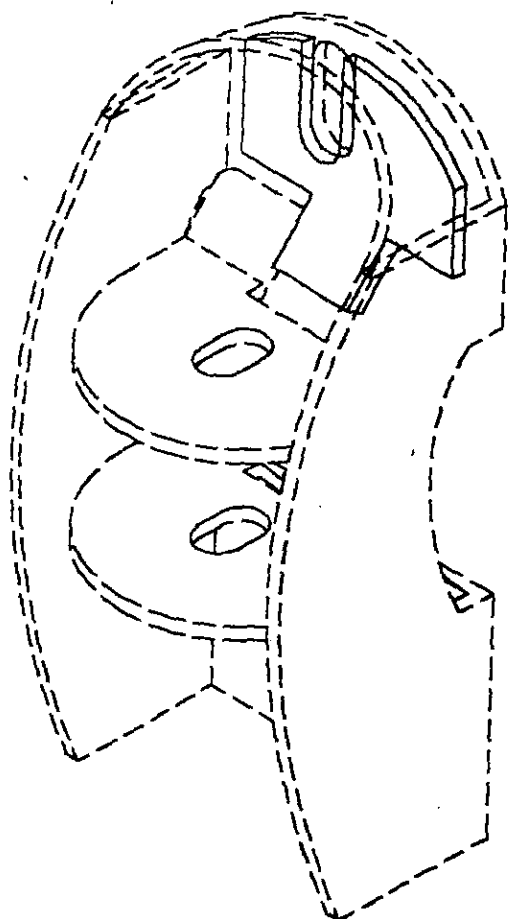
WHEEL BRACKETS

There have been a few instances of cracks in or around the slotted hole in the fixed type wheel brackets used on the smaller coasters, such as the Dragon Wagon, Go Gator, Clatterpillar and Miner Mike.

It is important to use only flange type nuts in this slotted area and check nut on a regular basis to ensure it is tight

Cracks can be field repaired. Grind a groove into the crack at least $\frac{3}{4}$ of the thickness of the base metal and slightly beyond the crack in both directions. Make sure area is clean and free of any grease. Weld with E7018 electrode and grind flush where weld or nut comes in contact with plate.

REPAIR CRACKS AROUND SLOT BEFORE INSTALLING PLATE. PLACE REINFORCEMENT
 PLATE INTO WHEEL BRACKET ALIGNING SLOT AND TAB. WELD AROUND PERIMETER OF
 REINFORCEMENT PLATE. FLANGE NUT MUST BE USED ON WHEEL BOLT.
