SERVICE BULLETIN

RIDE: Orbiter

SUBJECT: Lap bar release handle cover

BULLETIN NUMBER: 00102

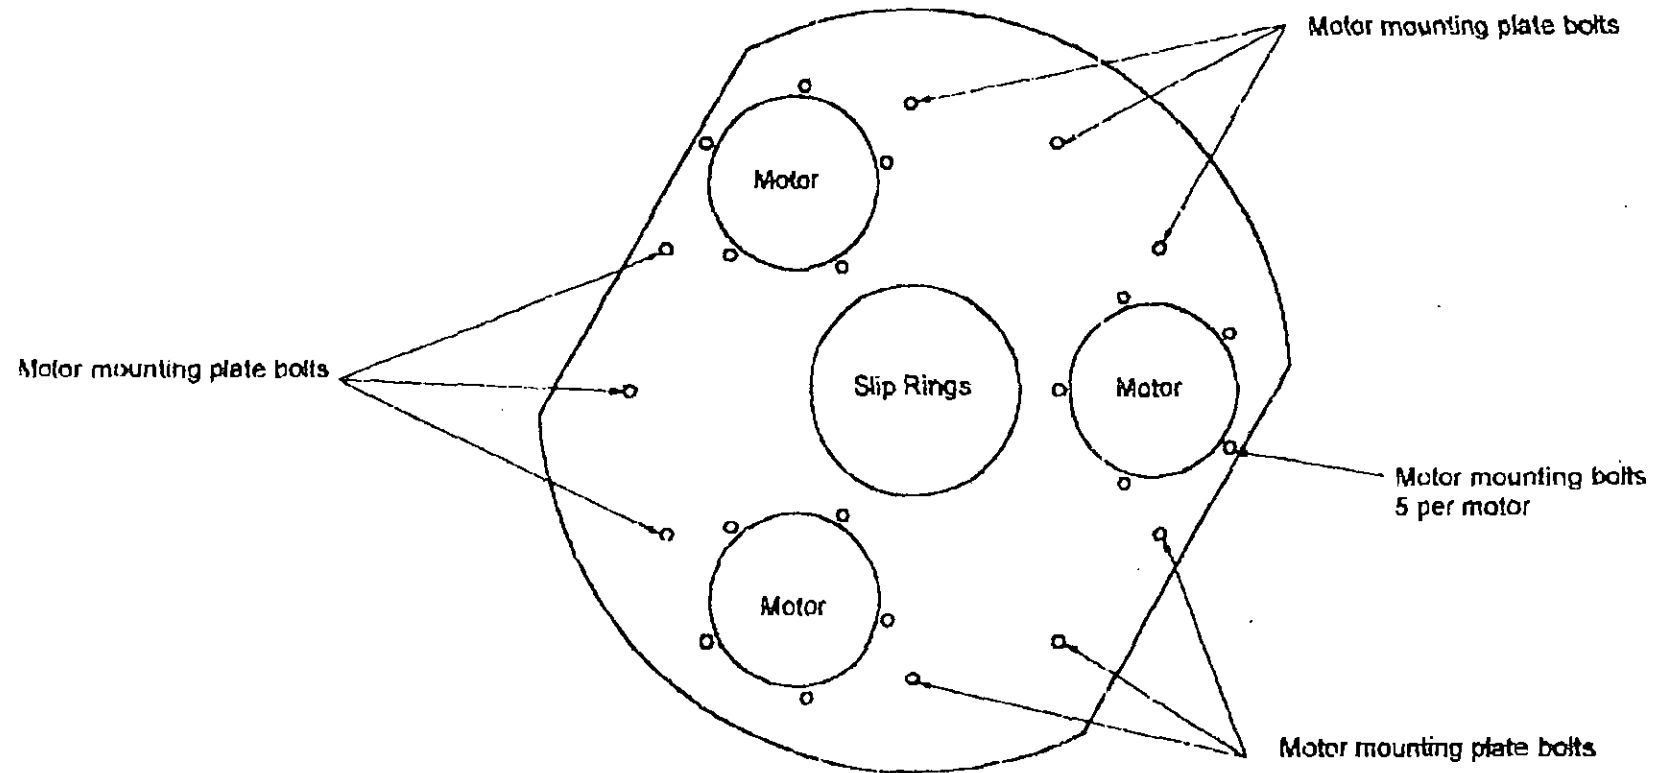
Drawing: ORSA002A

Orbiter center sweep motor mounting plate.

Motor mounting plate bolts 9 pcs.

Motor mounting bolts 5 bolts per motor, 3 motors.

- 9 – 12mm x 45mm bolts spread equal distance around outside parameter of plate. See Attached drawing ORSA002A.

Tightening Torque Requirements: Tighten bolts to 85 ft / lbs.

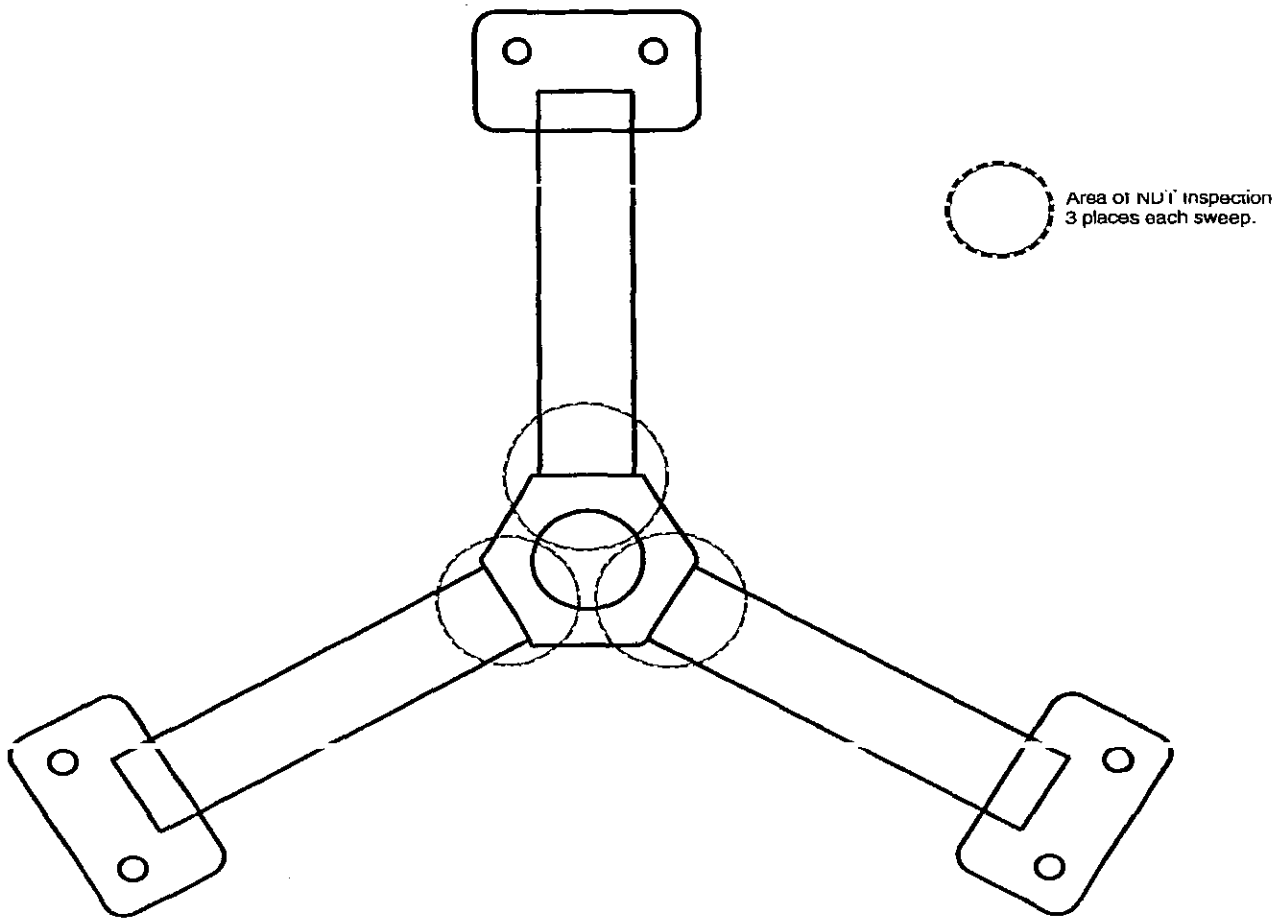
Vehicle Connection Frame

The cause of the separation of the vehicle was caused by a combination of corrosion and cracking of the welded tubing at the weld joint of the attachment frame as indicated in the accompanying drawing.

Tivoli requires that the welded connection and tubing in the area noted in the drawing be tested by magnetic particle NDT testing and visually checked for corrosion. Any additional testing or change in procedure will be at the discretion of the testing technician.

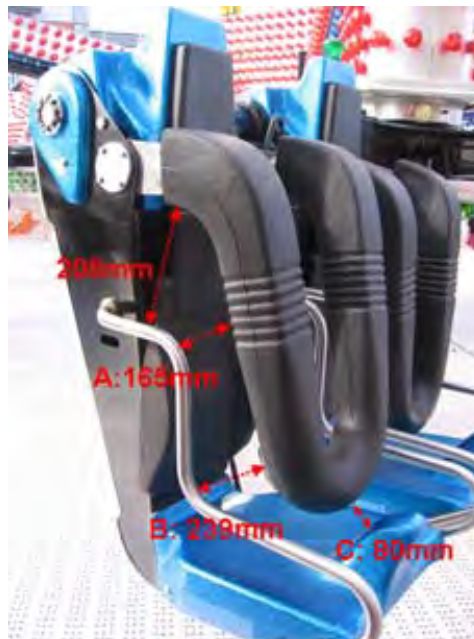
Fig 1:

Experiments on the ride involved with this seat configuration have shown that it is possible, given the movement characteristics of the ride and the rail positioning, for ejection to occur through the gaps in the containment. The gap in the containment marked A in Fig 1 (165mm) corresponds to the chest depth of 14-year-old boy, whose equivalent stature (with shoes) is estimated at 1750mm. The gap marked B in Fig 1 (239mm) is large enough for all children 16 years of age and under, and 17% of all adults to fit through and so possibly be ejected from the ride through this route, especially during the start up phase. In order to eliminate the risk of ejection through this gap, an estimated height restriction closer to 1950mm would be more appropriate (i.e. to eliminate all but large adults).

1. Until physical changes are made to the seat restraint bars and those changes have been reviewed and approved in accordance with the design review procedures in HSG 175, with immediate effect, no person under the height of 1.8m (one point eight metres) is to be permitted to ride this machine. The design review should be carried out by an appropriately qualified person and can be limited to the seat restraint bar system if that is the only part altered. It should be noted that there remains a slight possibility that persons of certain builds over 1.8m may still be ejected from the ride so a high level of operator vigilance is required.

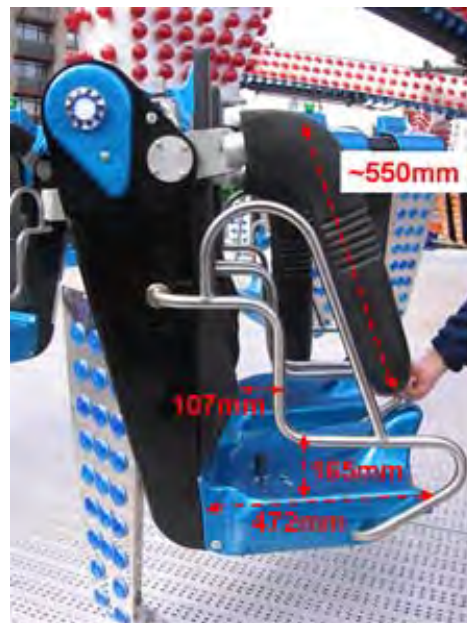
Fig 2:

It can be seen that the original side restraint bars are retained and the new piece welded to it. This addition should be capable of withstanding the weight of the upper torso of a large male rider, an approximate sideways force of 150 kg during all phases of the ride.

2. By 21 August 2009 the seat rails must be adjusted so that the gap between the overhead restraint and the new rail is not greater than 50mm and should fill the gap from top to bottom as shown in Fig 2. The 50mm measurement is to be taken with the overhead restraint at the 'first click' only and not utilising the pneumatic system. Tivoli have completed this work on at least one ride so far, an example of this work is below:

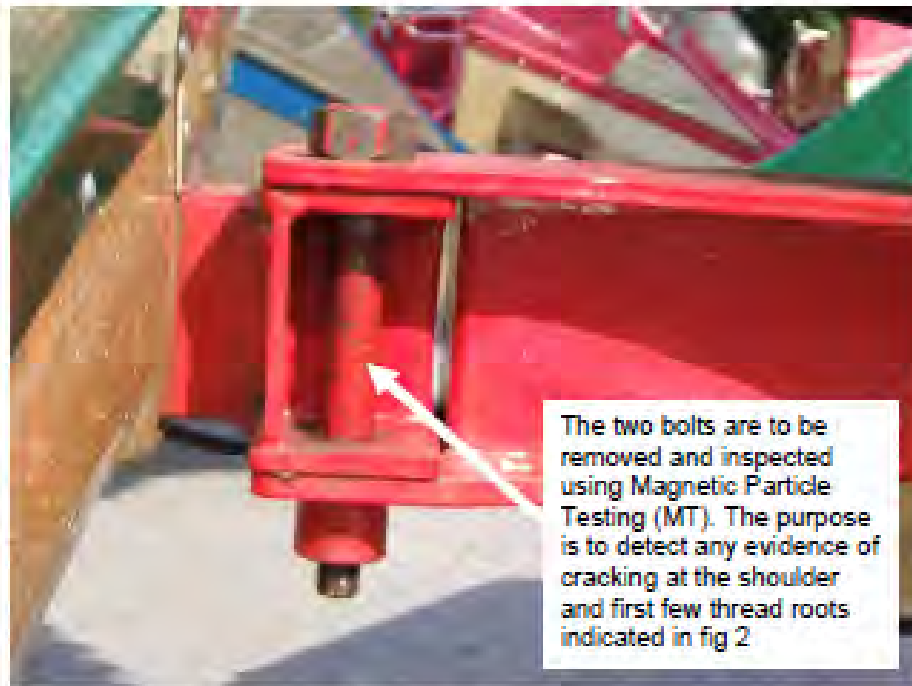
Fig 1: General view of the seat retaining bolt in position on the ride.

- A. Retaining bolts and surrounding material attaching the seat modules to the three legged spider fabrication.

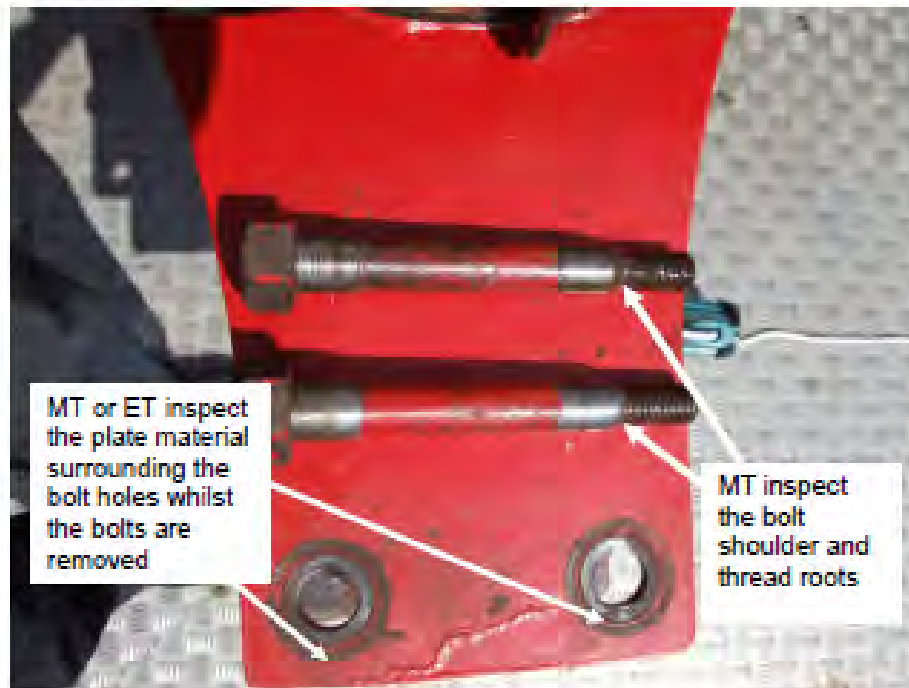
Fig 2: View looking down on the seat attachment arm with the seat assembly removed.

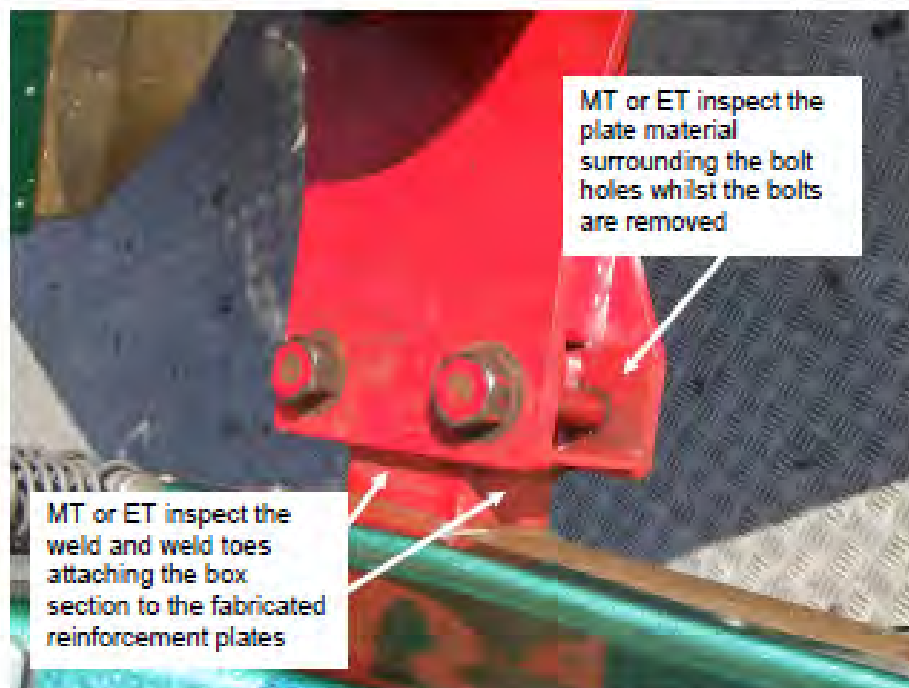
Fig 3: View from above the seat attachment bolts with seat in position.

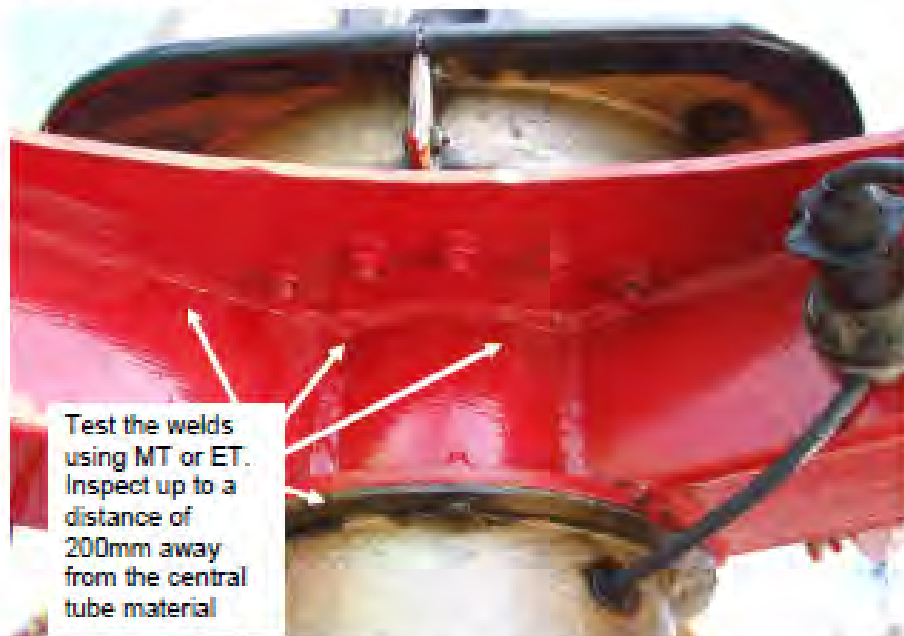
Fig 4: View of the welded fabrication attaching the three legs holding the seat assemblies to the slew ring (later design).

Note: This later design is reinforced by adding a profile cut plate fully welded across the top edge of all three box section legs.

B. Welded fabrication attaching the three legs to the slew ring assembly (later design).

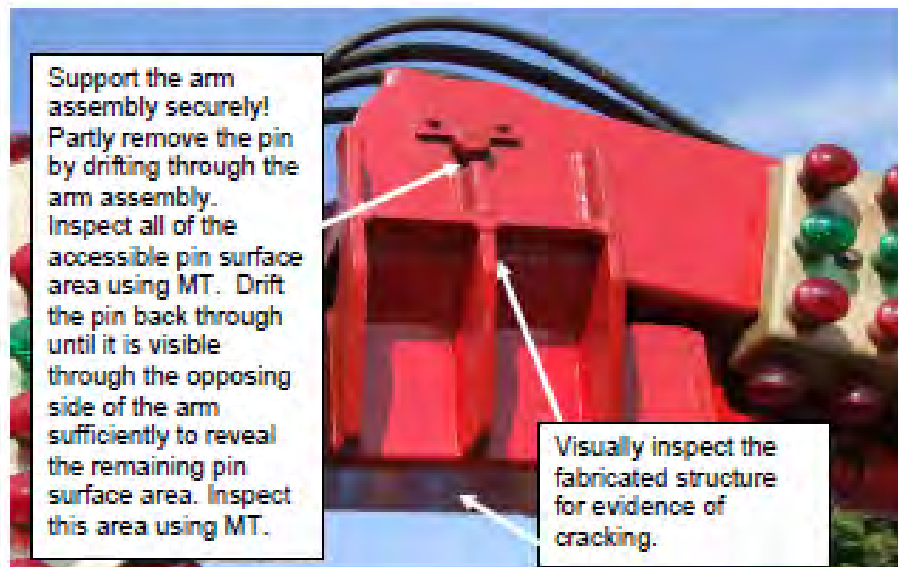
Fig 5: Magnetic Testing of the pin.

C: Articulating arm connecting pins and hydraulic ram mountings.

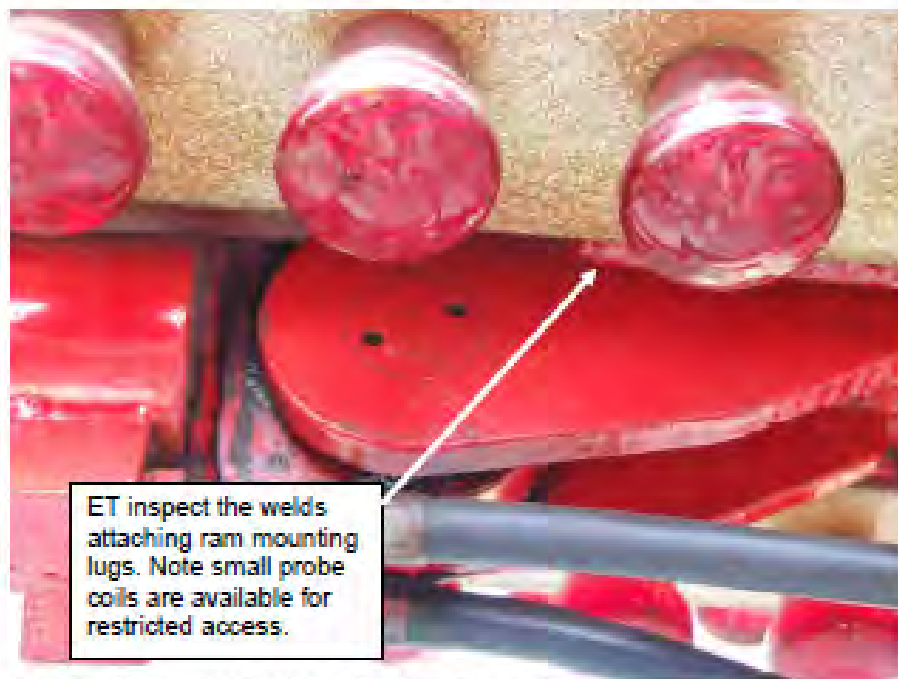
Fig 6: Attachment welds retaining the hydraulic ram on the arms.

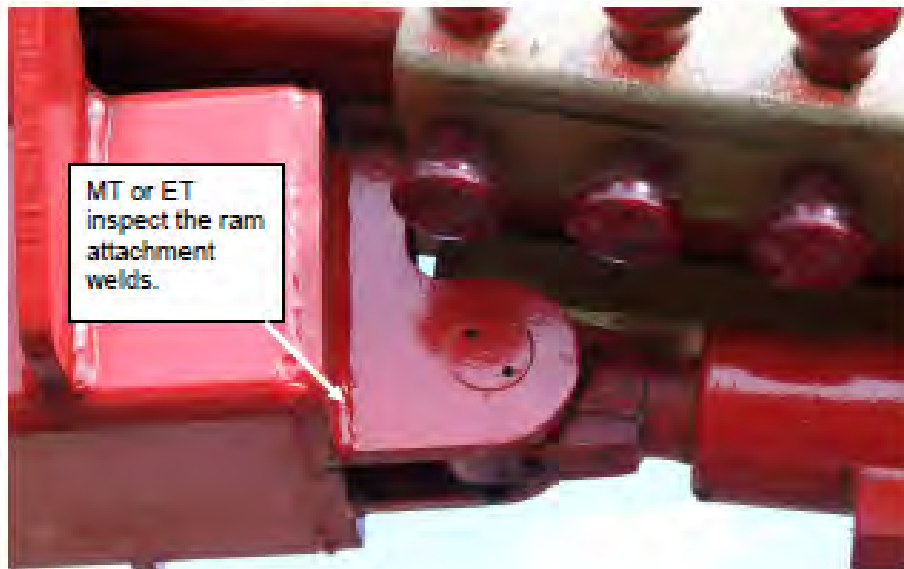
Fig 7: Welded brackets holding the hydraulic ram on the arm assembly.

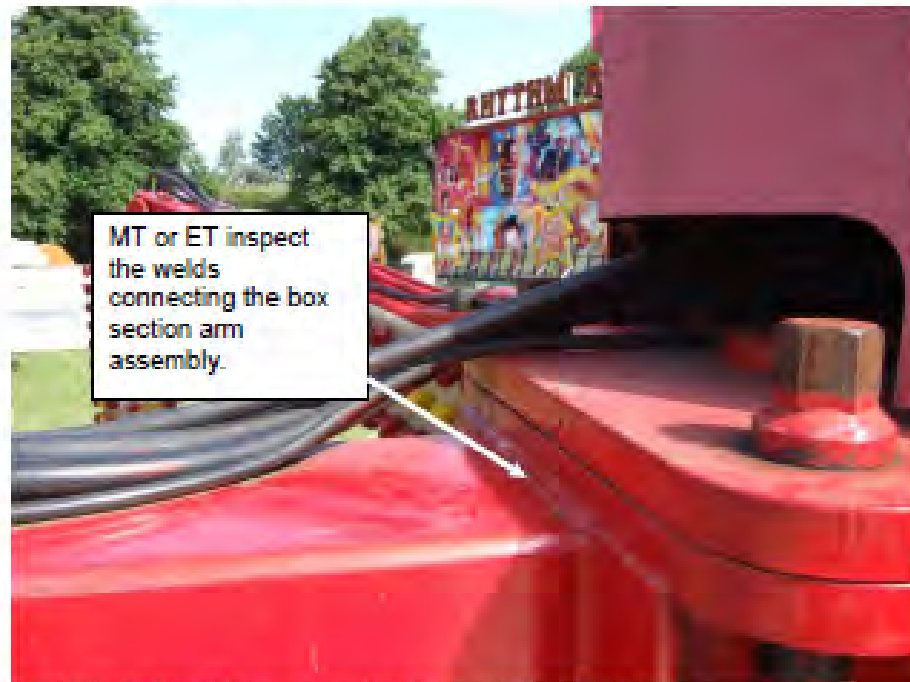
Fig: 8 Intersection of the arm assembly to the central tower fabrication.

D: Central rotating tower.

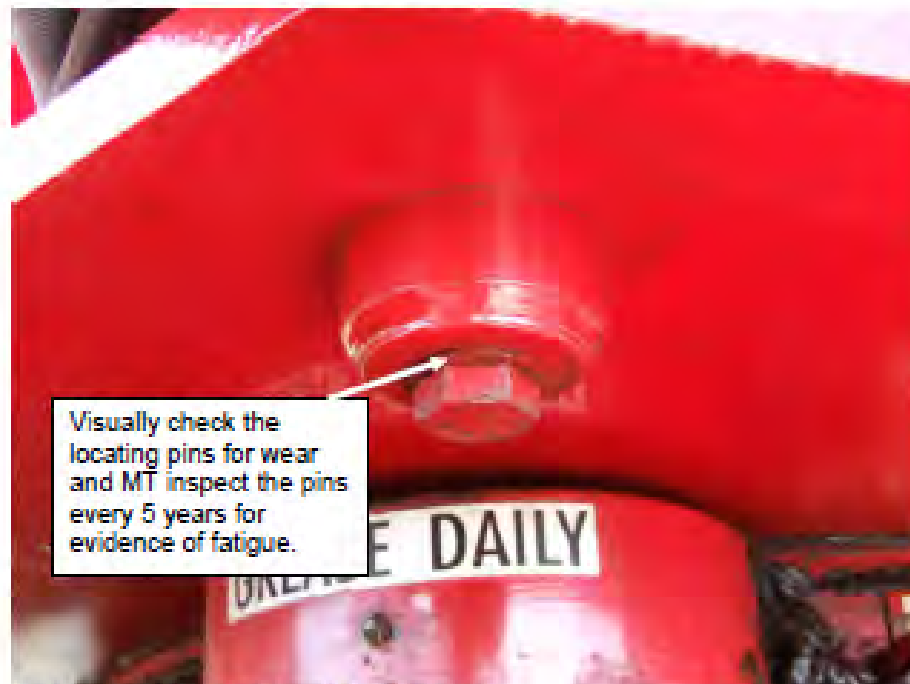
Fig 9: Retaining pins that prevent the arms folding.

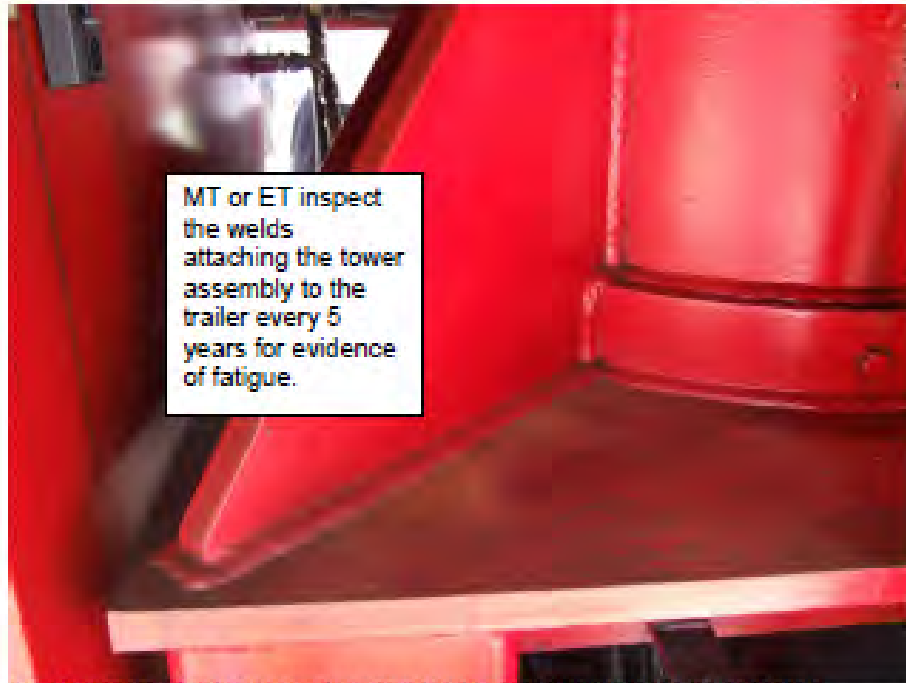
Fig 10: General structural inspection mounting the central tower to the trailer chassis.

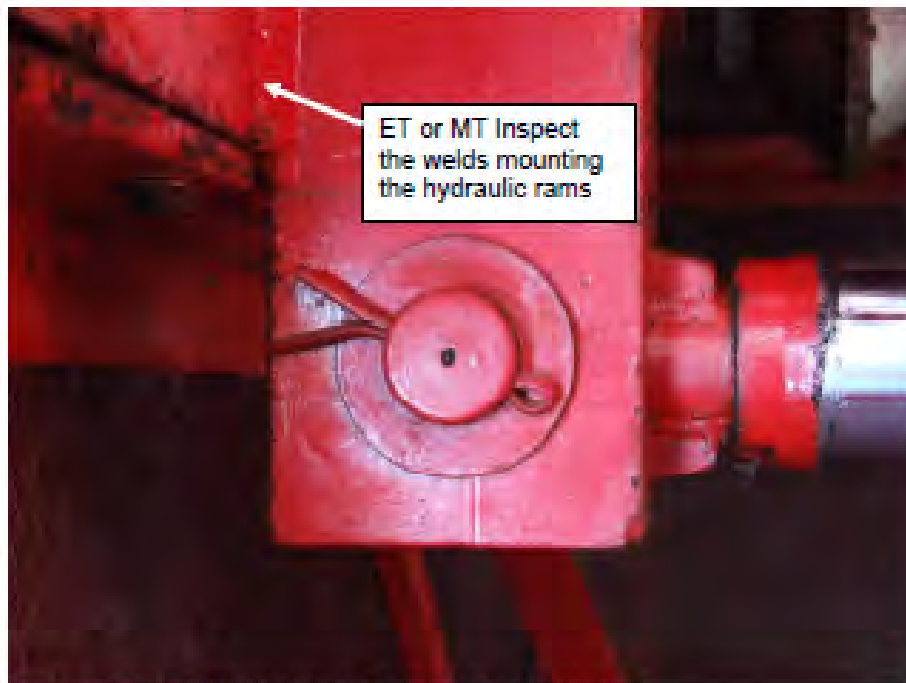
Fig 11: Welded brackets holding the central tower elevation rams.

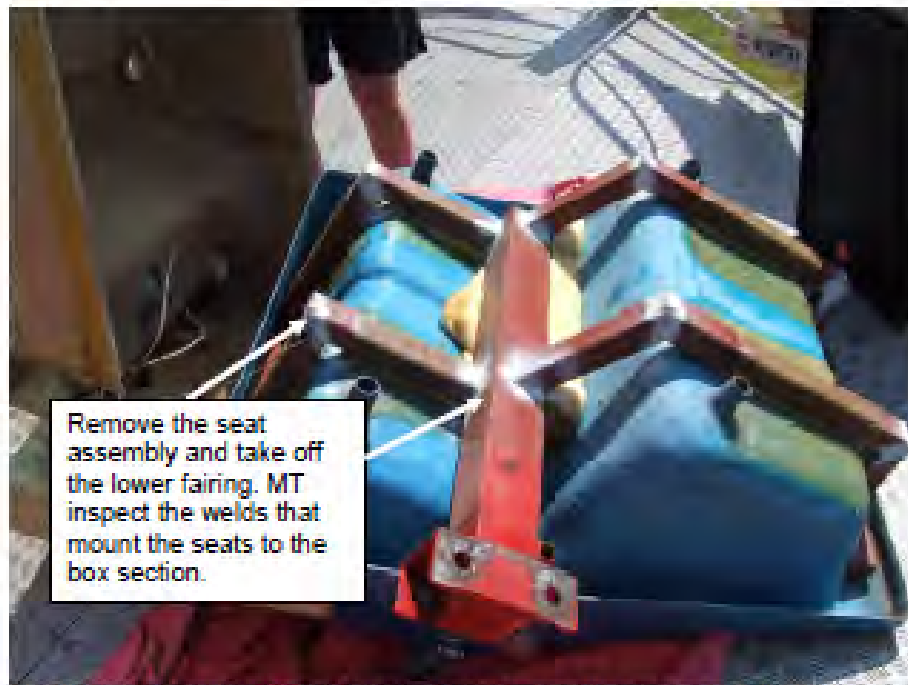
Fig 12: View of a chair assembly with lower fairing removed to gain access to the structure.

E: Chair assemblies.

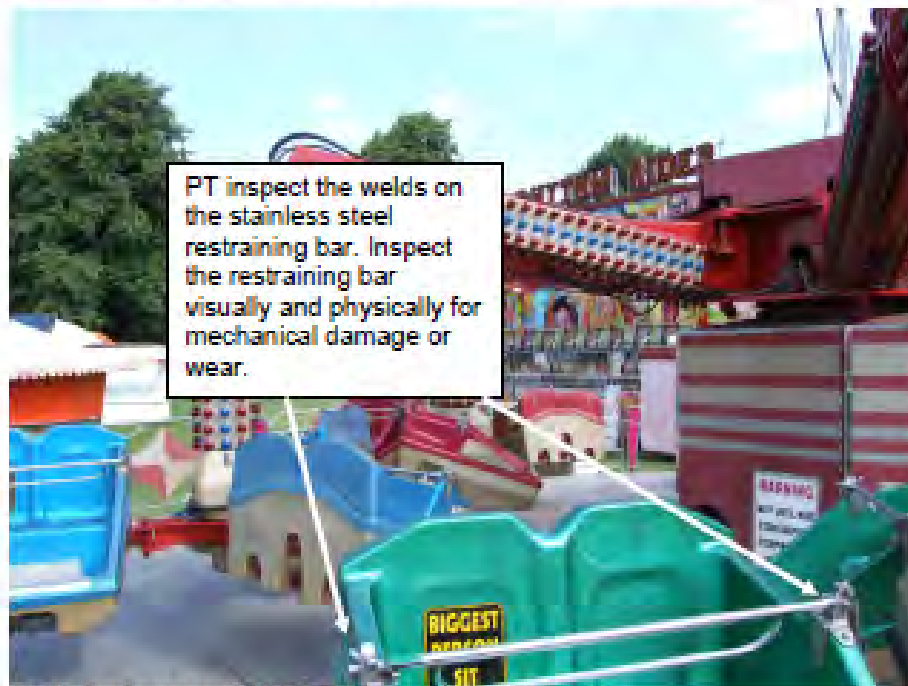
Fig 13: Passenger restraint bars fabricated from stainless steel.
