# Tivoli MFG Ltd.

## Service Bulletin

Bulletin No: SOSR001

Ride Type: Spin Out  
Date: September 8, 1998

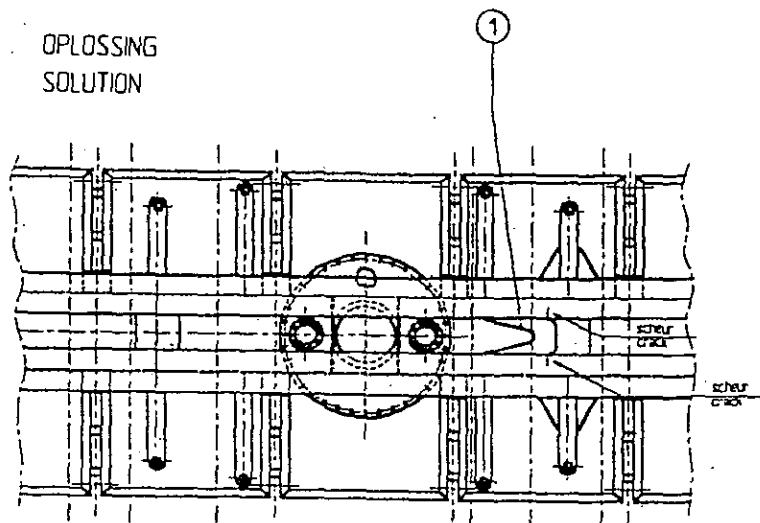
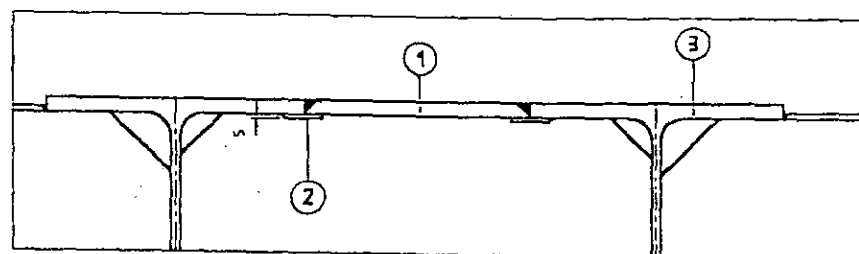
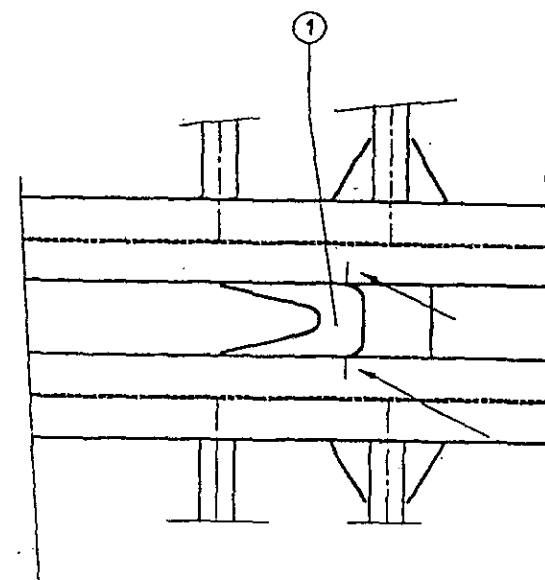
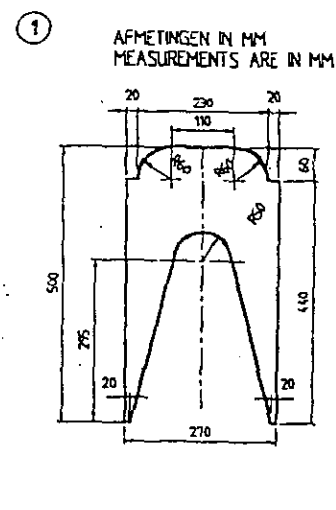
OPLOSSING  
SOLUTION

It has come to the attention of **Tivoli Mfg. Ltd.** from the original designers of the Spin Out, **KMG Europe BV**, that there has been cases where cracks have been detected on the center I beam of the rotating base frame as described in the accompanying drawings.

1. LAS STRIP POS. 2 ONDER DE CHASSIS BALKEN POS. 3  
WELD PLATE POS. 2 UNDER THE CHASSIS BEAMS POS. 3
2. LAS PLAAT POS. 1 IN DE TRAILER  
WELD PLATE POS. 1 IN THE TRAILER
3. REPARERE DE SCHEUR DOOR DE SCHEUR UIT TE SLIJPEN EN DICHTE TE LASSEN  
REPAIR THE CRACK BY GRINDING OUT THE CRACK AND WELD THE HOLE.

1. Locate end of crack and drill a 1/4" hole through beam where crack ends.
2. Grind and clean out crack to about 1/8" of bottom of beam.
3. Weld up ground out crack and grind of weld flush with I beam.
4. Install gusset plate as described in attached drawings and weld in place.

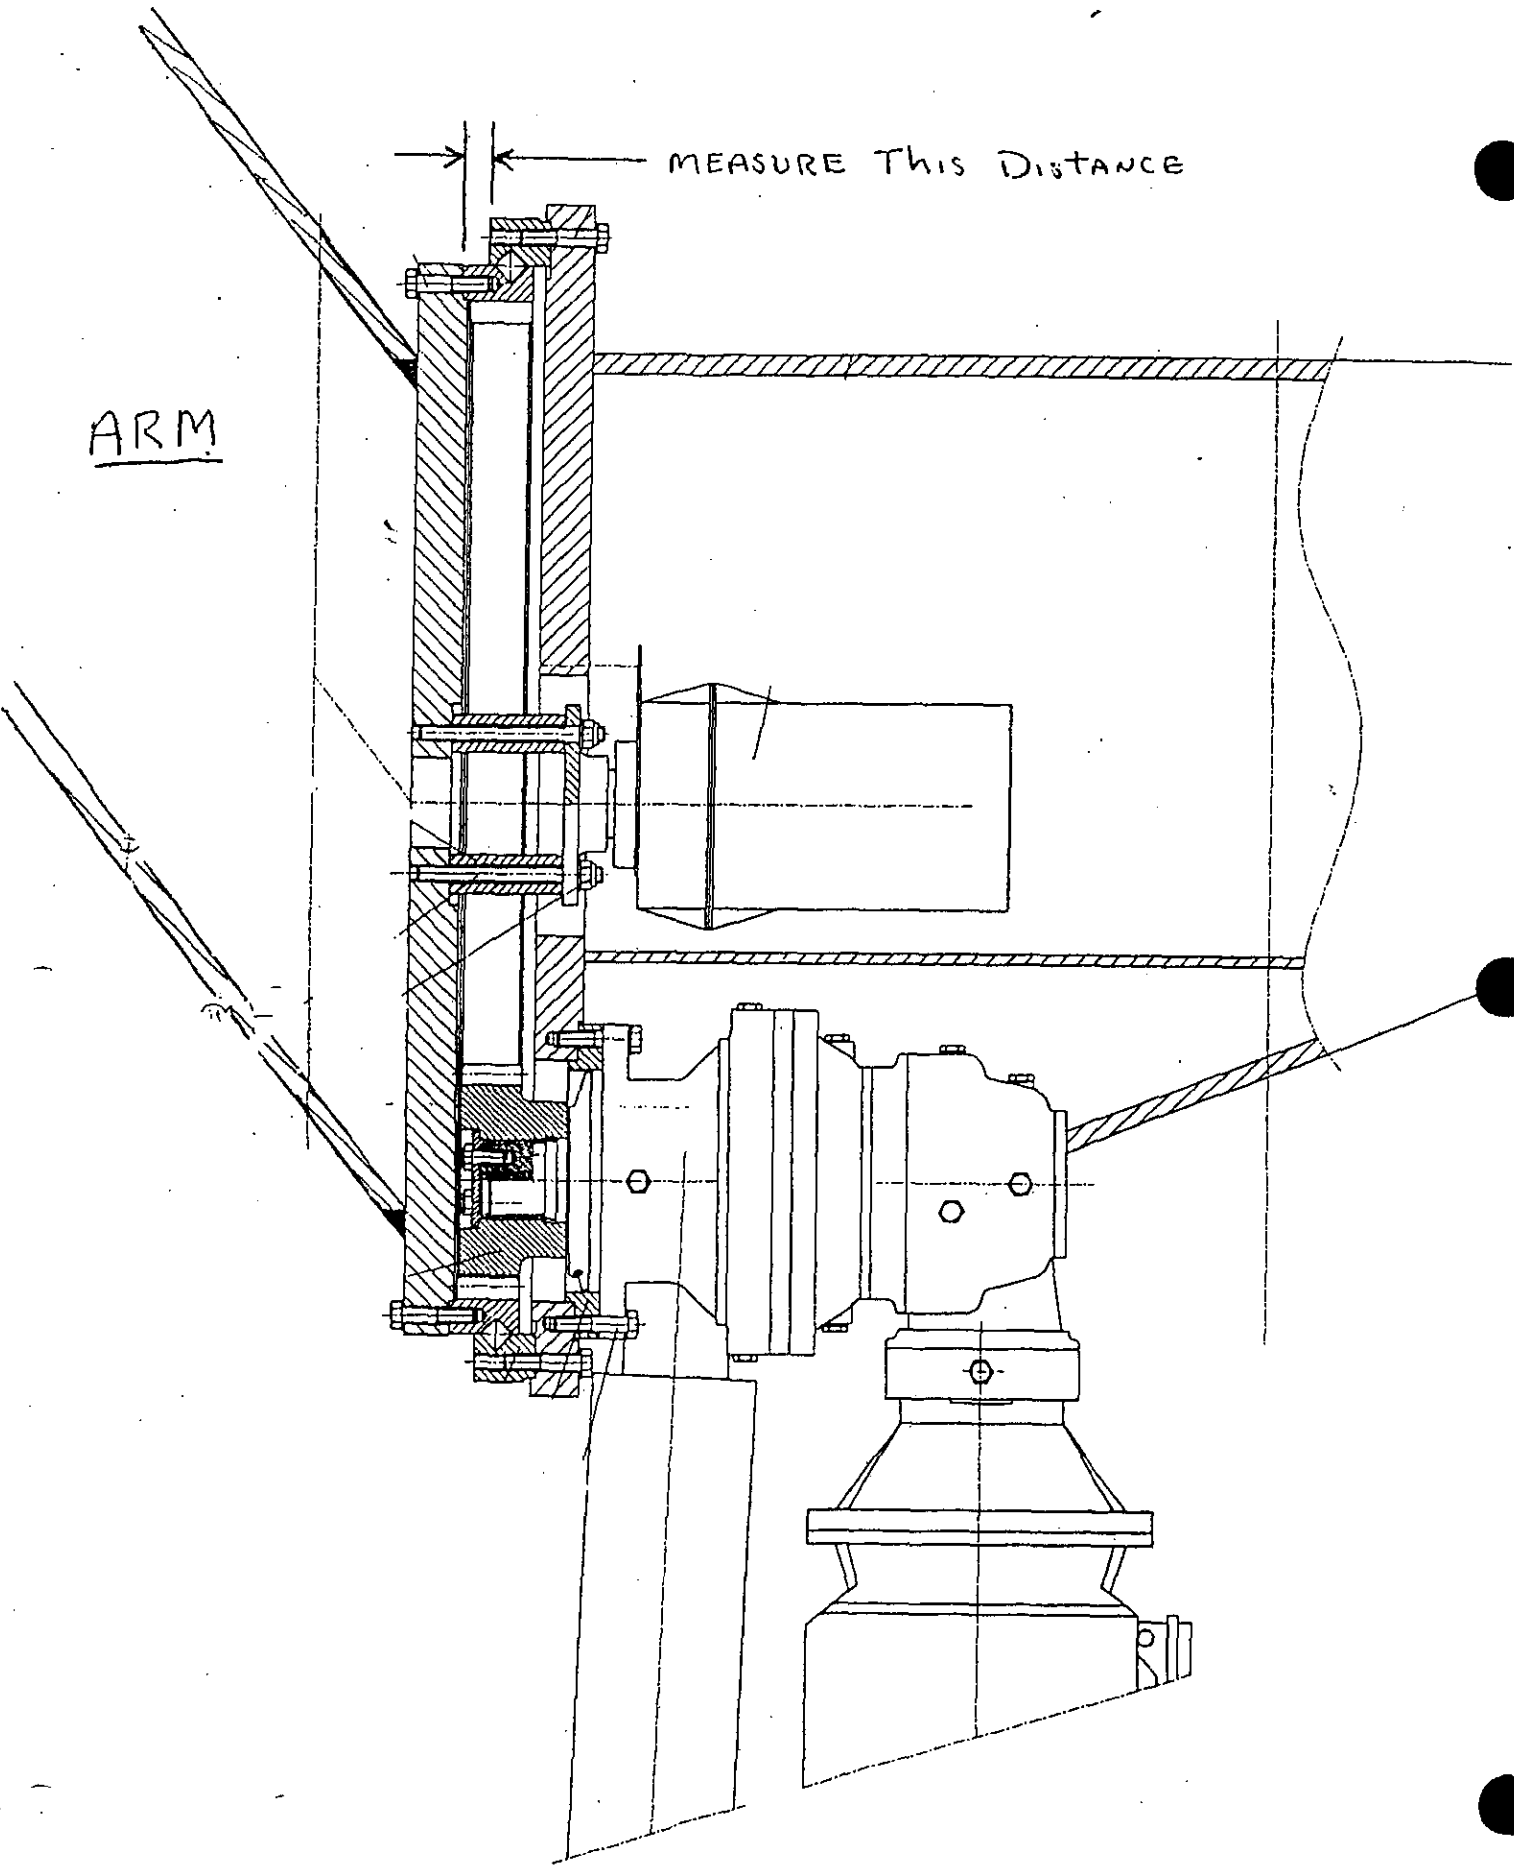
MEASURE THIS DISTANCE

Tivoli MFG. Ltd. requires the following inspection on the arm slewing ring to determine if bearing wear exceeds recommended tolerances.

Excessive wear can be caused by lack of lubrication, Wrong type of lubricant, or abuse. Proper lubrication is explained on page 3.

Measure the distance as described on page 2 at the 12:00 O'Clock position of the arm slewing ring and record measurement in ride log book. Check this measurement on a monthly bases. If the measurement increases over 1/8" the bearing is wearing to a point that it must be replaced.

If the bearing is starting to wear metal filings will be noticeable in the grease around the seal. Inspect this on a weekly bases.

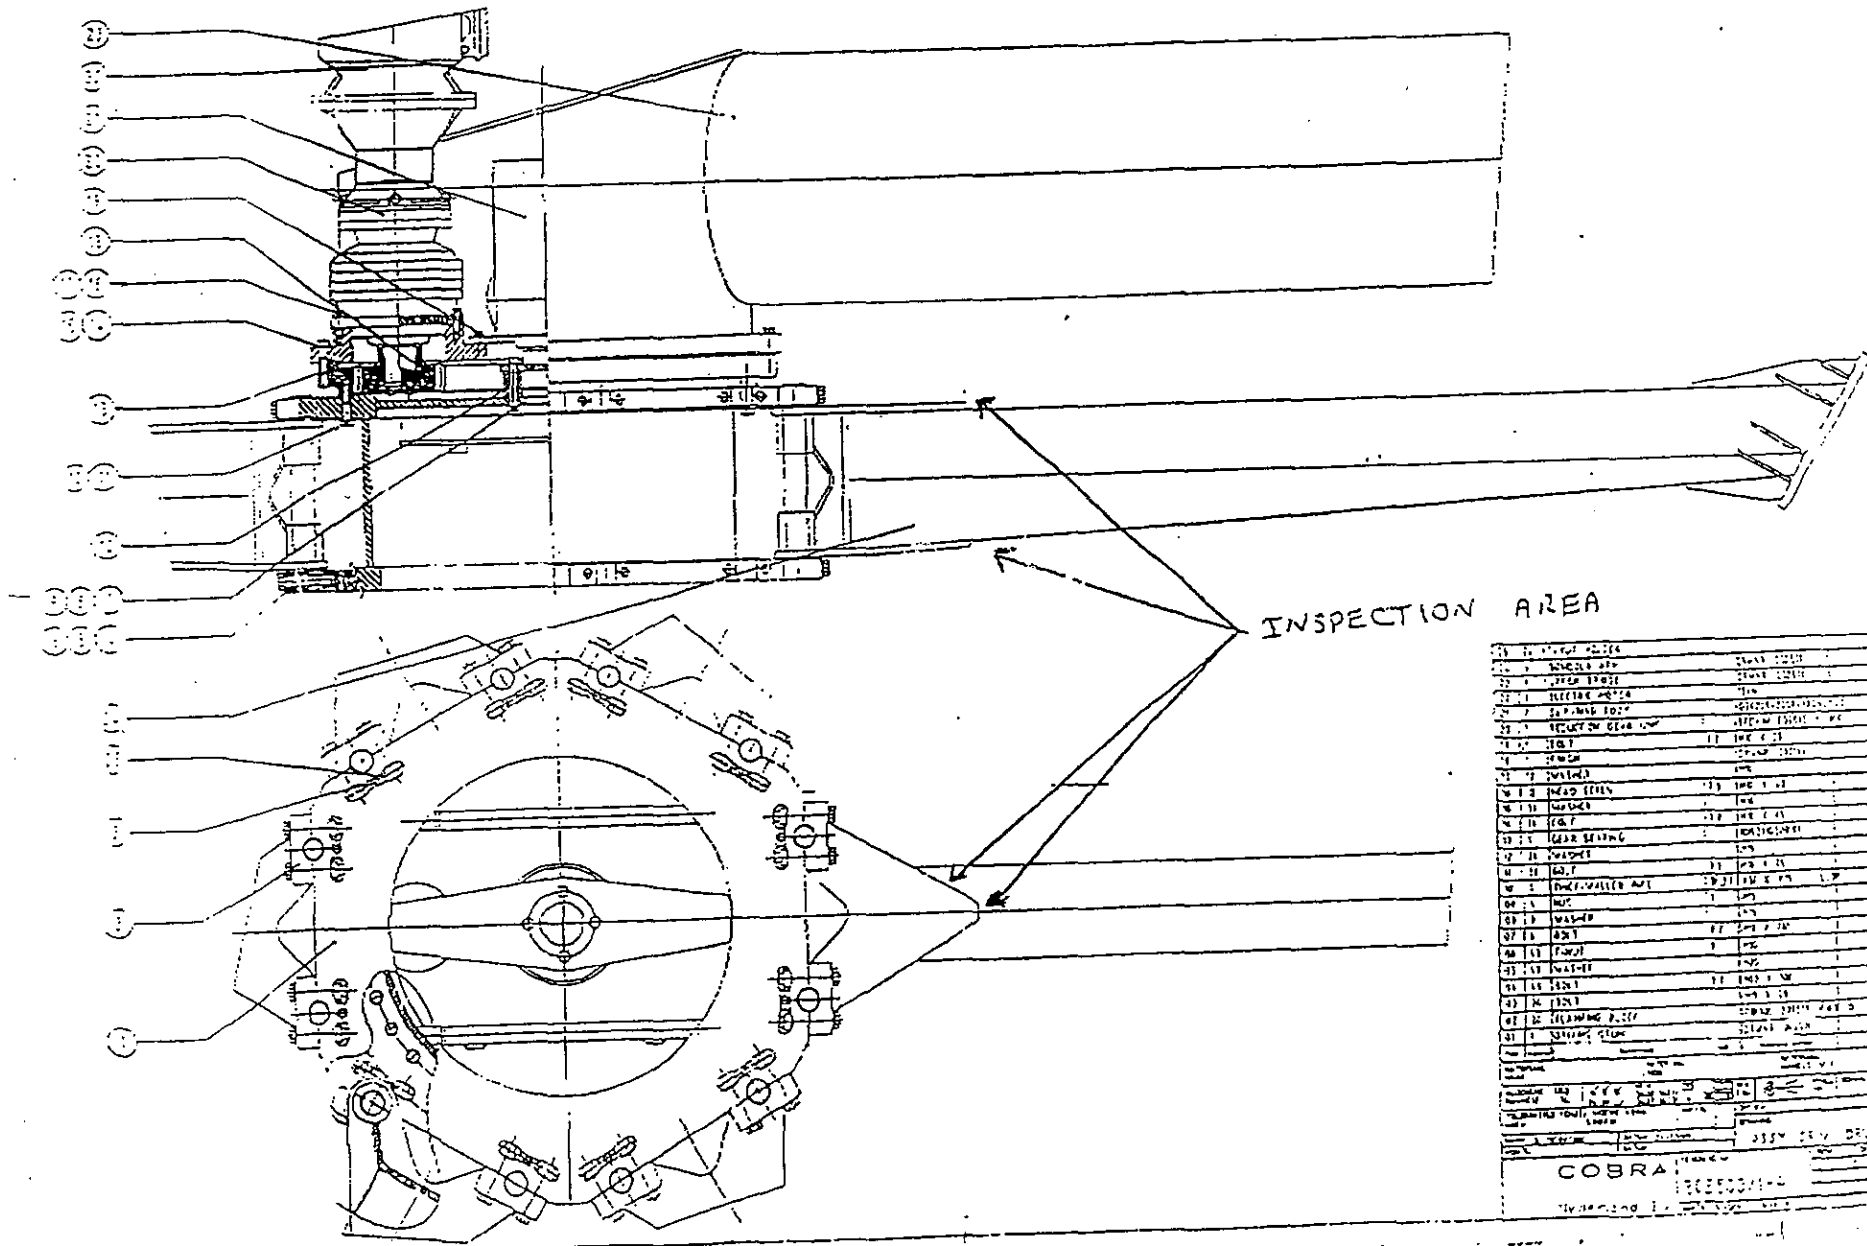
It has come to the attention of **Tivoli Mfg. Ltd.** from the original designers of the Spin Out, **KMG Europe BV**, that there has been cases where cracks have been detected on the sweep arms (see attached drawings) of Spin Out rides operating in Europe.

Tivoli Mfg. Ltd requires that all operators inspect the areas indicated on the attached drawings. If cracking is detected please report to AmTech / Amusement tech. intl. Inc. at 817-641-5045 for repair procedures and gusset kits.

Repair procedure: Drill 1/4" though hole at each end of crack. grind out crack  
approximately 3mm deep and weld up crack using 7018 low  
hydrogen welding rod.

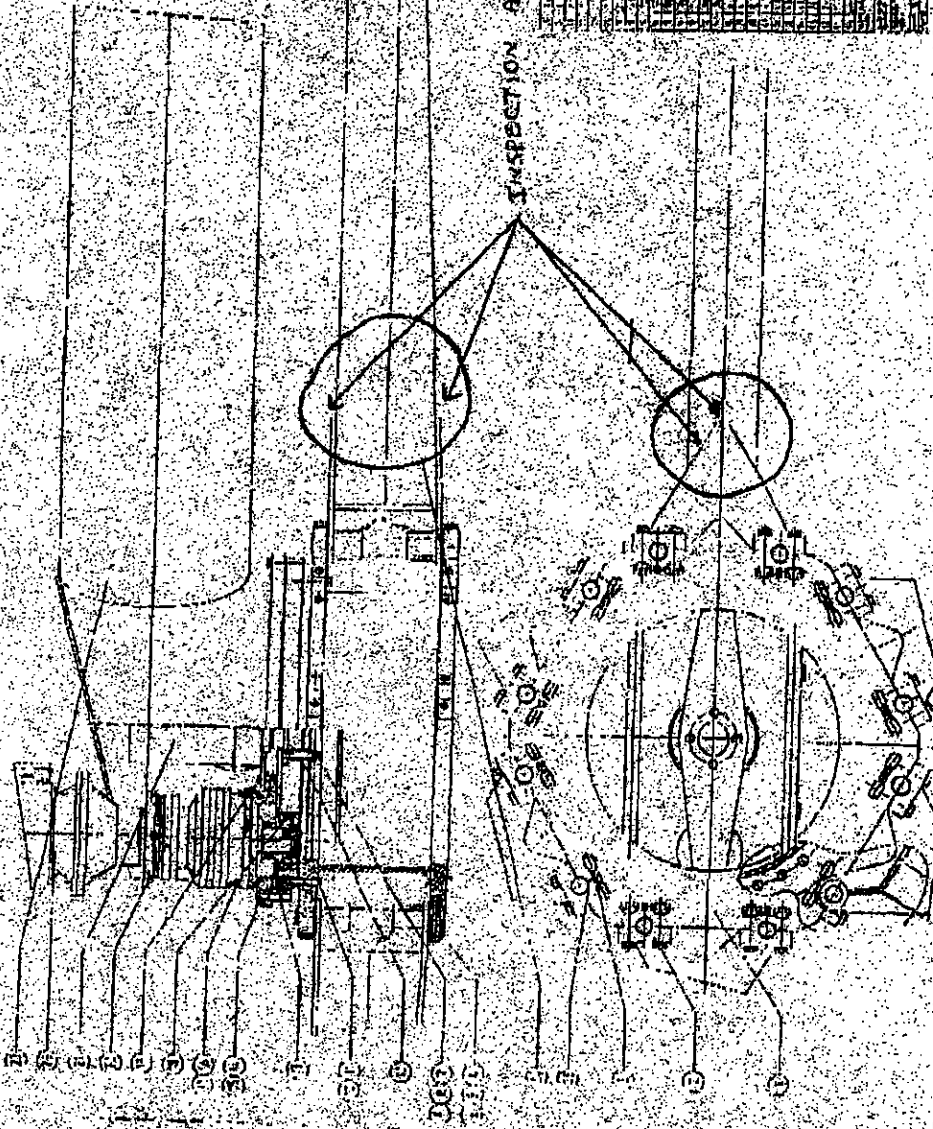
INSPECTION AREA

Tivoli Mfg. Ltd. has been informed of a structural failure, which caused the vehicle support sweep(1 of 6) to detach from the ride. This ride was being operated by Amusements of America in Puerto Rico. From information received through operators no life threatening injuries had occurred.

It is absolutely necessary that all vehicle support sweeps on all Spin Outs be inspected immediately according to the bulletin SOSA005 Issued July 1, 2001. If any cracking is detected stop operation of ride immediately until proper repairs are made.

If Cracks are detected the ride must remain closed until a reinforcement procedure / kit is developed and installed.

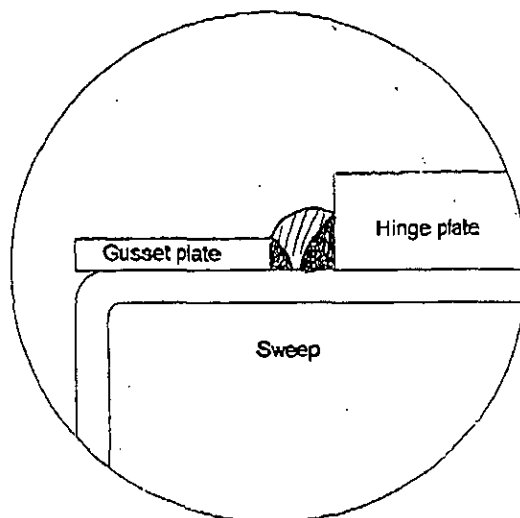
During routine inspection of a Spin Out Sweep, it was found that the upper and lower "H" gussets were not welded to the triangular hinge plate properly. Tivoli Mfg. Ltd requires that the gusset plate be welded completely to the hinge plate. This may require up to 4 welding passes where the gusset plate does not meet up to the hinge plate. Please review the safety bulletin SOSA010 and confirm that the gussets have been installed correctly. Below is an example of proper welding of the gusset plate to the hinge plate where there is a gap between plates.
