475.

Kolmax Plus s.r.o. Flying Dumbos radial arm cracking

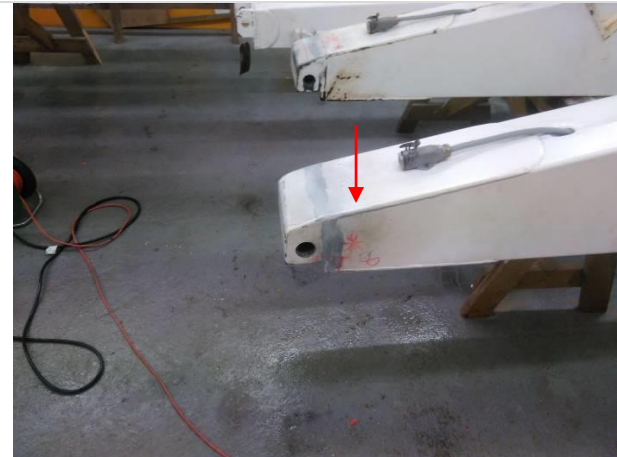
Figure 1
Location

The defects were found during the annual inspection of a 2014 machine and were located on the hub connection end of the radial arm. It must be noted that numerous areas of additional cracking were found once the paint was removed from all of the connection areas.

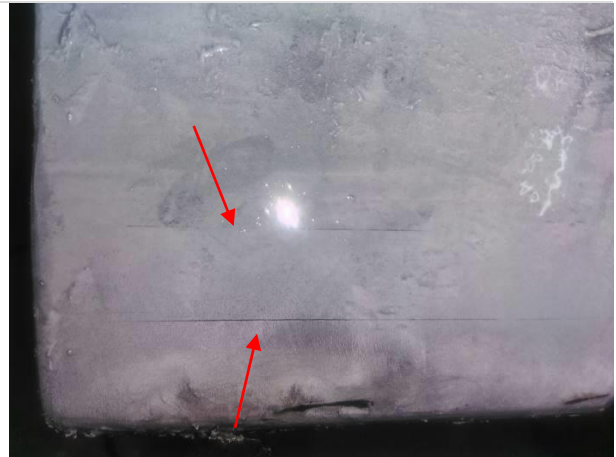
Figure 2
Areas of cracking

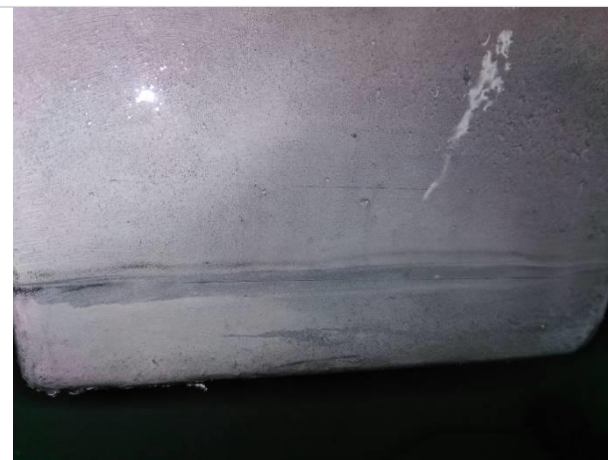
Figure 3
Cracking still present after grinding to a depth of 1.5mm

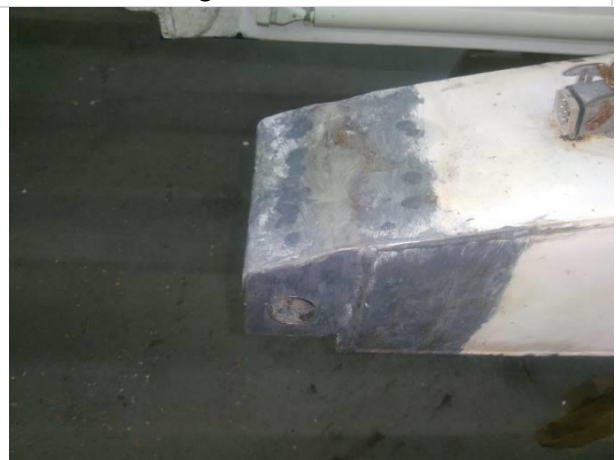
Figure 4
Area of paint removal

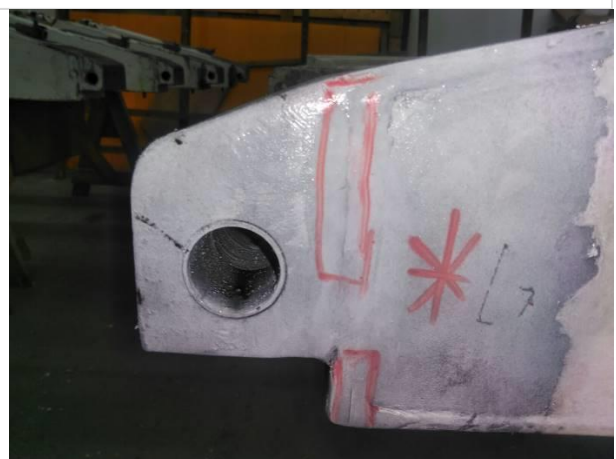
Figure 6
Areas of cracking

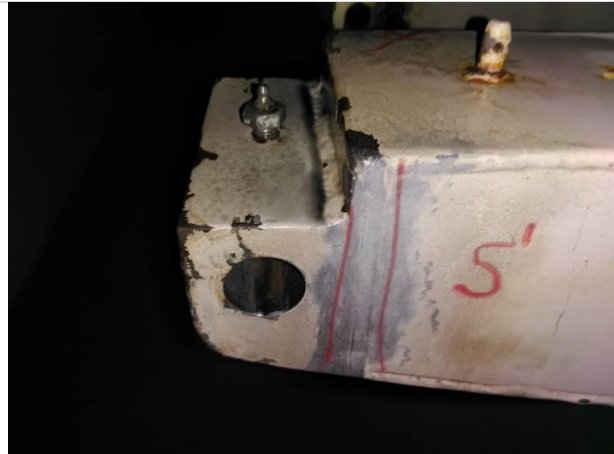
Figure 7
Additional picture of cracking

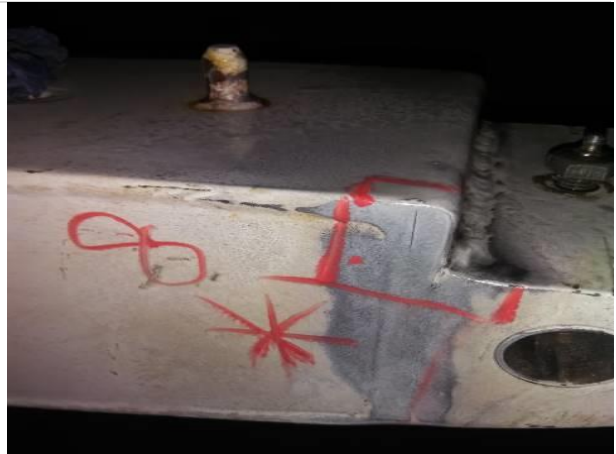
Figure 8
Additional picture of cracking

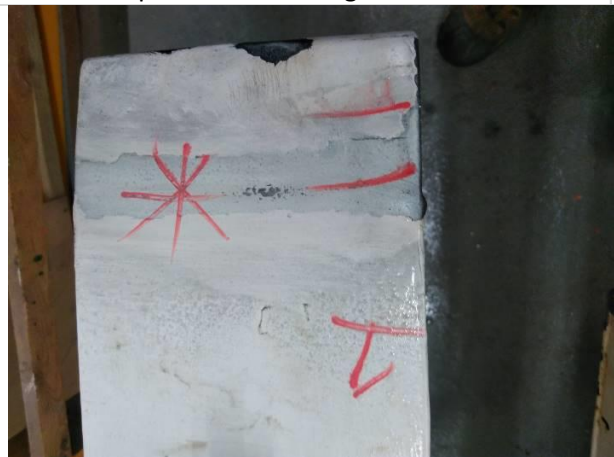
Figure 9
Additional picture of cracking

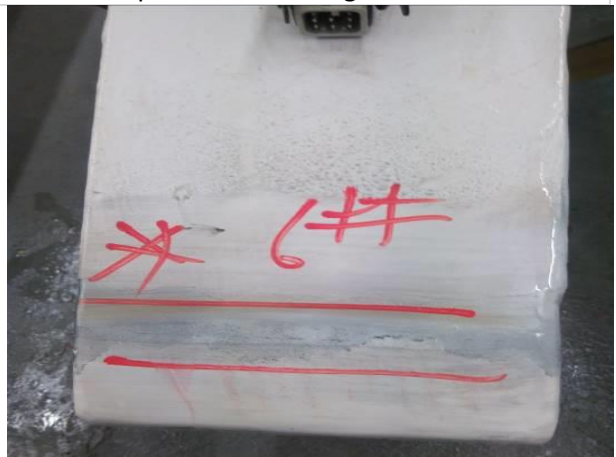
Figure 10
Additional picture of cracking
