## 484.

# Generic Miami restraint ratchet failure

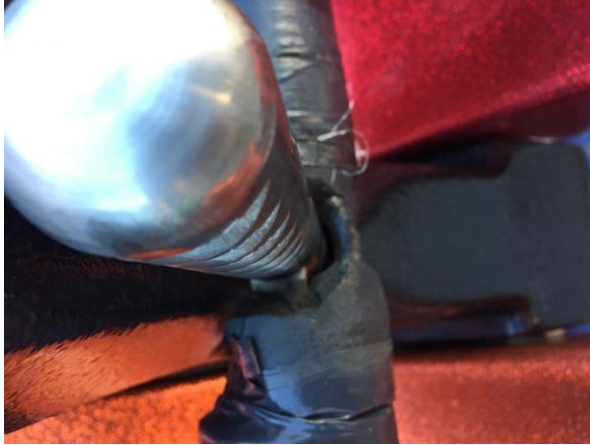
The primary latching mechanism of the harness is a sleeved pawl ratchet which is contained in the lower cross-bar element of the drop down harness. The ratchet element, or 'Christmas Tree' (tree), rotates when the release mechanism is activated to allow the pawl to be pushed back into the sleeve and the harness to raise. In this particular instance it is believed that the pawl became stuck in a partially locked position with insufficient engagement to the ratchet to prevent the release of the harness.

"Christmas tree" ratchet bar (tree)

It is recommended that the sleeve bores containing the pawls are inspected annually by IBs and checked for free movement by operators daily.

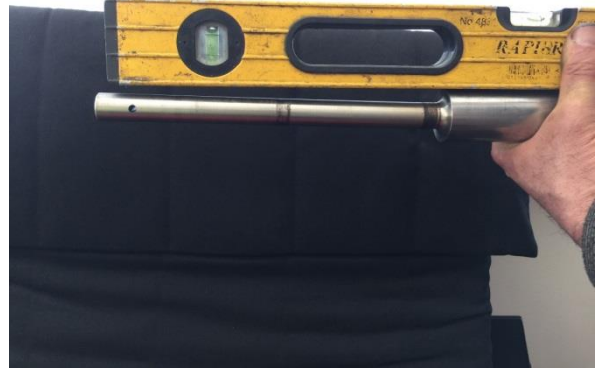
It is further considered that the pawl may have previously locked in an extended position such that when the tree rotated the locked position caused permanent deformation of the tree, if the adjoining harness was in the fully depressed position. It has been observed by several operators that the trees are found to be bent, leading to maintenance, replacement or straightening being undertaken. In the particular device of the incident the sleeve for the pawl was found to be ridged internally and although there is a lubrication pocket at the base of the sleeve, there is significant potential for the pawl to become stuck.

Removed bar showing bend

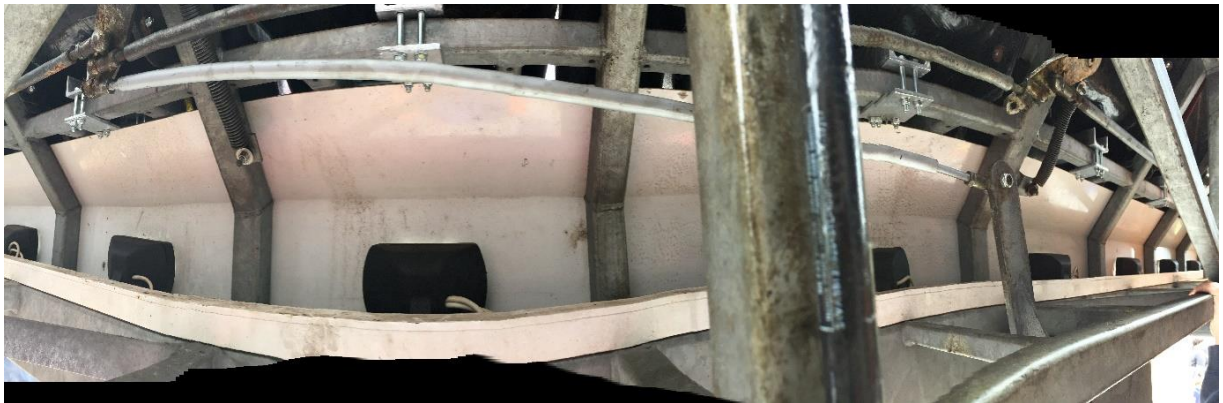
The consequence of poor adjustment can result in the lateral movement of the secondary lock occurring prematurely and with pressure on the harness cause wear of the hinge cam.

Main adjustment bar to co-ordinate secondary mechanism with primary – note adjustment to right of photo

The adjustment of the system of bars operating the secondary mechanism also requires inspection to ensure the laterally moving blocks are only actuated after the cessation of the ride cycle and prior to partial rotation of the ratchet trees.

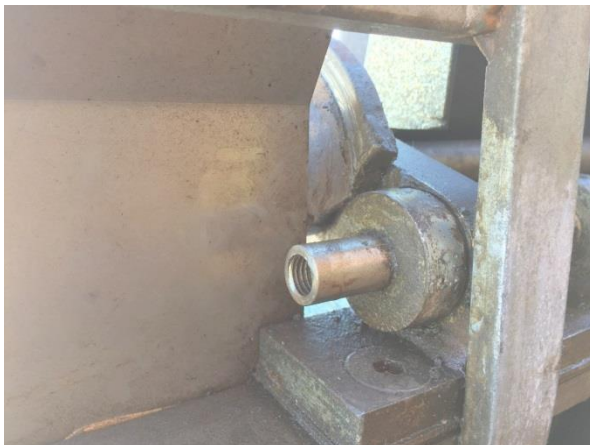
The ratchet pawl has a varying width of contact due to the angle of the tree and the downward arc of the harness. With pressure from a passenger this could lead to ratchet release (if there is some sticking of the pawl); the mismatch of the secondary release timing having caused wear of the secondary cam can then wedge open the secondary lock.

Note wear to cam plate due to harness being able to be raised before lateral movement has completed

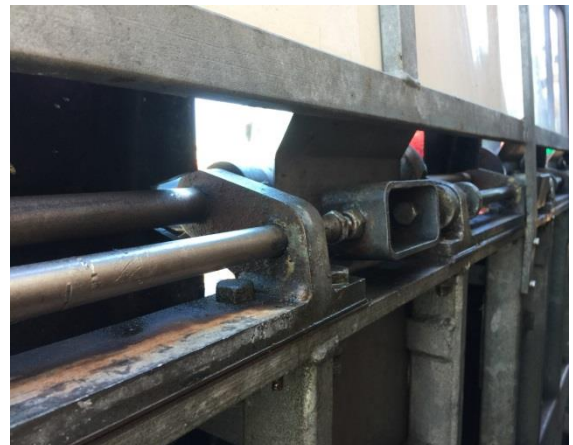
Horizontal bar adjustment point

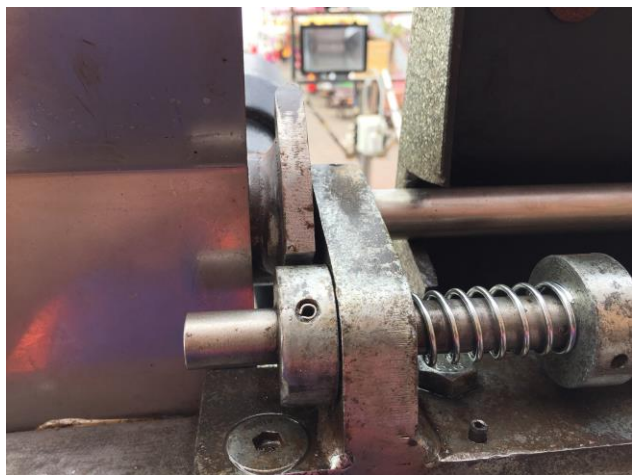
Secondary cam in lock position

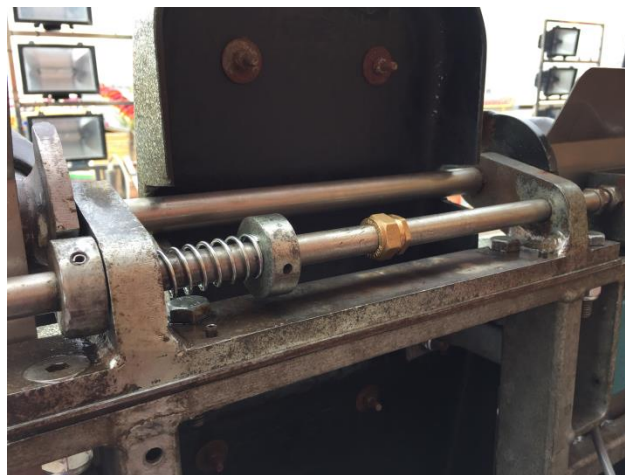
Spring holding horizontal bar in lock position
