## INSTRUCTIONS FOR REPLACING OIL SEAL IN SCRAMBLER PINION CASTING ASSEMBLY

# UNIT POLE MODIFICATION

#### MODIFICATION OF SCRAMBLER TOP SWEEPS

## URGENT WARNING

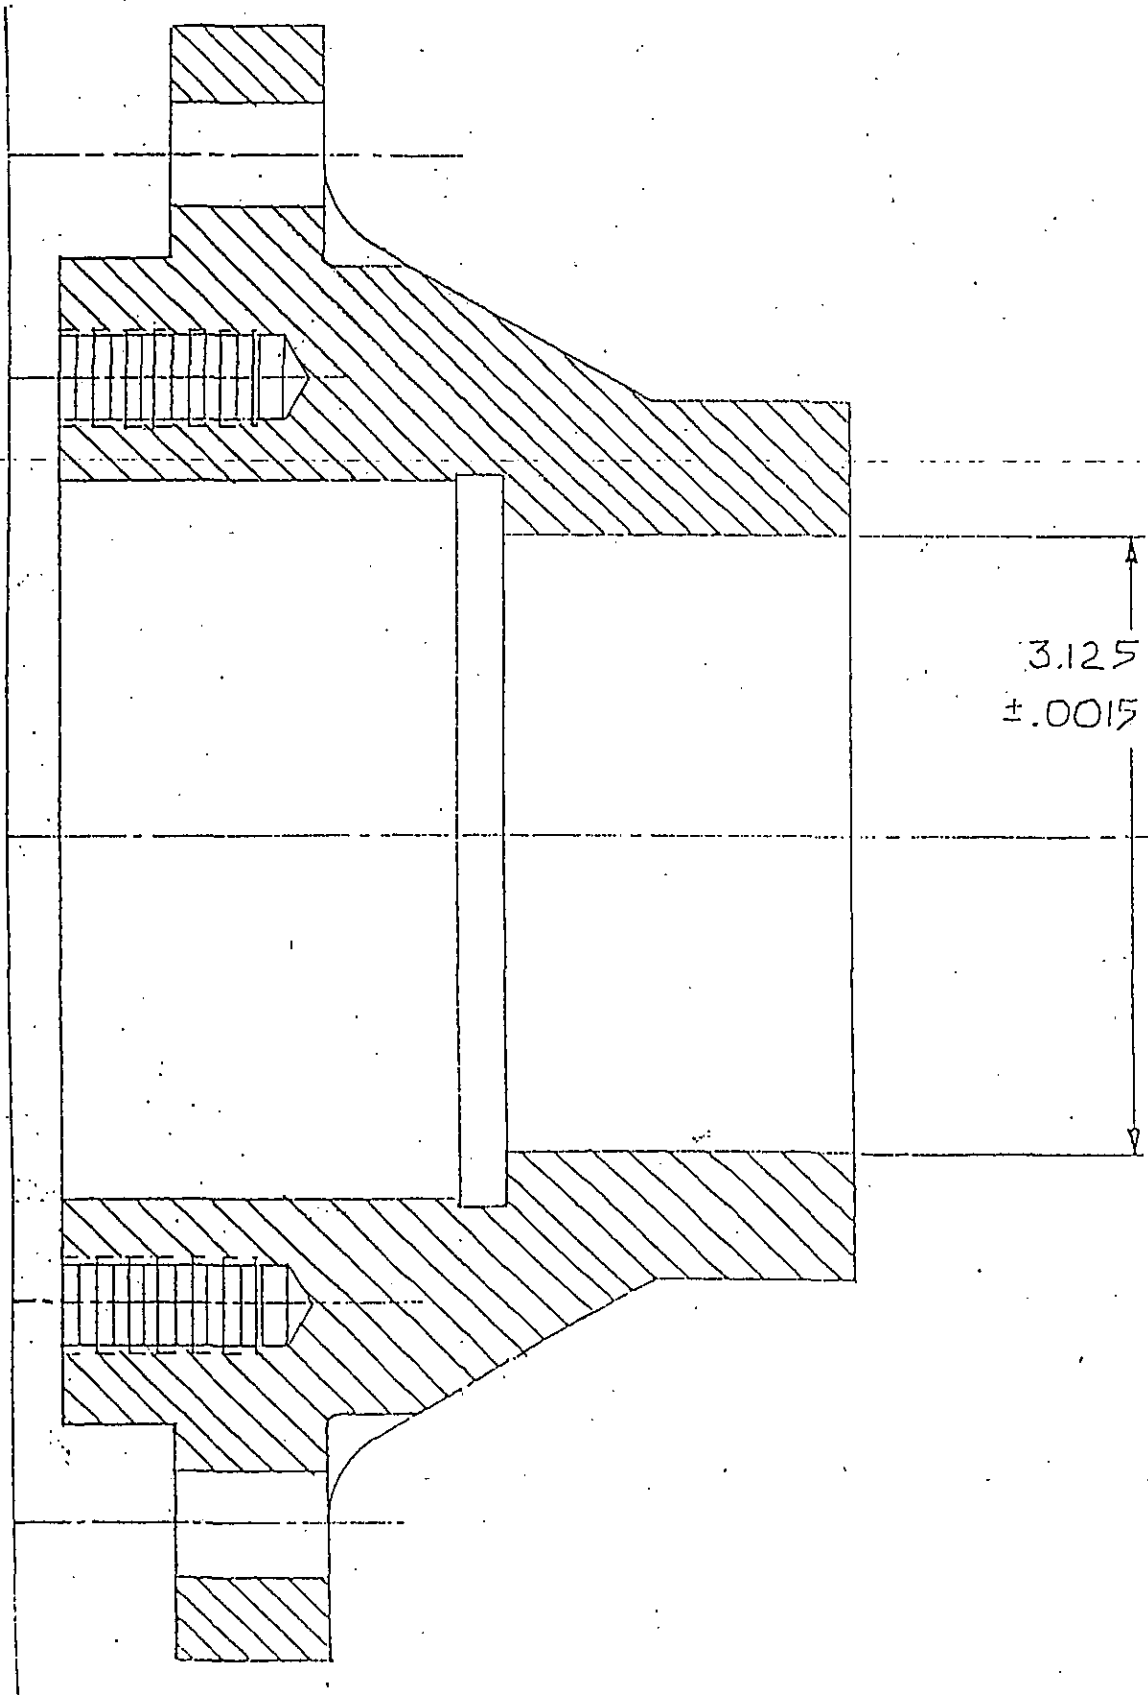
Therefore, to replace the seal it is necessary that the pinion casting assembly be disassembled and the casting re-bored to  $3.125" \pm .0015"$ .

The pinion casting was originally machined by gripping the casting at the small end in a three-jaw chuck. All the turned faces on the casting were finished from that one setup except for the facing off of the small end, and that was done after the rest of the machining was completed by reversing the casting in the chuck and gripping it on the large diameter locating shoulder. To re-bore the casting to the new larger diameter, grip the casting in a three-jaw chuck on the large diameter as if you were going to face off the small end. Check the original seal diameter with a dial indicator to be sure that the bore is running true before re-boring to  $3.125" \pm .0015"$ .

3.125  
± .0015 DIA

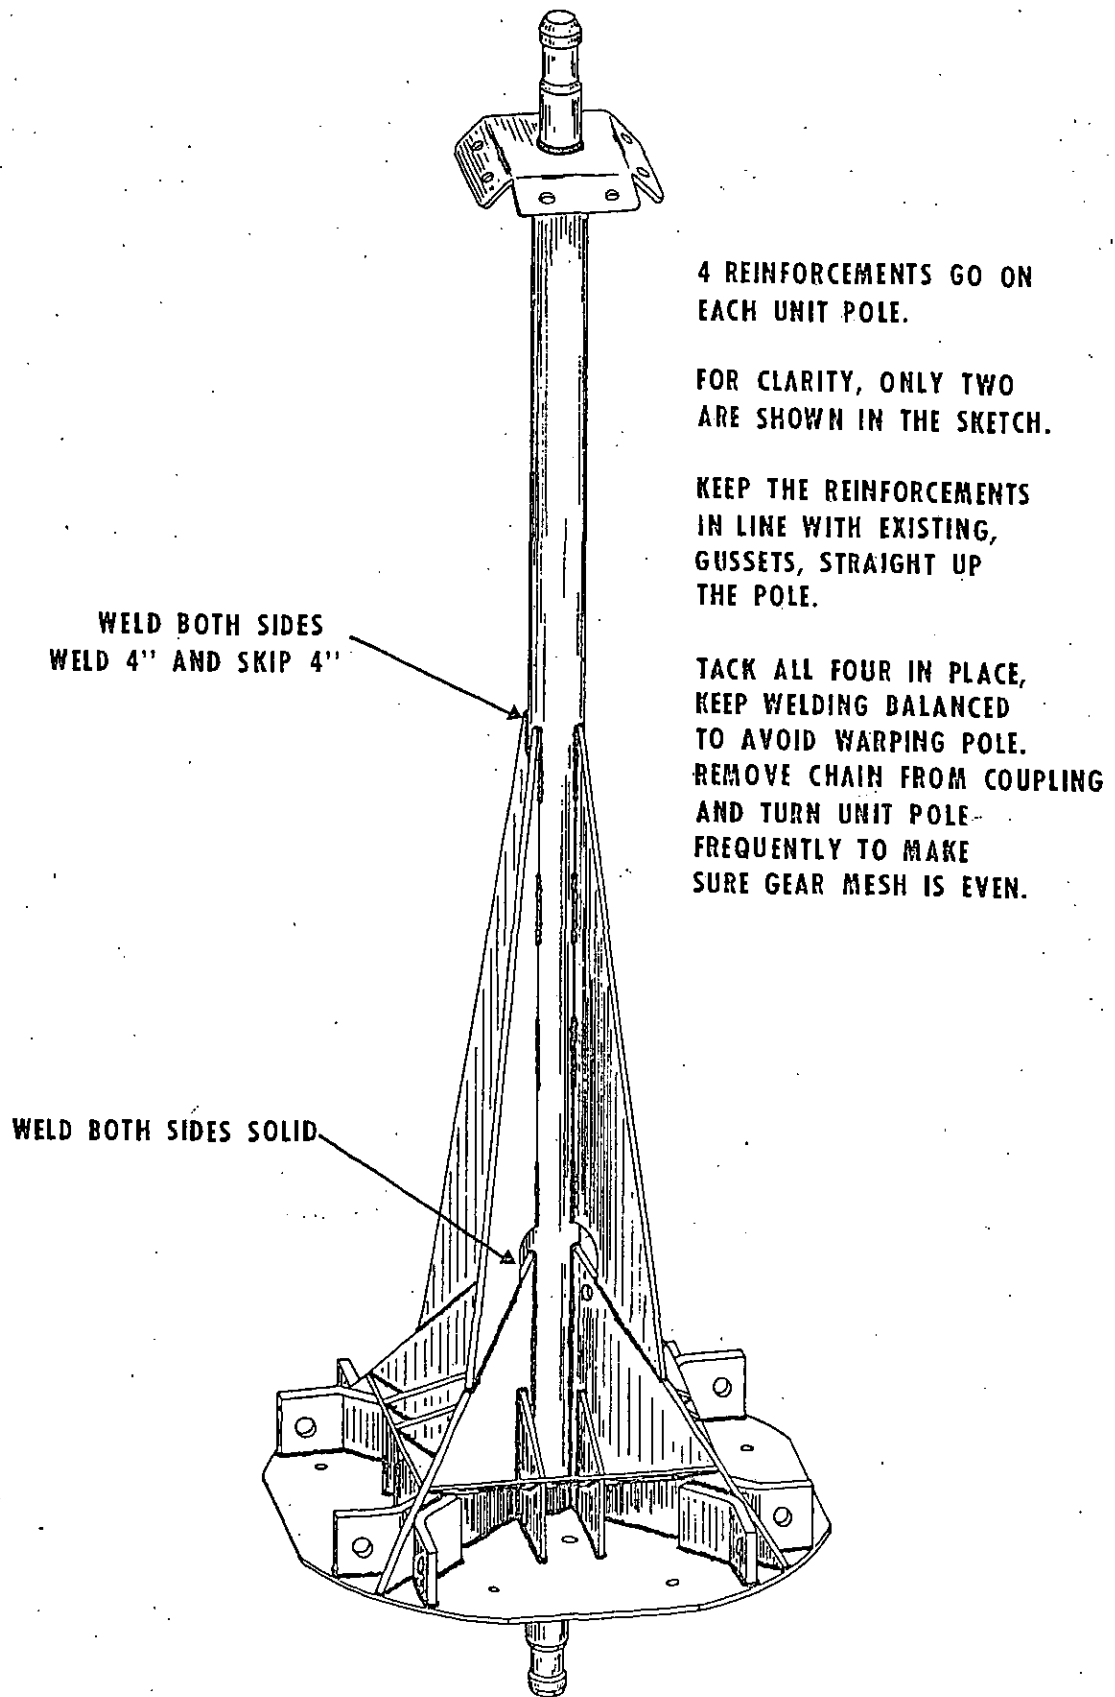
In limited instances it has been reported to us that a slight crack, and even a complete break, has occurred in one or more of the three Unit Poles of a Scrambler ride. When this happens it can be a severe hazard to any passengers who may be riding at the time.

In all cases known to us the crack or break has occurred immediately above the top of the four gusset plates of the Unit Pole. Due to the seriousness and similarity of this problem, we turned the matter over to an outside firm of consulting engineers for critical study and solution. Their investigation revealed that this failure is caused by operation of the ride at speeds in excess of that which is recommended by Eli Bridge Company.

To avoid this problem in the future, the consulting engineers have made two recommendations. First, DO NOT allow your operator to "goose" the ride to speeds in excess of those recommended by the factory (the centerpole of the ride should not turn more than 11 rpm when powered with gasoline motor, or, 11.4 rpm when powered with electric motor). Second, they have strongly recommended that all Scrambler rides presently in operation be equipped with additional gusset plates, as shown on the attached drawing. These extensions to existing gusset plates are designed to give the Unit Poles proper strength and safety - even though a crack may have already begun to form immediately above the original gussets.

It has been plainly stated that this failure is caused by improper operation, not by a design failure. However, we do recommend and strongly encourage that you immediately add these extension gusset plates to your Scrambler ride - BEFORE you begin your 1968 season's operation. These plates can easily be installed in your own winterquarters, or by a local machine/welding shop.

4 REINFORCEMENTS GO ON EACH UNIT POLE.

FOR CLARITY, ONLY TWO ARE SHOWN IN THE SKETCH.

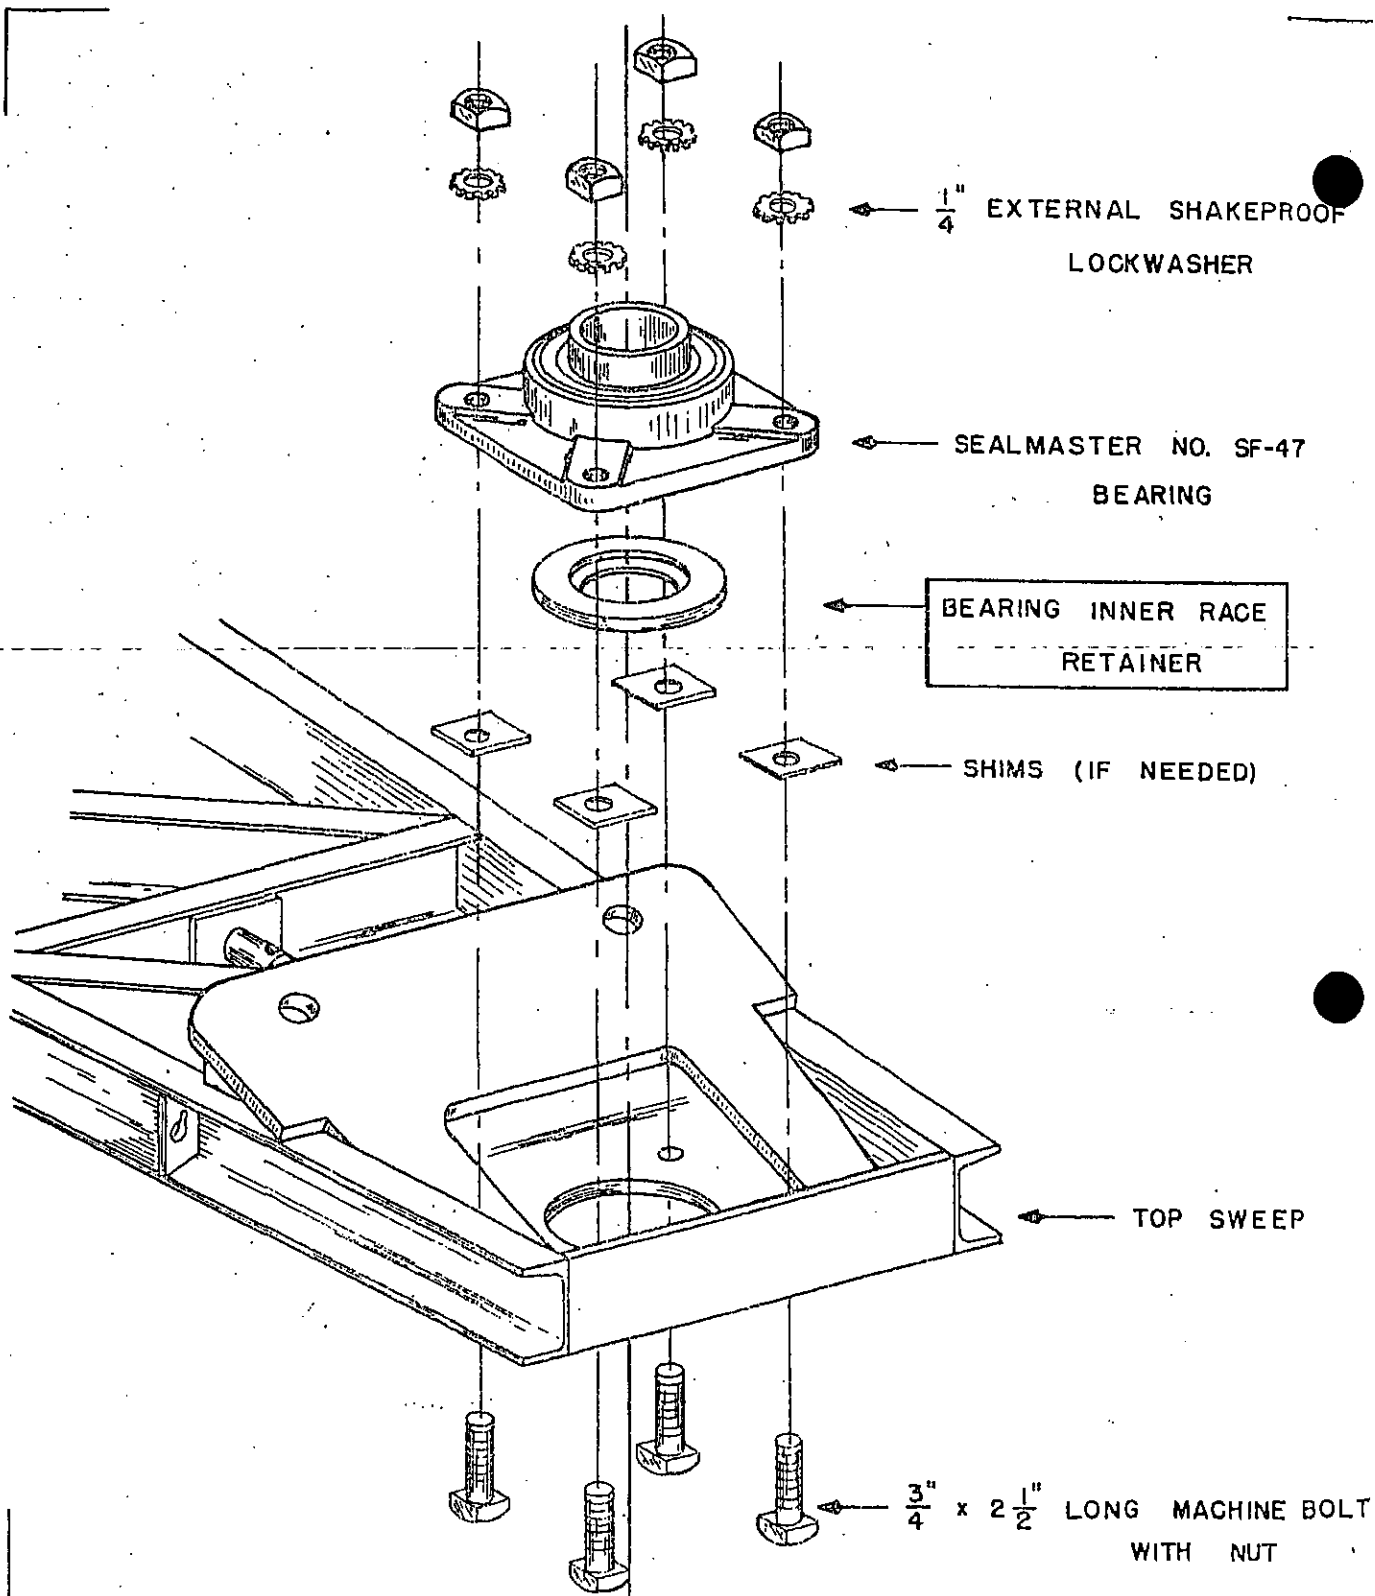
In two instances it has been reported to Eli Bridge Company that the Sealmaster SF-47 flange bearing casting has failed, allowing the unit pole to drop through the opening in the top sweep. When this happens it can be a severe hazard to any passengers who may be riding at the time. Therefore Eli Bridge Company is making available the special bearing inner race retainer shown, as a safety measure. Remove the bearing on the top sweep, set in place the bearing inner race retainer with its biggest diameter on the top side, and then put down the bearing again. The bearing inner race retainer is a loose piece, and be sure that when you tighten down the bearing, the bearing inner race retainer is still loose. This will not interfere with normal procedure for assembling the unit pole to the top sweep, but will insure that if the bearing casting should fail, the unit pole will not drop to the ground.

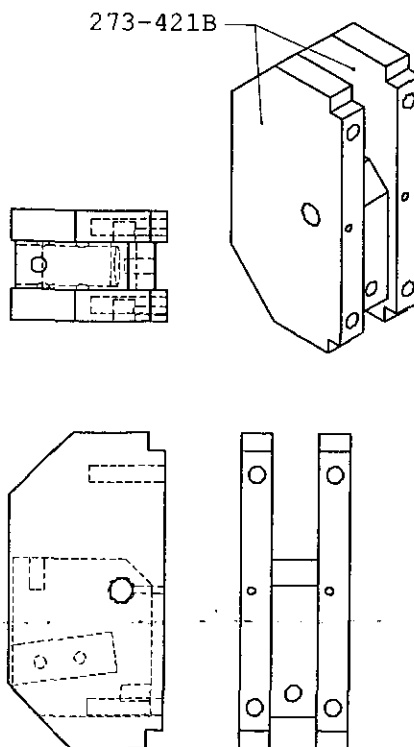
**Reason For Release:** It has been brought to our attention that it is possible to pinch fingers between the lap bar pivot block and the lap bar hinge blocks if care is not used.

**Actions to be taken:** Eli Bridge Co. has redesigned a wider lap bar hinge block that covers the sweep of the lap bar pivot block movement to minimize the possibility of pinching the fingers when raising or lowering the lap bar. The suggested replacement part # is 273-421B which consists of 4 lap bar hinge blocks that can be screwed to the existing door in place of the original block # 273-421A. All existing components are reused with the wider hinge blocks. Two 5/16 -18 x 3/4" long pan head screws (stainless steel) hold the hinge blocks to the handle bar.
