415.

Sartori Runaway Train/Big Apple roller coaster braking system defects

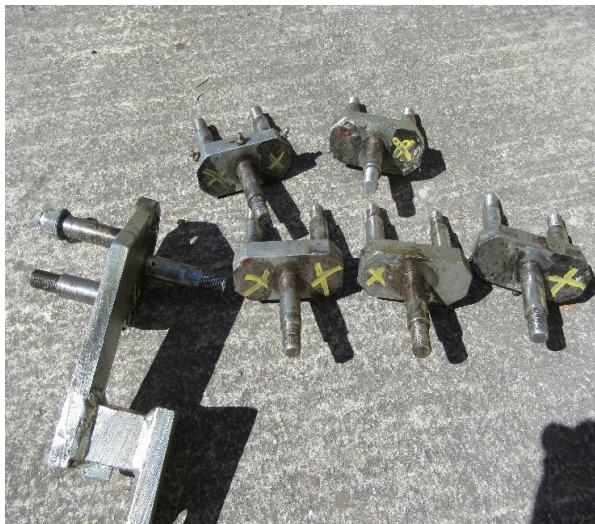
▲ Figure 1

The station brake is a simple 'pinch' brake attached to the station track section with a pivot block consisting of a central pin and two outer pins to hold the brake shoes parallel (See Fig1).

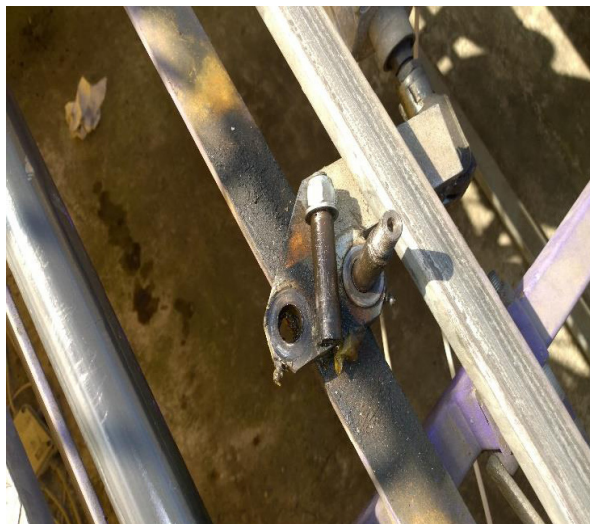
▲ Figure 2

The pins appear to be an interference fit in the pivot block and are welded circumferentially to the lower side of the block (See Fig 2). By removing the accumulated grease and observing the pivot block from the underside, defects (cracking) to the weldments can be easily found (See Figs 3 and 4).

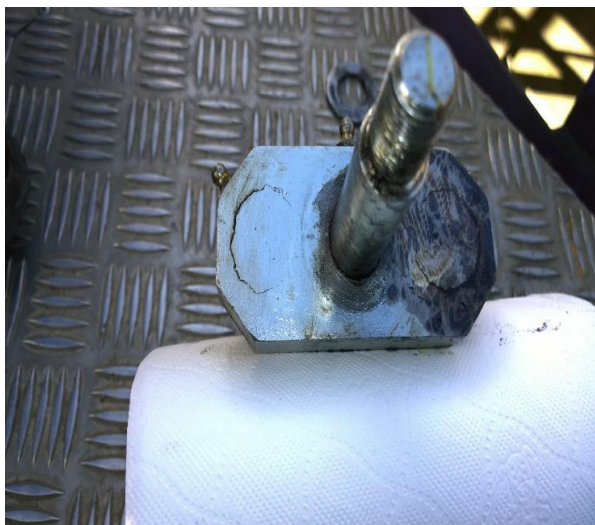
▲ Figure 3

In extreme cases the grease will escape from the 'crack' due to wear between the pin and the block.
