# SAFETY ALERT

Ride: THUNDERBOLT

Subject: Inspection and Adjustment  
Of Spreader Bars

Subject: Spreader Bar Rework Kit

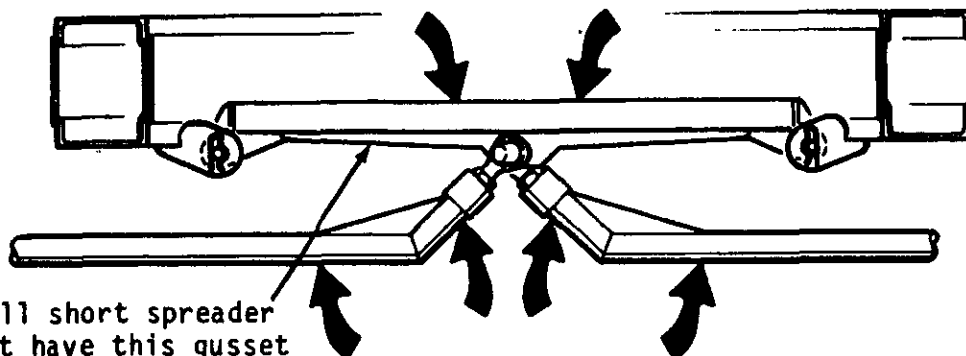
Inspect for cracks in the areas indicated by arrows in the following illustration. Also check the spreader bar mounting points for worn bushings or pins. If wear or damage is found in any of these areas, contact the CHANCE CUSTOMER SERVICE DEPARTMENT immediately.

NOTE: All short spreader bars must have this gusset

**IMPORTANT:** Do not attempt to repair spreader bars in the field. Any spreader bar which has been welded, drilled or otherwise repaired must be discarded and replaced with a new part.

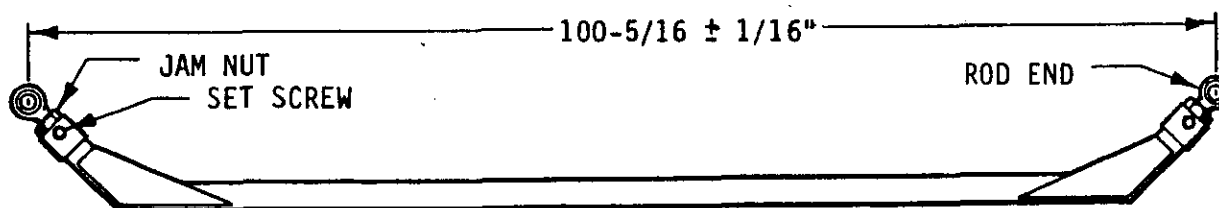
1. Remove all long spreader bars.
2. Loosen ALL jam nuts and set screws.

3. Measure the length between the rod ends, center to center, on all long spreader bars. This measurement must be  $100-5/16 \pm 1/16$  inches. Adjust the length by turning the rod ends.

**IMPORTANT:** Both rod ends must be threaded into the sockets an equal number of turns. Always adjust both rod ends equally, within one-half turn.

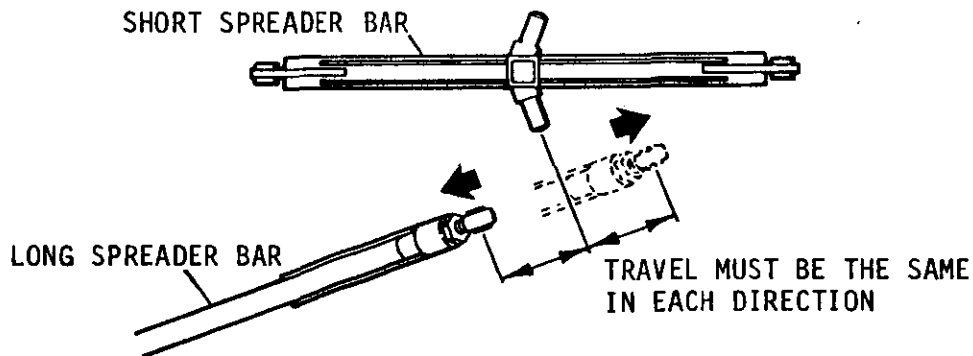
As the ride turns, measure the distance the disconnected rod end travels in relation to the pin on the short spreader bar. This distance of travel must be the same each direction from the pin.

7. If the travel is equal in both directions, install the spreader bar and tighten all jam nuts and set screws.

If the travel is not equal in both directions, adjust the length of each long spreader bar (either longer or shorter) by turning the rod ends. ALL SPREADER BARS MUST BE THE SAME LENGTH. If one spreader bar is adjusted to a longer length, ALL spreader must be lengthened by the same amount.

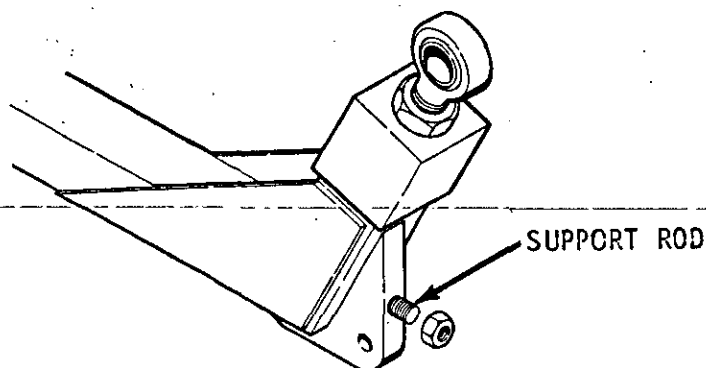
1. Remove one long spreader bar.
2. Remove the nut from one end of the support rod. Remove and discard the rod.

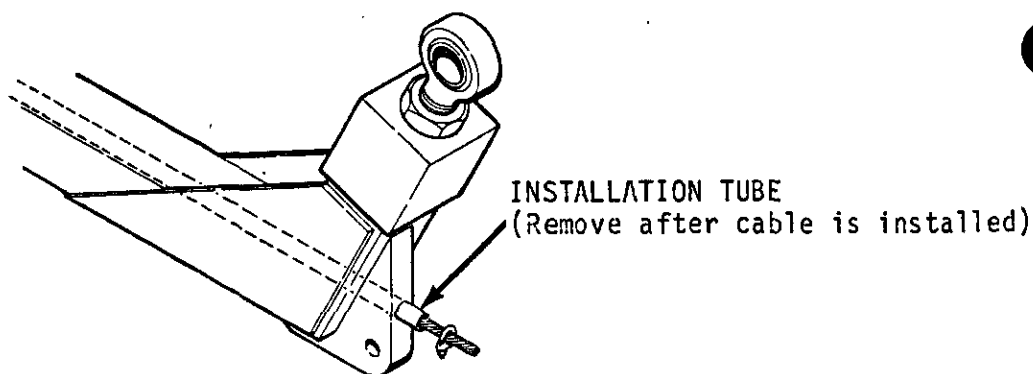
3. Insert the installation tube provided through the holes in the spreader bar. Insert the cable through the installation tube. Attach a cable clamp approximately 1 to 1-1/2 inch from one end of the cable. Tighten the nuts securely.

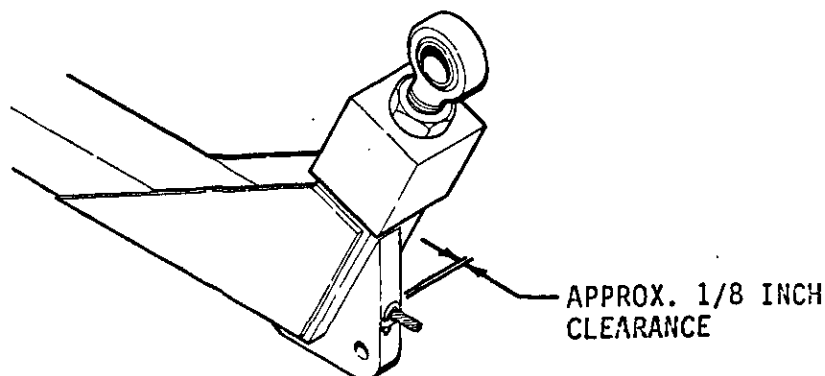
4. Remove the installation tube. Pull the cable tight by hand and install a cable clamp to allow approximately 1/8 inch clearance to the spreader bar.

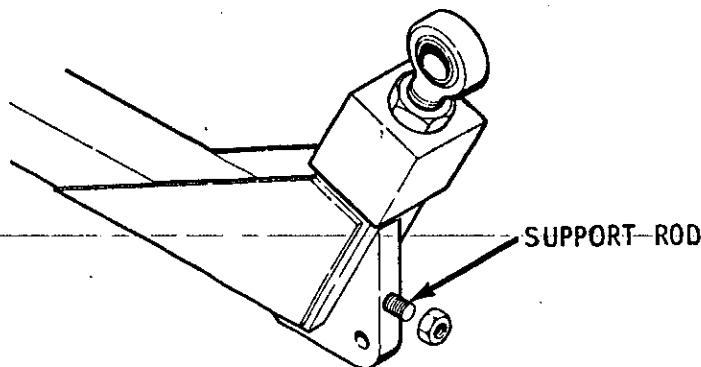
1. Remove one long spreader bar.
2. Remove the nut from one end of the support rod. Remove and discard the rod.

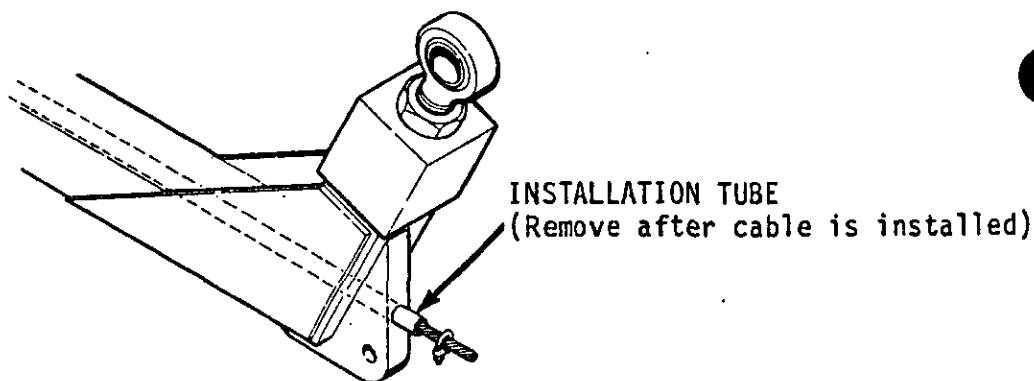
3. Insert the installation tube provided through the holes in the spreader bar. Insert the cable through the installation tube. Attach a cable clamp approximately 1 to 1-1/2 inch from one end of the cable. Tighten the nuts securely.

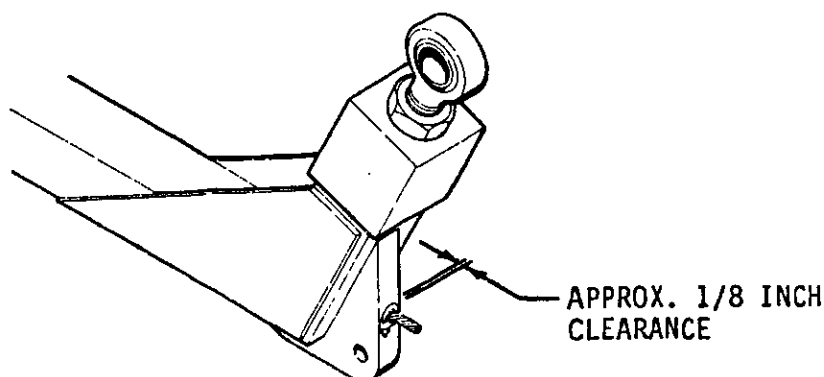
4. Remove the installation tube. Pull the cable tight by hand and install a cable clamp to allow approximately 1/8 inch clearance to the spreader bar.
