# BOLLIGER & MABILLARD

### SERVICE BULLETIN

INVERTED COASTER

Vehicle seat columns

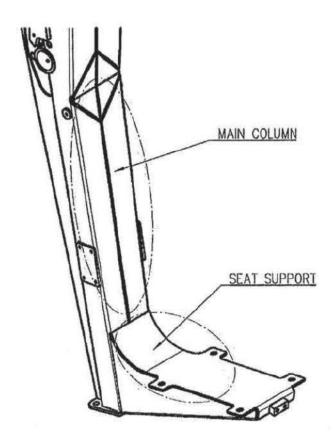
Corrosion under the seats and behind the seat backs was discovered on several seat columns.

#### Detail of Issue:

Visual inspection after dismantling of the seats and seat backs.

- Within 10 days, the components attached to the seat columns shall be dismantled to allow the NDT and visual inspection as per the Detail of Issue.
- 2. Renew if necessary corrosion protection.
- Significative loss of material thickness (above 0.6 mm on the main column or above 0.8 mm on the seat support) dictates columns replacement.
