## INSTRUCTIONS FOR REPLACING OIL SEAL IN SCRAMBLER PINION CASTING ASSEMBLY

# UNIT POLE MODIFICATION

#### MODIFICATION OF SCRAMBLER TOP SWEEPS

## URGENT WARNING

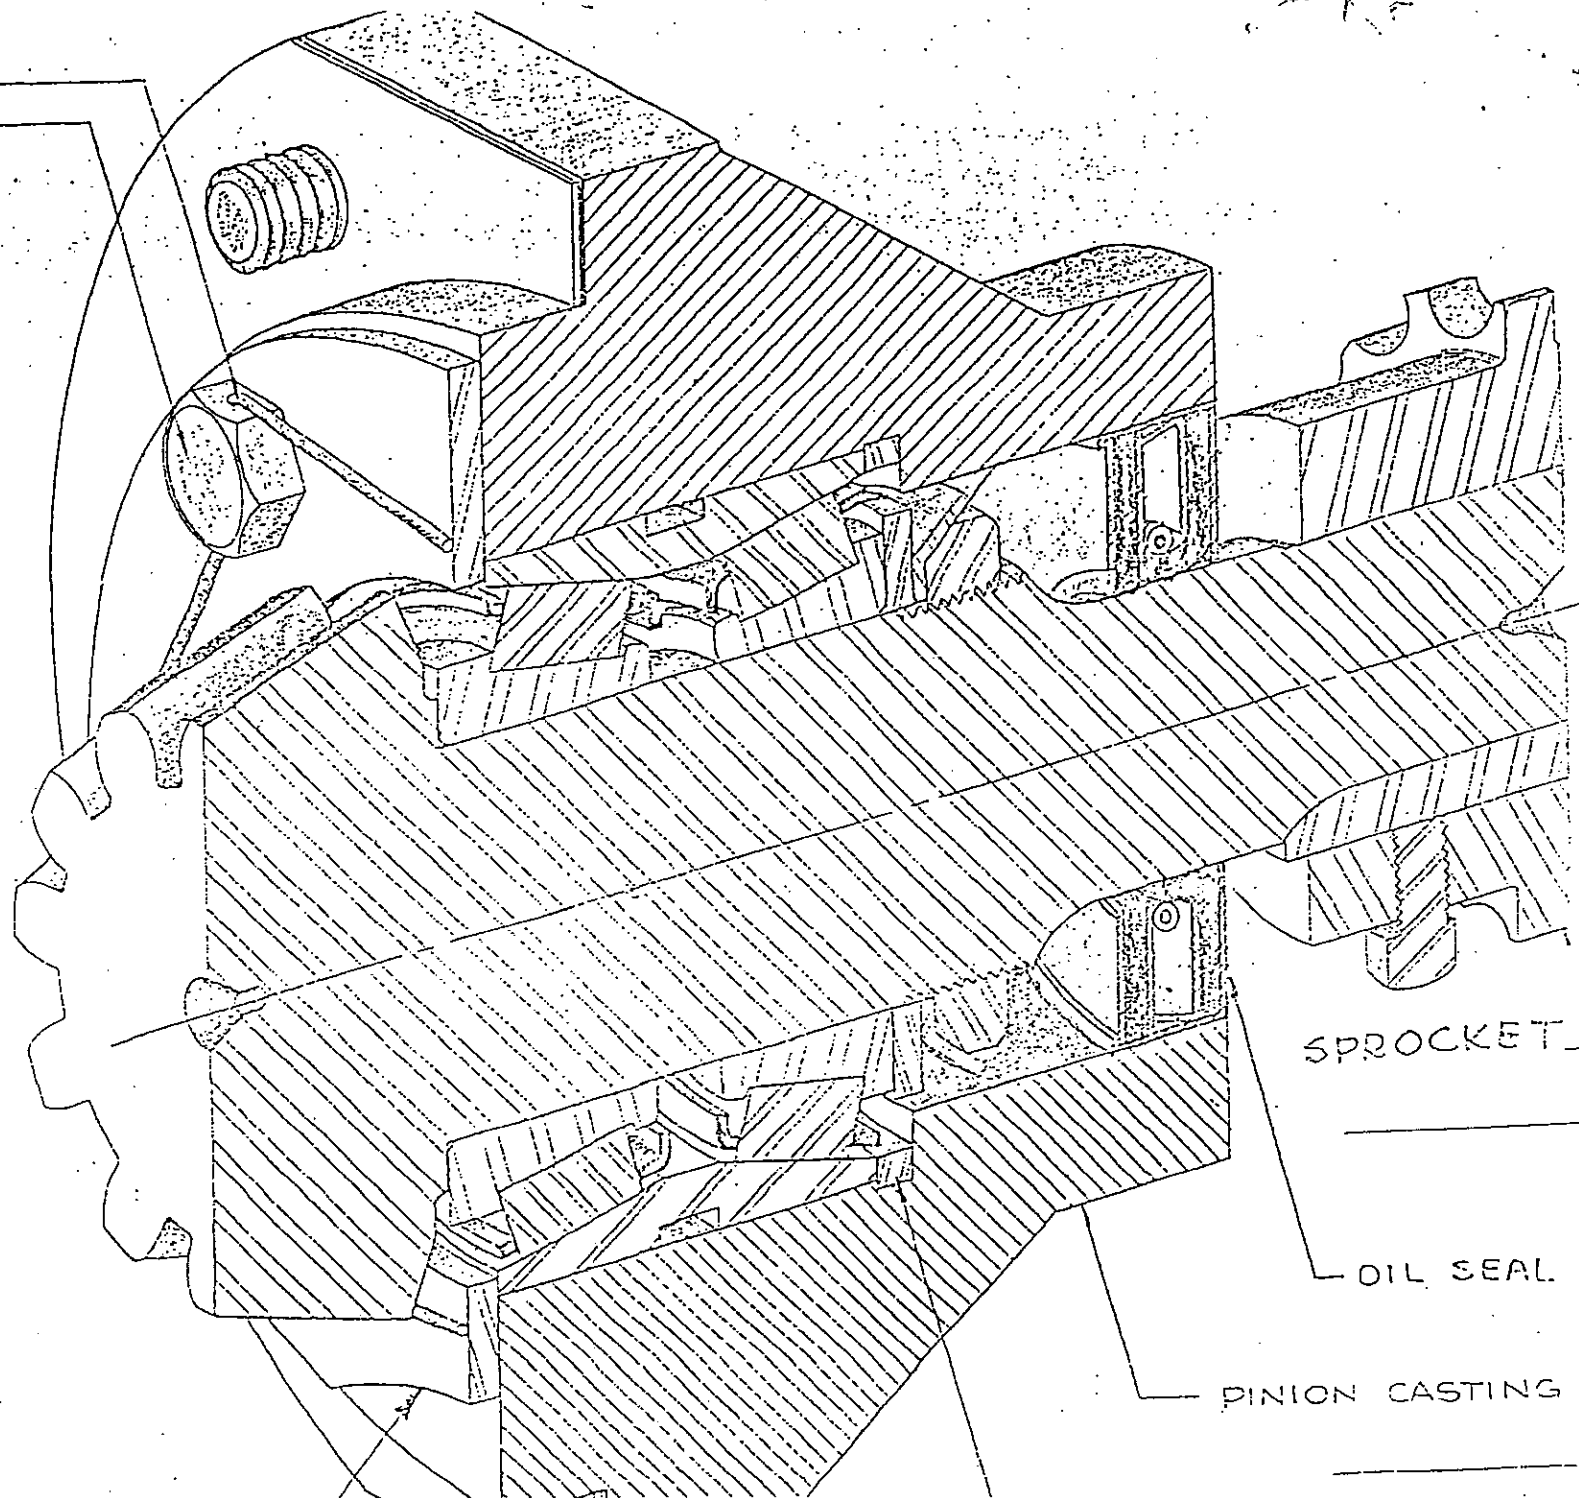
The original seal used in the pinion casting assembly was a Chicago Rawhide "Perfect" oil seal Part No. 15245. The manufacturer discontinued that seal, and we could not find an interchangeable replacement from any other manufacturer. The closest seal in size was a Chicago Rawhide Part No. 15250. The original seal had an outside diameter of 3.066", and the replacement had an outside diameter of 3.130".

Therefore, to replace the seal it is necessary that the pinion casting assembly be disassembled and the casting re-bored to  $3.125" \pm .0015"$ .

1. Remove the pinion casting assembly from the Scrambler, by taking out the six cap screws that secure it to the stationary base gear pot cover plate.
2. Remove the chain sprocket from the end of the shaft.

3. Remove the locking wire. It is 19 gage, dead soft iron wire, two feet long. When the time comes to replace it, thread the wire through the bolt heads so that loosening of the bolt will cause the wire to tighten, and then twist the ends of the wire together tightly with four turns to keep it from unwinding.

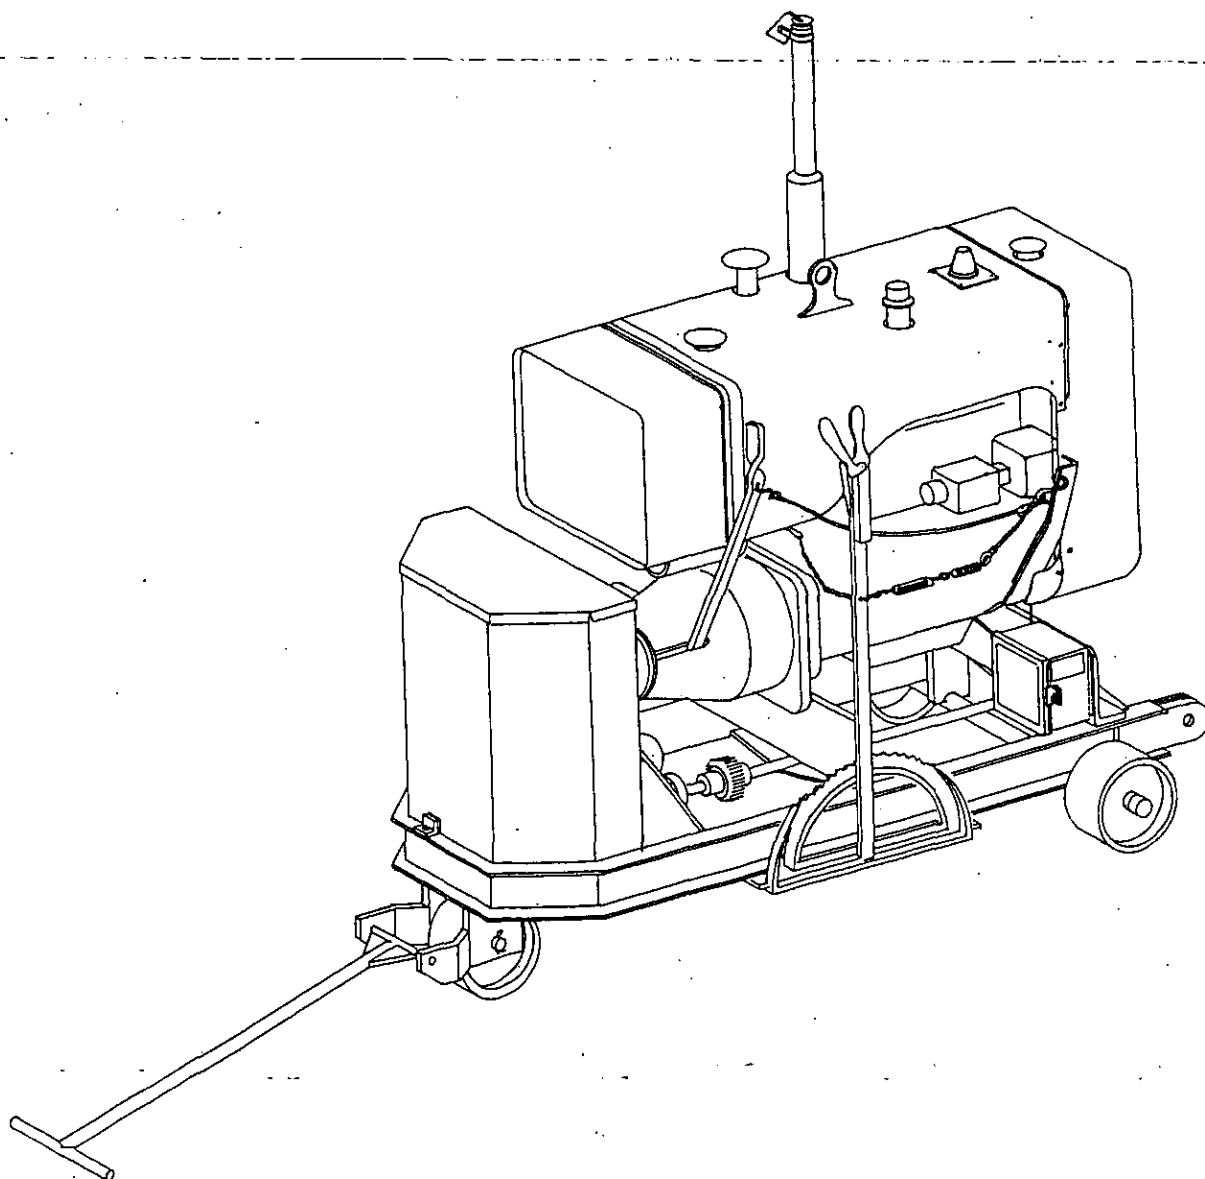
FIGURE NINE

OVERSPEED SWITCH MOUNTED ON ALLIS-CHALMERS POWER UNIT

- 1) Locate the box on the Power Unit as shown in Figure three, with the top and side of the flange flush with the upper corner of the angle beam. Mark the four holes. Also see Figure Nine.
- 2) Centerpunch the marks on the angle beam. Drill first with a small drill like 1/8, then redrill with a 3/8 size.
- 3) File the burrs from the holes.
- 4) Bolt on the box. The wiring harness should face the engine.
