BREDGE COMPANY

RE: BIG EII Rides that have been trailer-mounted, modified, or otherwise "re-manufactured" elsewhere.

BIG ELI® WHEEL BULLETIN NUMBER 3

Big Eli® Wheel Bulletin No. 6

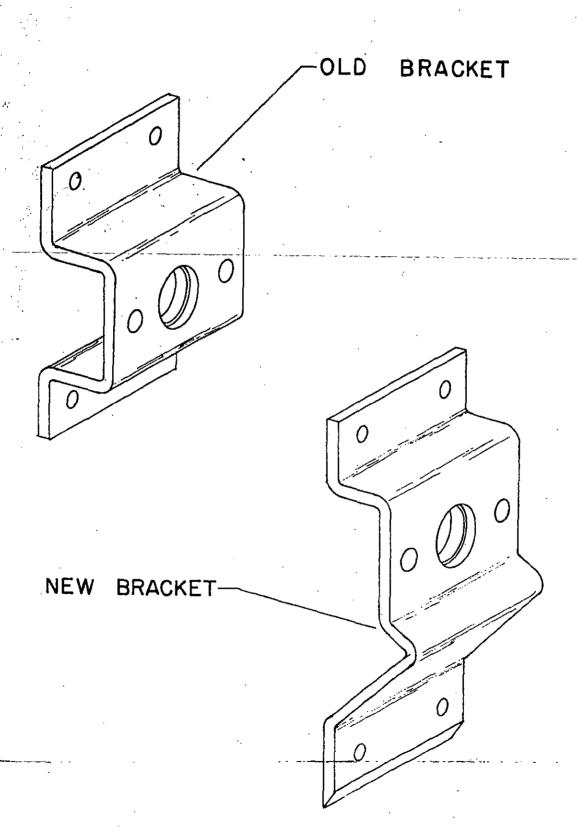
Improper installation of the brackets, plus lack of inspection of the completed Wheel before carrying passengers, appear to have caused an accident involving one fatality. What appears to have happened is that in hanging the seat on the Wheel the right end (off-tower side) was not hung on the seat pin but on the improperly installed hair guard bracket. The seat pin has a large diameter on the end which can just slip inside the hairguard bracket when it is improperly installed with the open end down. A glance at the end of the seat would have shown that the seat was not hanging properly, but such an inspection obviously was not made. Consequently, after the Wheel had turned two or three times the seat pin apparently rolled out of the bracket, allowing that end of the seat to drop.

Both of these modifications, if done according to our instructions, will, in our opinion, give you complete protection against this kind of thing ever happening again, even if an operator does not make a proper inspection, because these two modifications will eliminate any ledge or recess for the seat pin to fit into or lodge against.

To eliminate absolutely the possibility of this ever happening again, Eli Bridge Company has developed a new bracket to be used on each side of the seat to replace the ones you have already installed there. The necessary brackets, rivets, and instructions

Secondly, take your seat pins to a machine shop and have them turn a radius on the end of the pin as shown in the accompanying drawing. Changing the brackets will not give you the protection you need unless you have also rounded off the outer edge of each seat pin.
