# NAFLIC

TECHNICAL BULLETIN — February 2015

## **388. Huss Enterprise/UFO boom cracking**

### Service-Information 05-02

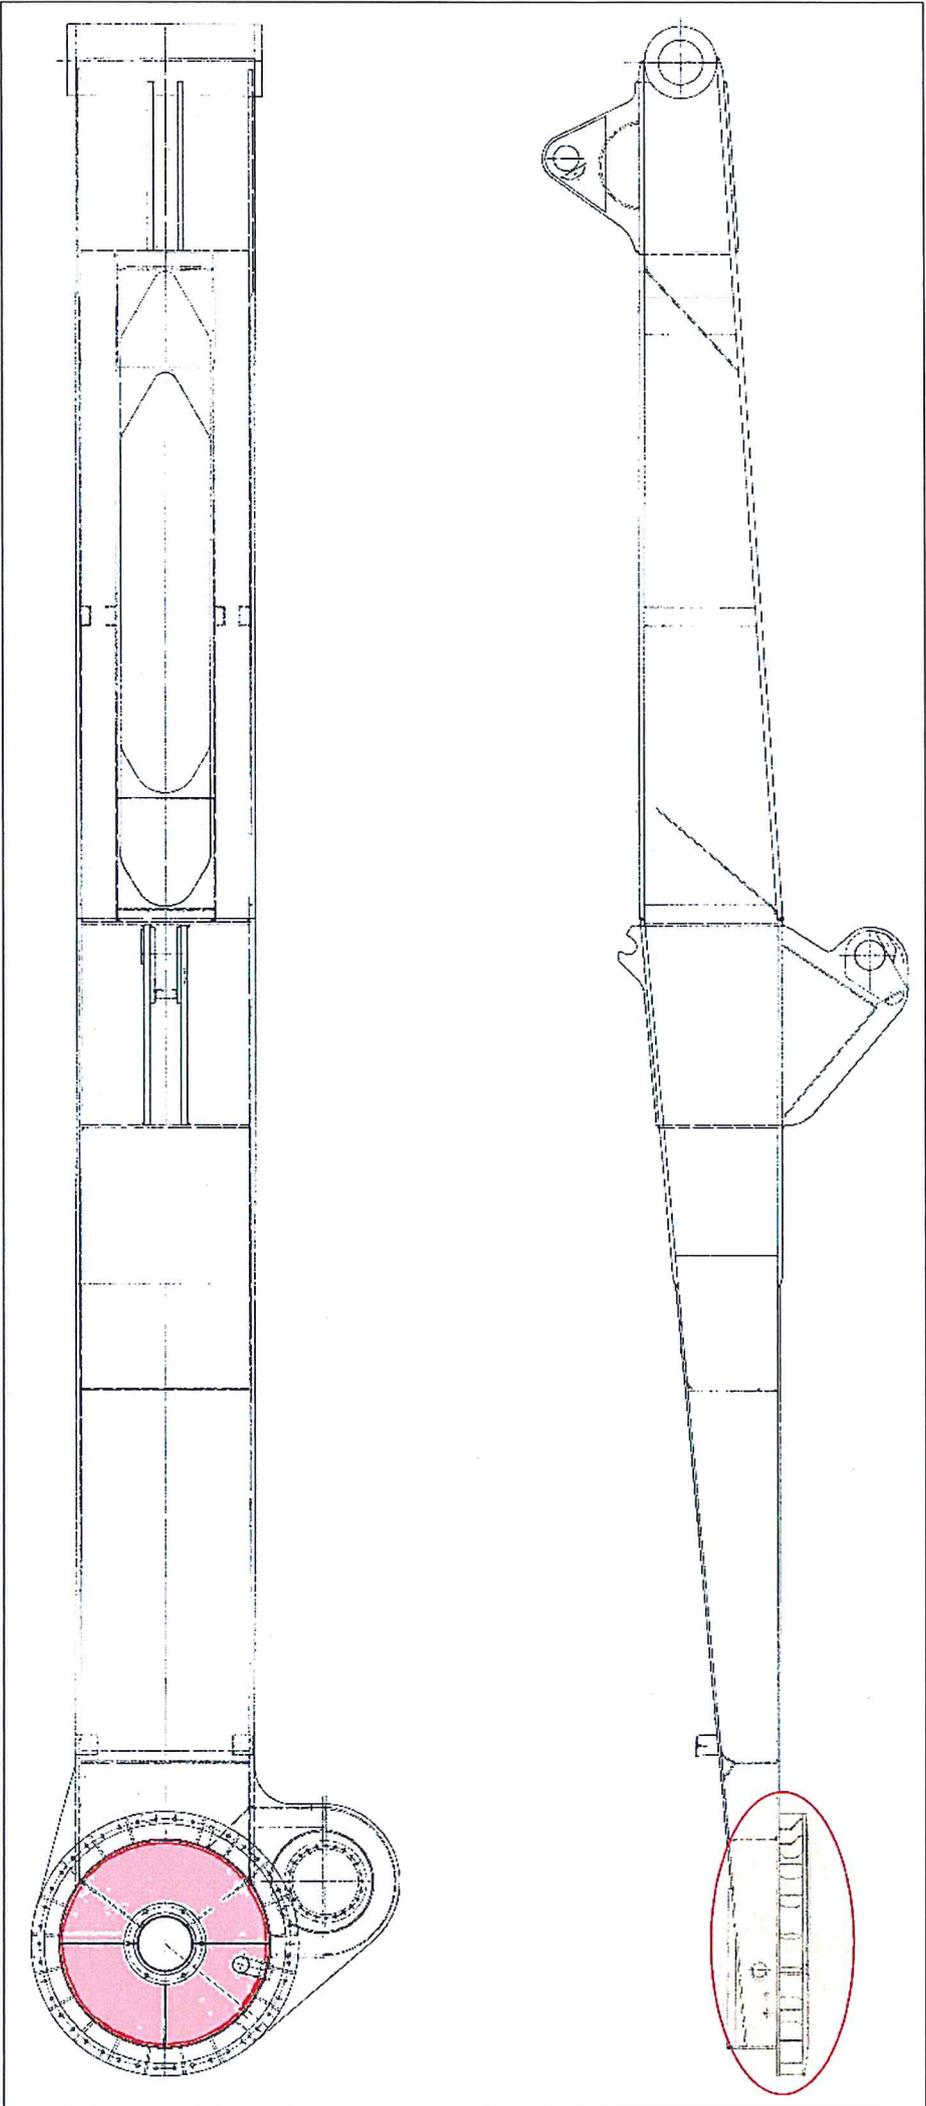
During a general overhaul of an Enterprise ride, cracks in the area of the boom head have been detected.

CENTRE LINE CRACK  
L=1600mm

It is strongly recommended to get this area inspected by a certified company.
