**WISDOM
INDUSTRIES, Ltd.**

SAFETY BULLETIN

DATE: OCTOBER 18, 2004
RIDE: SIZZLER AND DELUXE SIZZLER ONLY
SUBJECT: SIZZLER SEAT FRAME AND FOOT TUB
ATTACHMENT INSPECTION
TIME: IMMEDIATE
FREQUENCY: ANNUAL

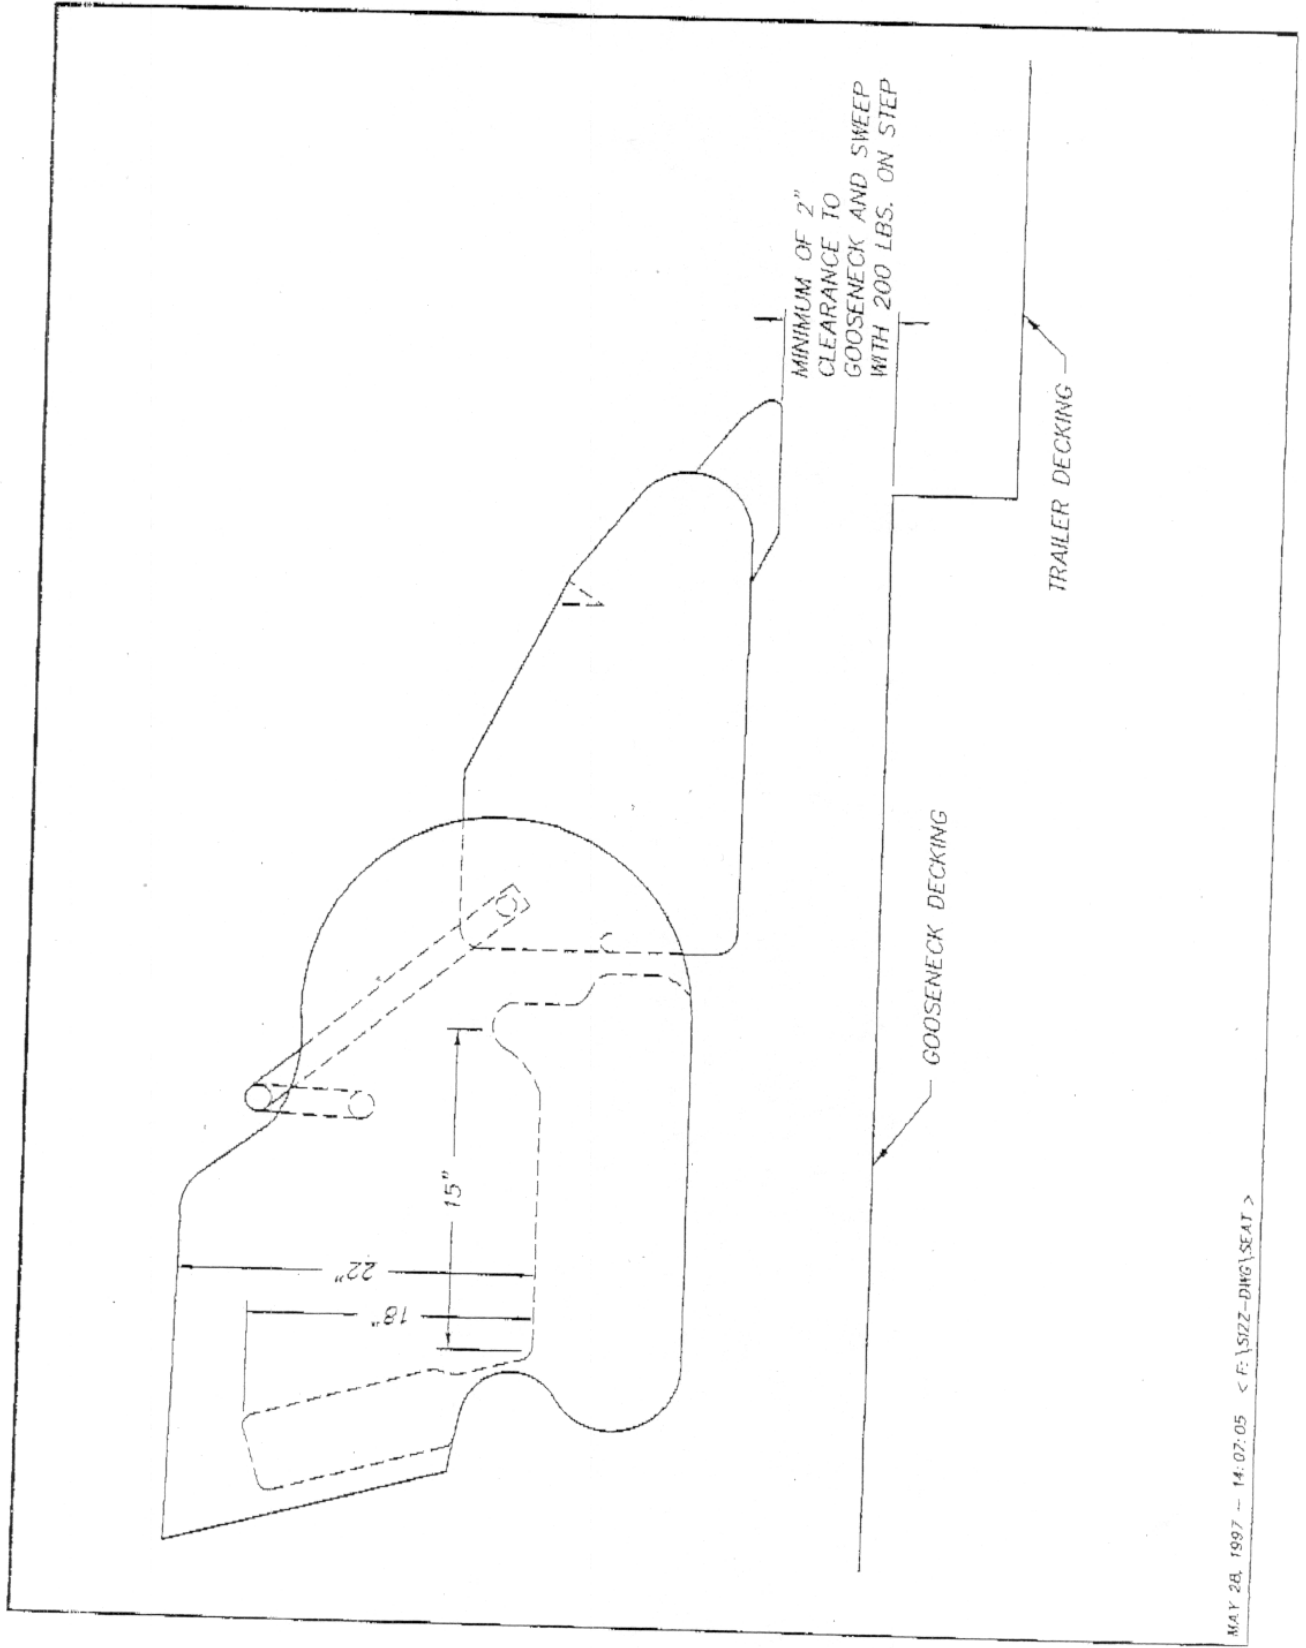
WISDOM INDUSTRIES		Merino, CO 80741	
SCALE: N.T.S.	APPROVED BY:		DRAWN BY: MFK
DATE: 08-25-94	REMOVED		
DESCRIPTION			
SEAT INSPECTION HOLE LOCATIONS			
EQUIPMENT: SIZZLER		DRAWING NUMBER SEAT

1. Remove seat liner to perform annual inspection.
2. Cut a hole in the left side of the car body using a hole saw. Review the enclosed drawing for the location of the hole. Use a 5 inch diameter hole saw.
3. Inspect the two internal frame mounting bolts for proper Grade 5.
4. Replace if they are loose or broken and use Red Loctite.
5. Inspect bolts for proper 7/16 inch diameter. Proper head size of a 7/16 inch bolt uses a 5/8 inch socket.
6. Check that torque of 7/16 inch bolt is 60 foot pounds.
