SERVICE BULLETIN

RIDE: Orbiter

SUBJECT: Lap bar release handle cover

BULLETIN NUMBER: 00102

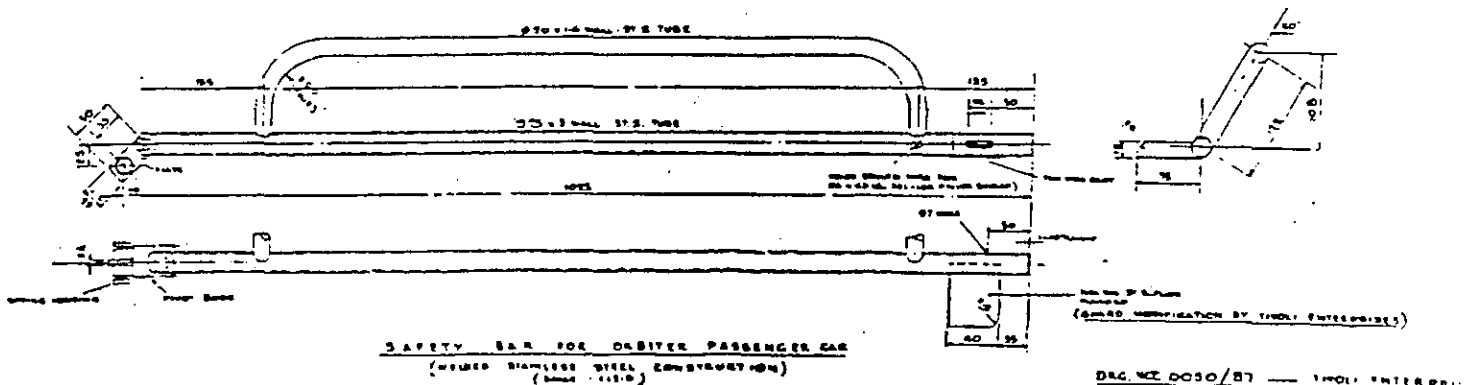
In order to prevent accidental release of lap bar Tivoli recommends the addition of a cover plate to be installed on lap bar as described below. The cover plates are available at no charge from Exsaco Corporation.

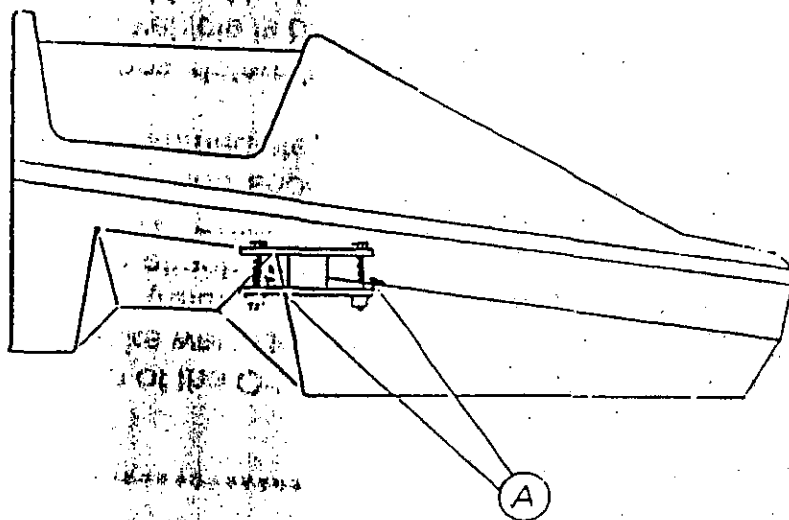
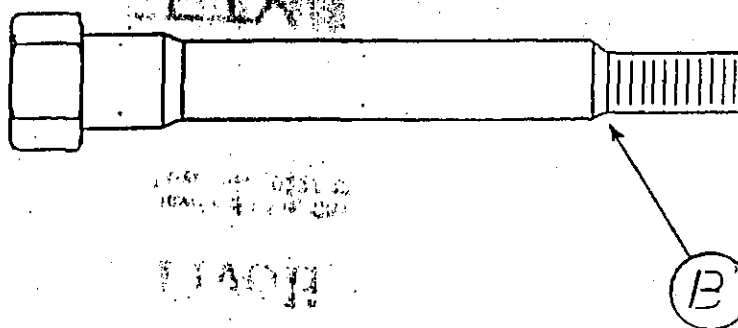
Through routine inspection of the Orbiter Amusement Ride seat attachment pins, (refer to Point A) cracks were detected in the area where the threaded portion meets the pin shaft (refer to Point B). It is recommended by Tivoli Enterprises that these seat attachment pins be inspected by an approved non-destructive testing (NDT) process to determine condition of pins. If cracks are detected, these pins should be replaced immediately. This inspection should be done immediately and then on an annual basis.

After investigation, Tivoli has determined that cracking of pins is due to excessive tightening when vehicle is being attached to sweep. As stated in the manual, these pins should not be tightened in excess of 70 foot pounds. The ride is supplied with an electrical impact wrench which is to be used only to speed the operation of installing and removing these pins. If abused, excessive tightening could damage pins. Use impact wrench to bring pins down until it meets the base metal only.

If it is in owner's or inspector's opinion that use of this impact wrench is being abused by the operator, it is recommended by Tivoli that the electric wrench be replaced with a 3/4" drive ratchet hand wrench.

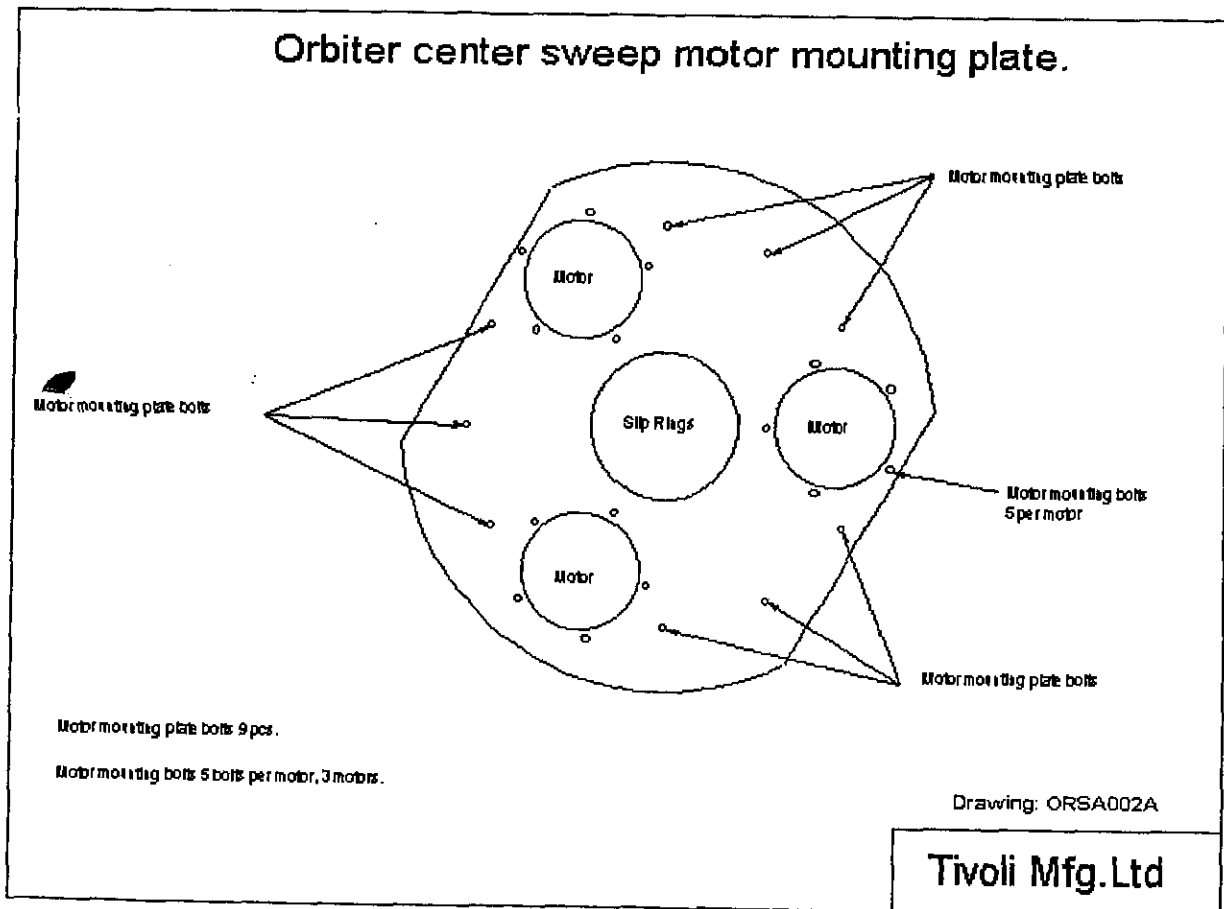
On February 1, 2004, an Orbiter amusement ride caught fire while operating at a fair in West Palm Beach, Florida. The fire originated in the top center hub area of the ride. A fire was initiated when bolts securing the motor mounting plate became loose and eventually sheared allowing the motor plate to turn causing one or more hydraulic hoses to pull loose from their crimps, spraying fluid into the top hub area. The source of ignition is still under investigation at this time. As a precaution Tivoli Mfg. Ltd. requires that the inspection recommendations described below be carried out **immediately** on all Orbiter rides.

If loose, damaged or show signs of re-use, replace immediately with new bolts and tighten to correct torque.

- **Replace all nine (9) bolts securing motors mounting plate to hub.**
 - 9 – 12mm x 45mm bolts spread equal distance around outside parameter of plate. See Attached drawing ORSA002A (See Attached)
