# Tivoli MFG Ltd.

## Service Bulletin

Bulletin No: SOSR001

Ride Type: Spin Out  
Date: September 8, 1998

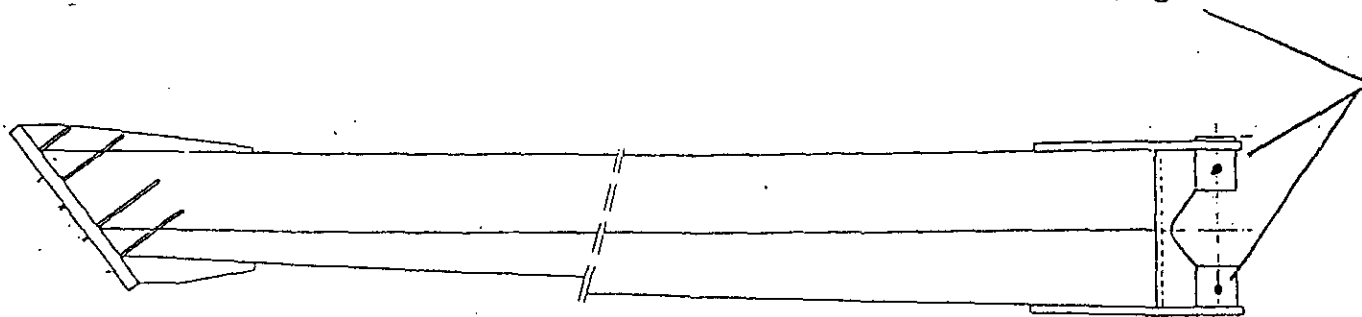
Fig. 1

Locate Grease Fittings

1. With both pins installed in sweep, Remove the threaded collar from the bottom of the pin below the sweep hub. This requires the removal of a set screw locking the collar to the threads.
2. With the other pin slightly loosend, remove hing pin by tapping out with hammer and brass or alluminum rod.
3. After pin is removed drill a 3/16" hole through the center of the sweep bushing collar so the hole comes through between the two internal bushings.
4. After all 3/16" holes are drilled 2 per sweep, 8 total, counter bore a 21/64 hole approximately 10mm deep ( 3/8" ). As in step 1 use a shop vac to collect filings while drilling.
5. Tap counter bore with a 1/8" pipe tap, Clean toughly.

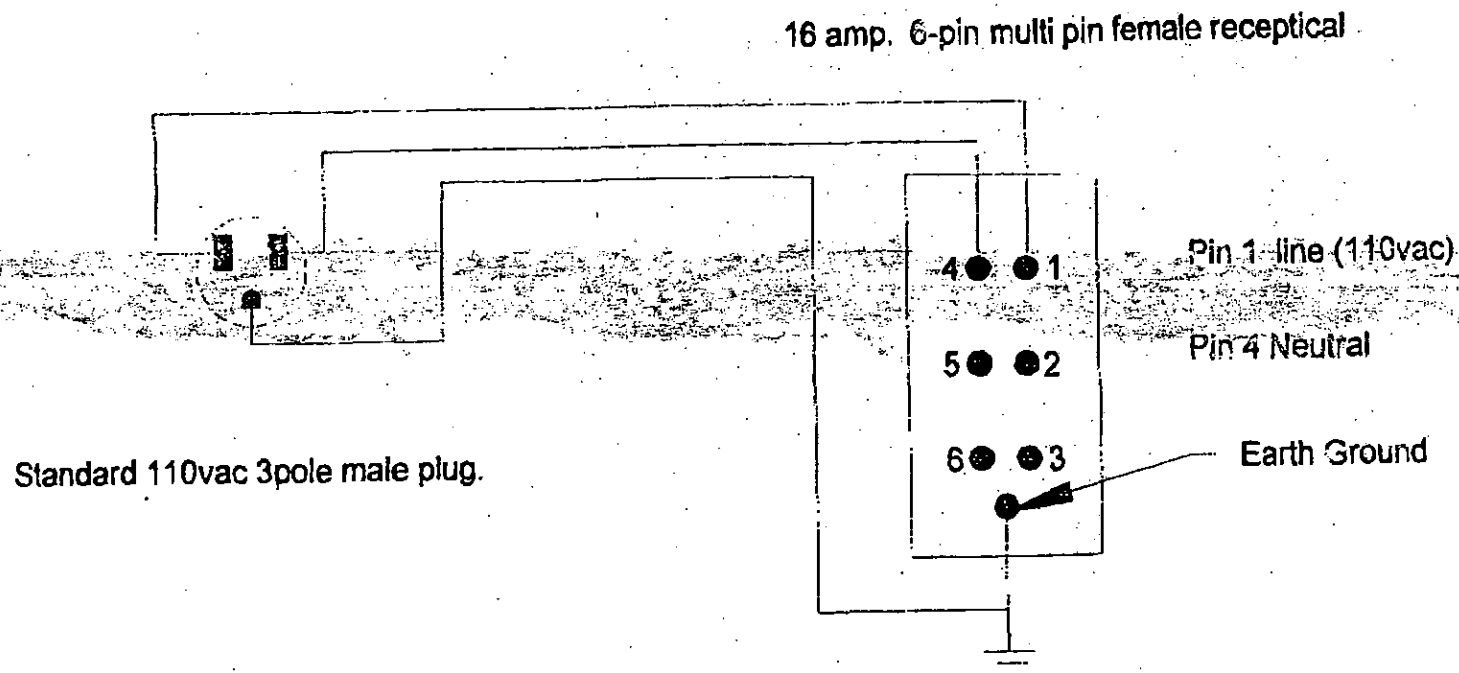
Drawing # SOSA007A

# 110vac Adapter plug Wireing scheme

Tivoli requires this plug be assembled by a qualified electrician capable of understand the function and use of the components.

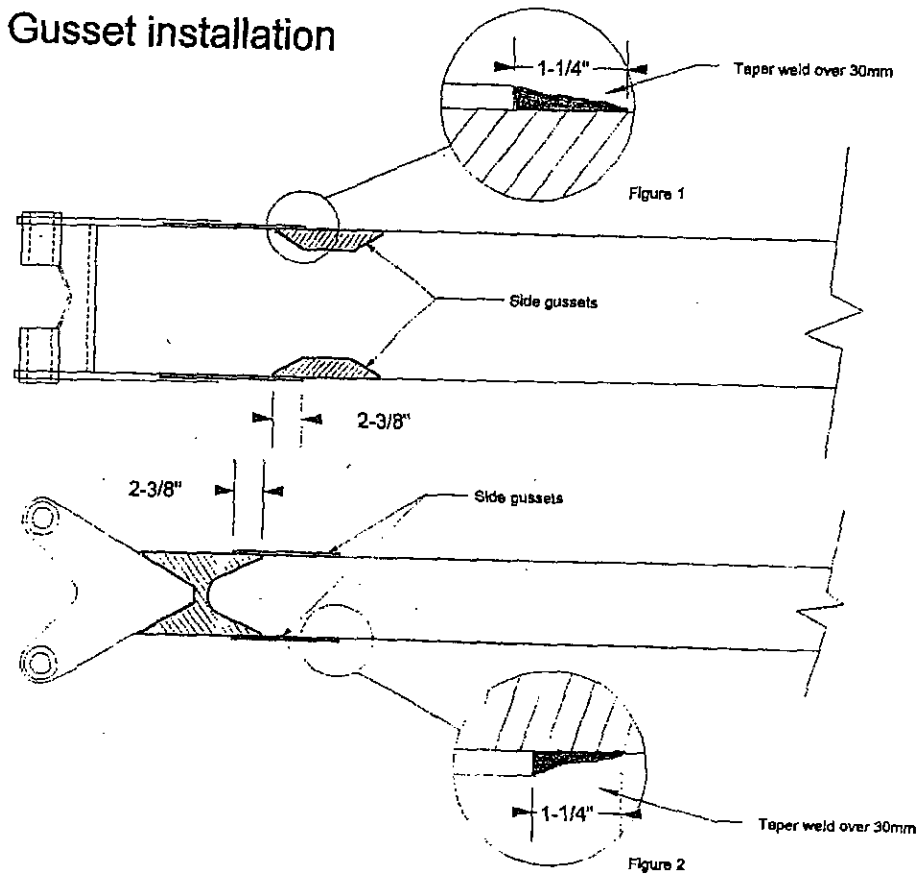
**Figure B**

## Side Gusset installation

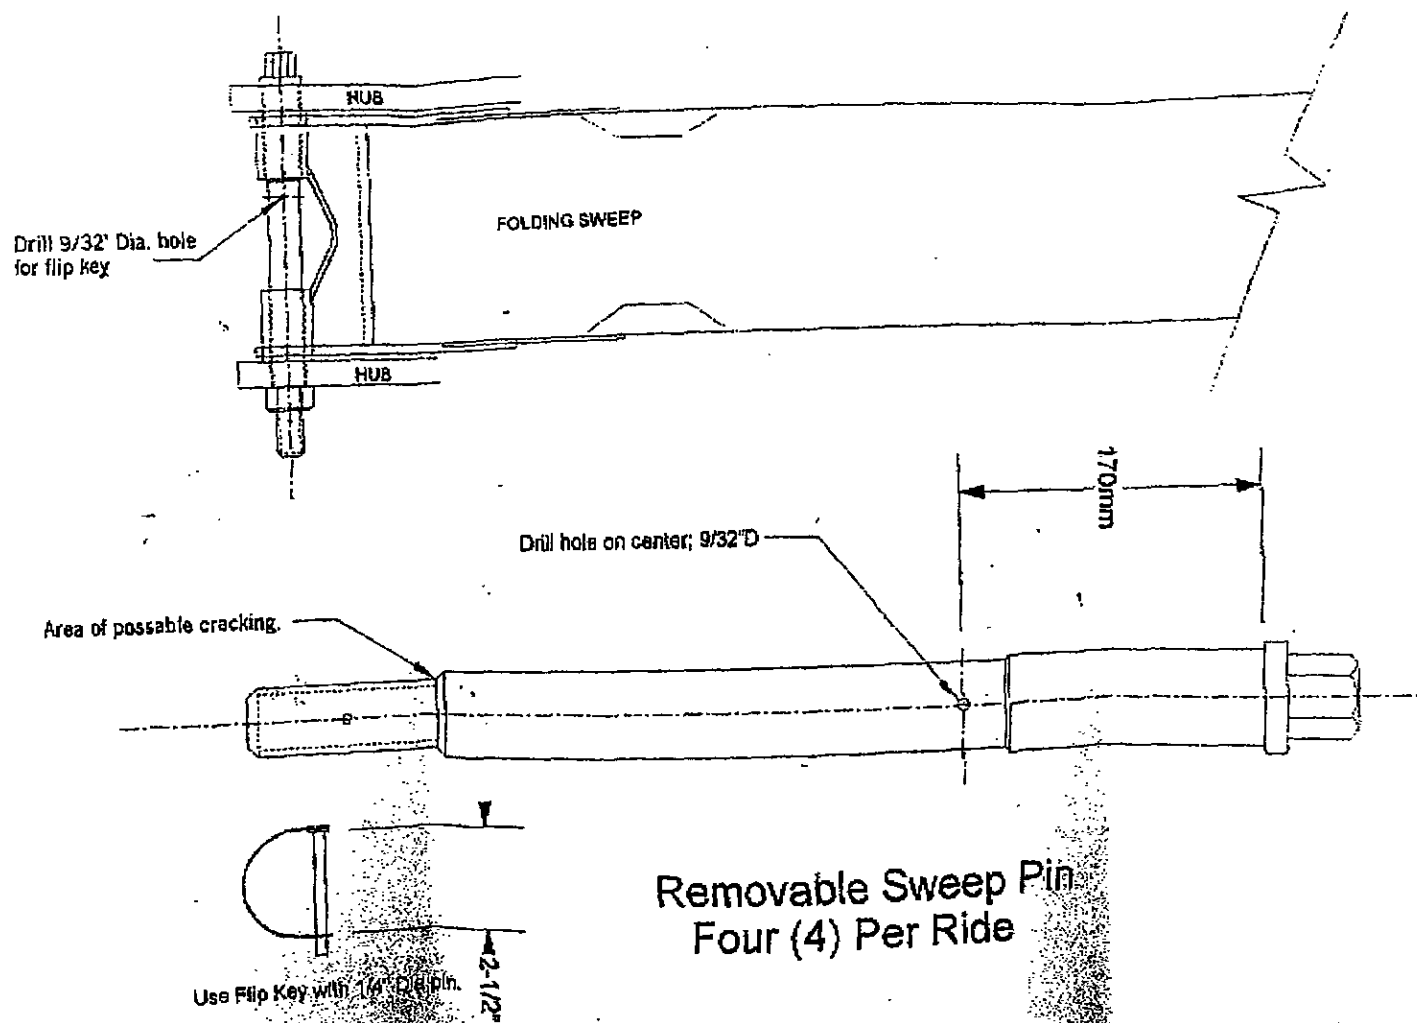
Tivoli Manufacturing Ltd. has become aware of some rides where the hinge / attachment pins used to hold the sweep to the center hub have become tight and make folding the sweep up for set up or tear down difficult. Tivoli Manufacturing Ltd. is recommending that grease fittings be installed in the pin sweep hub of the four (4) sweeps that pivot on their pin when folding.

Removable Sweep Pin  
Four (4) Per Ride
