Amusement Device Inspectors Support

**Safety Report No 5**

## Failure of a Miami Counterweight Weld Connection.

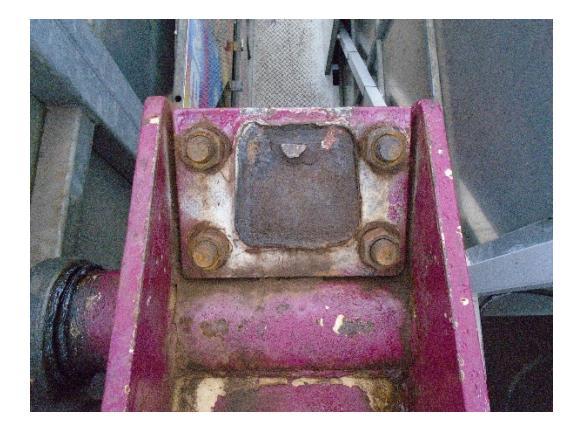
The weld, attaching the RHS (box section) that supports the counterbalance to the bolted connection plate between the fish plates, appears to have failed.

In the photograph below the bolted connection plate is still attached the fish plates and the area where the RHS member abutted the plate is clearly visible

From our investigation, it is clear the NDT was carried out with the counterweight in the attached or assembled condition.

The bolts and plates either side of the counterweight makes NDT of several areas of this weld very difficult in its assembled state. It may not be possible to clearly see the weld and there may be difficulty in getting the magnet or the yoke in position where it will develop sufficient flux. We believe that in order to carry out the NDT effectively the counterbalance must be unbolted.

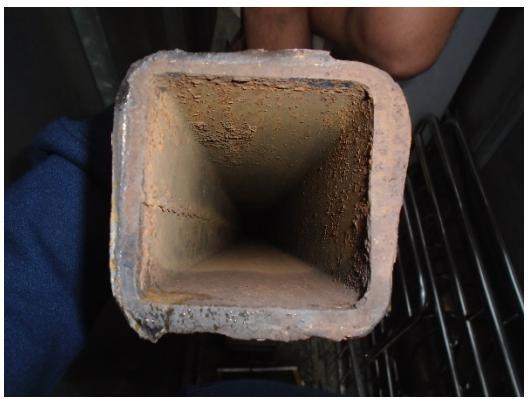
Above is the fractured end of the RHS member and it is questionable whether the end was prepared correctly prior to welding and it appears the manufacturers attachment weld may never have penetrated adequately.
