NAFLIC - Standards & Related Documents Committee | TECHNICAL BULLETIN - June 2015

410.

Zamperla Willy the Whale cracking

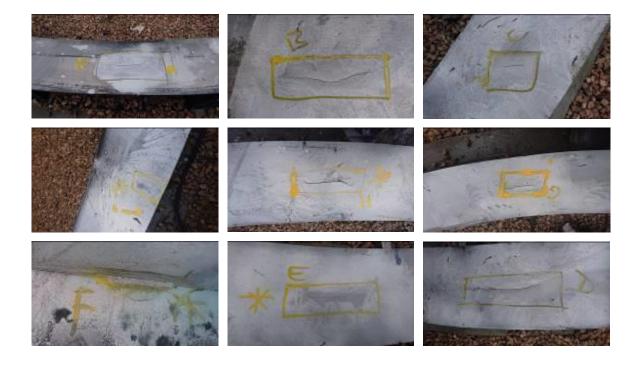
We have received a report from a UK registered inspection body that numerous areas of cracking have been found on the undulating track of a Willy the Whale device which has been in operation for six years. The cracking was found visually and confirmed by NDE. Crack lengths found range between 50mm and 300mm.
