## Service-Information

Based on field data collected from TOP SPIN installations worldwide, we would like you to check your ride for possible wear at the swing arm hinge as well the gondola suspension. The enclosed drawings/pictures shall help identifying the locations where to take the necessary measurements. They can be taken by your personnel or our field service engineers.

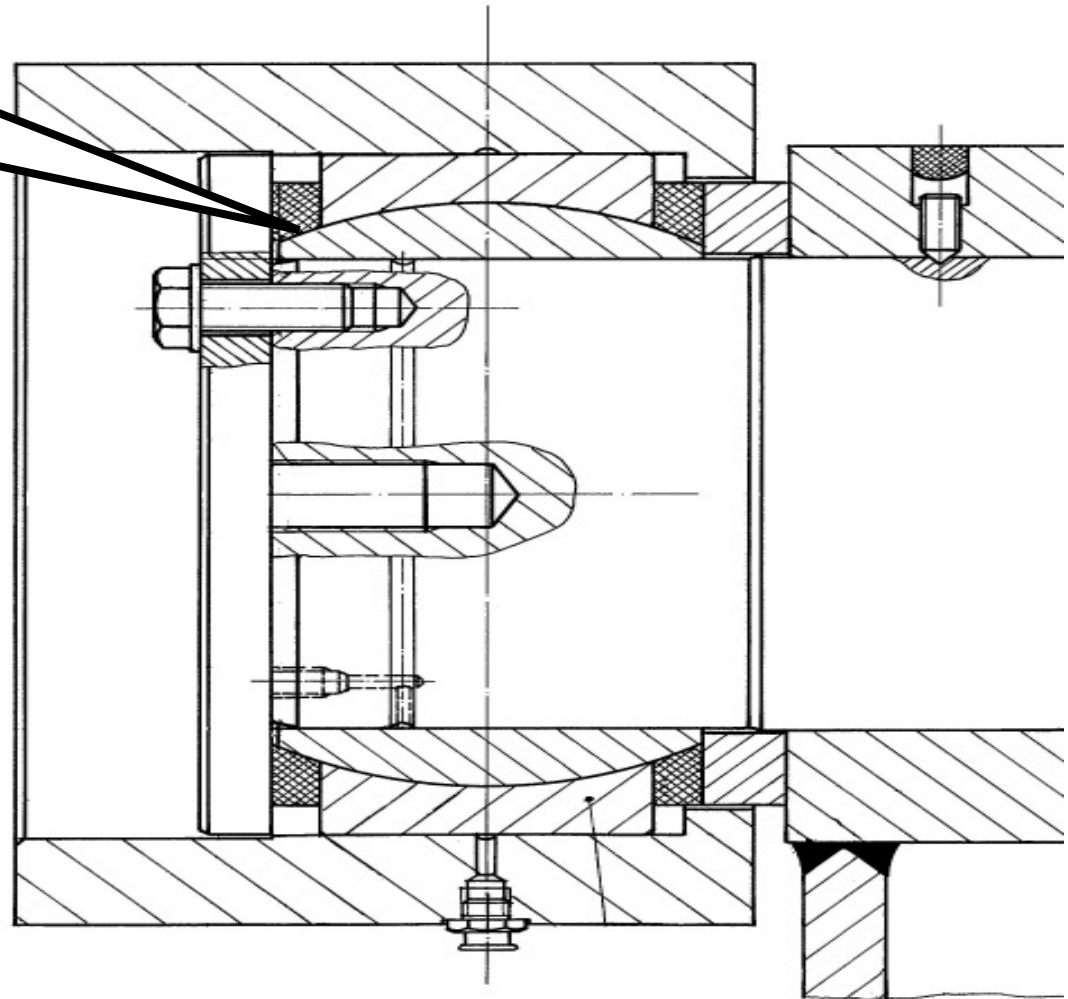
## Boom arm hinge front / Drehträgergelenk vorn

Surface of the inner bearing  
Ring have to be free of rust.  
If desired will a HUSS technician  
assist the evaluation.

Die Oberfläche der Lager Innenkugel  
muss rostfrei sein. Wenn gewünscht,  
kann ein HUSS Techniker bei  
der Beurteilung behilflich sein.

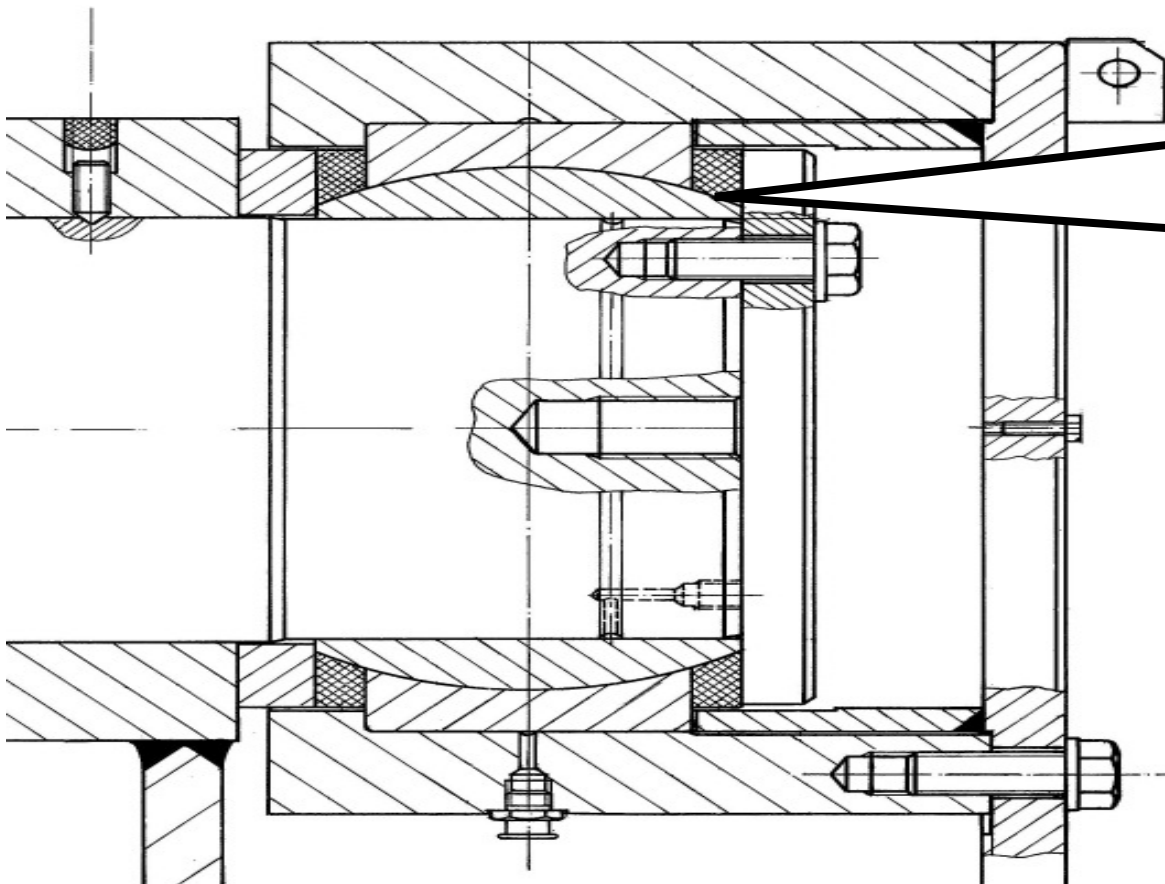
## Boom arm hinge back / Drehträgergelenk hinten

Surface of the inner bearing  
ring have to be free of rust.  
If desired will a HUSS technician  
assist the evaluation.

Die Oberfläche der Lager Innenkugel  
muss rostfrei sein.

Wenn gewünscht, kann ein HUSS Techniker  
bei der Beurteilung behilflich sein.

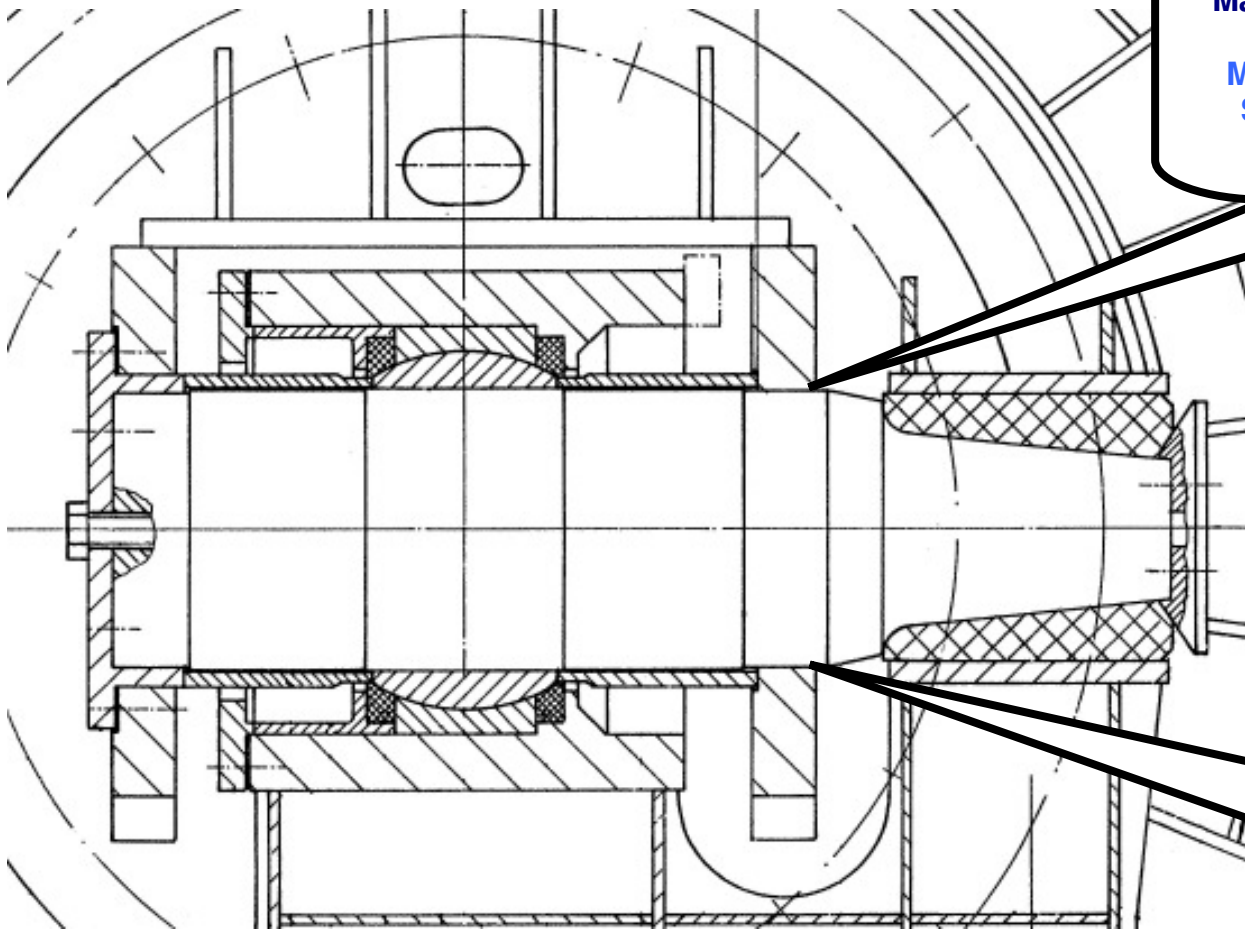
## Gondola suspension left & right / Gondelaufhängung links & rechts

Maximum allowed gap between steel  
structure and shaft is 0.3 mm  
Maximal zulässiger Spalt zwischen  
Stahlkonstruktion und Welle darf  
0,3 mm nicht überschreiten
