**WISDOM
INDUSTRIES, Ltd.**

SERVICE BULLETIN

DATE: APRIL 22, 2002
RIDE: SILVER STREAK/ FAMILY HIMALAYA
SUBJECT: SWEEP INSPECTION (16 SWEEPS)
COMPLIANCE: MANDATORY
COMPLETION DATE: IMMEDIATELY

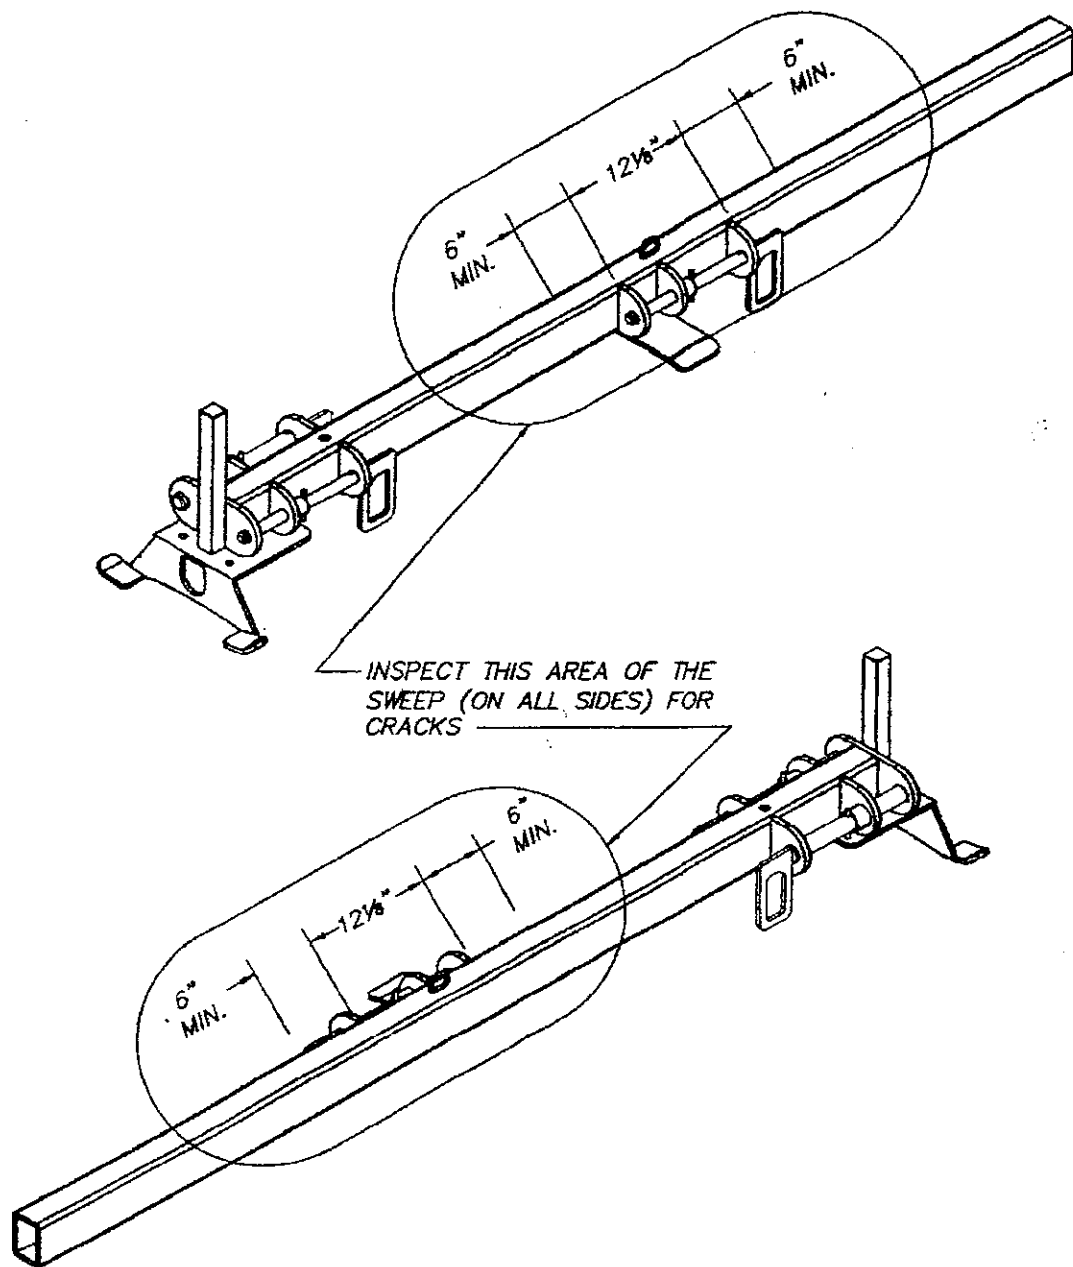
4H 105

One Family Himalaya has experienced cracking on one sweep where the inside seat attachment is welded. Review the drawing on the reverse side and inspect for cracking around the sweep. If cracks are indicated contact Wisdom Industries at 800-634-6907 for repair or replacement of the sweep before continuing operation.

INSPECT THIS AREA OF THE
SWEEP (ON ALL SIDES) FOR
CRACKS

1. Clean area on each sweep where the inside seat attachment is welded.
All 4 sides of sweep. (See Drawing)
2. Visually inspect 6" each side of the attachment for cracks on all 4 sides of the tubes.
3. Follow the visual inspection with magnaflex or dye penetrant.
4. If cracks are found contact Wisdom Industries before operating the ride.
5. Repeat for the other 15 sweeps.
6. Repeat inspection on a semi annual basis
