Zamperla Samba Balloon gondola shaft cracking on older rides

SERVICE BULLETIN

Ride Manufacturer: A. Zamperla SpA	Affected Production Dates: 2015 and earlier
Ride Name: Samba Balloon	Affected Serial Nos.:
Model Number: Samba Balloon - all	All

SAMBA BALLOON – NDT & Replacement Schedule Rev.3

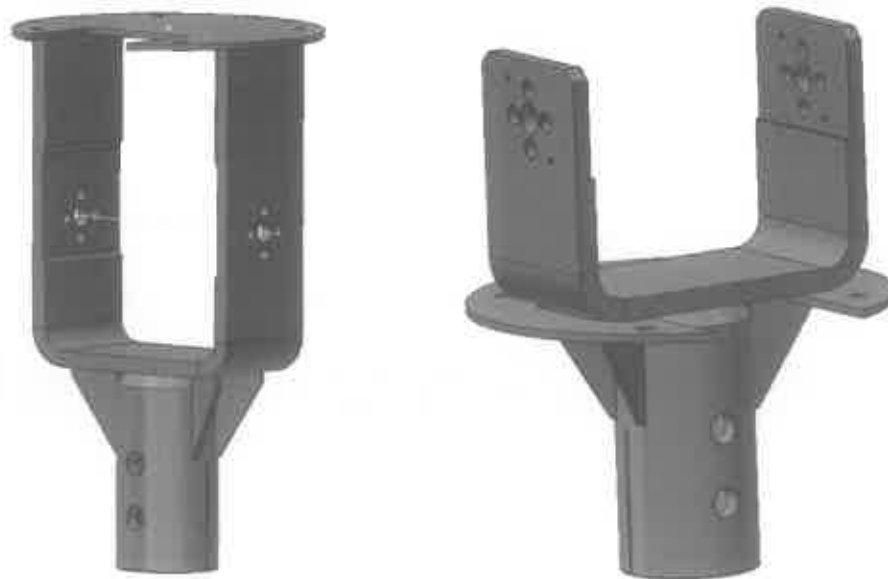
IMAGE 4 – SHAFT SUPPORT

4.1		SHAFT SUPPORT (weld)	4	VT	M6	Check welds
				MT	Y4	Check for cracks, corrosion
4.2				VT	M6	Check welds
				MT	Y4	Check for cracks, corrosion
4.4		SHAFT SUPPORT (holes and tube)		MT	Y4	Check for cracks, corrosion, ovalization at pin holes
5		SUPPORT PIN	5	MT	Y4	Check for cracks
				UT	Y4	Check for corrosion

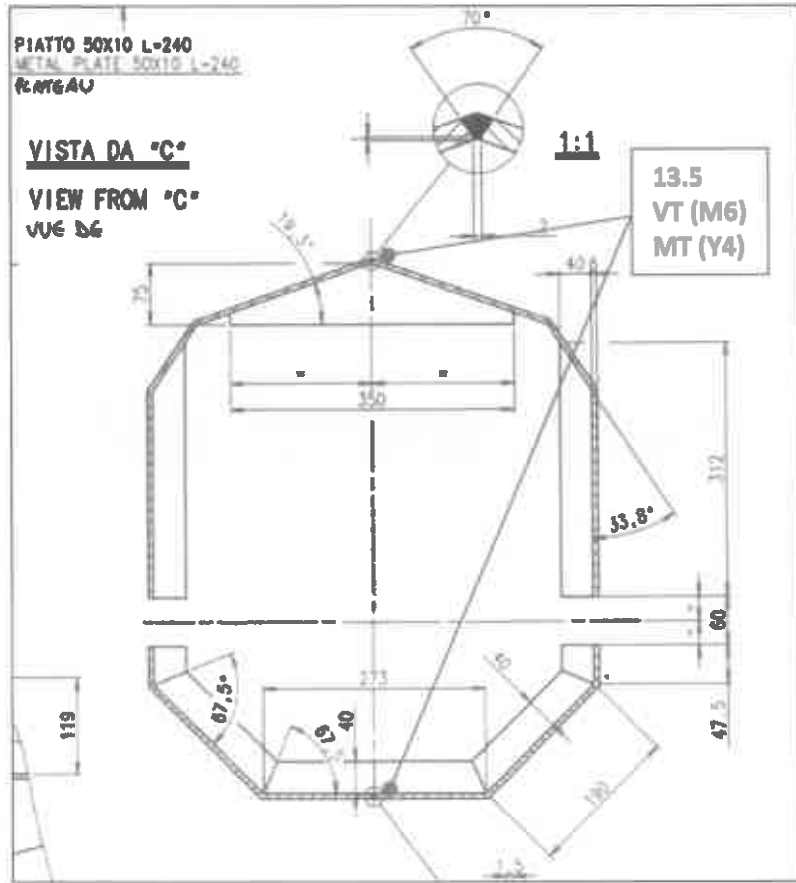
IMAGE 13 - FIXED CENTRE

12.4				VT	M6	Check welds
				MT	Y4	Check for cracks, corrosion
12.5				VT	M6	Check welds
				MT	Y4	Check for cracks, corrosion
13.1		FIXED CENTER	13	VT	M6	Check welds
				MT	Y4	Check for cracks, corrosion

13.2				VT	M6	Check welds
				MT	Y4	Check for cracks, corrosion
13.3				VT	M6	Check welds
				MT	Y4	Check for cracks, corrosion
13.4				VT	M6	Check welds
				MT	Y4	Check for cracks, corrosion

13.5				VT	M6	Check welds
				MT	Y4	Check for cracks, corrosion
14		WHEEL TROLLEY	14	MT	Y8	Check for cracks
				UT	Y8	Check for corrosion
15		WHEEL TROLLEY SUPPORT PIN	15	MT	Y4	Check for cracks
				UT	Y4	Check for corrosion
16		HYDRAULIC CYLINDER PIN	16	MT	Y4	Check for cracks
				UT	Y4	Check for corrosion
17		COLUMN	17	VT	M6	Check welds
				MT	Y4	Check for cracks, corrosion
